**National TAB
1329 E. KEMPER ROAD
SUITE 4210
CINCINNATI, OH 45246**

**Report: WALGREEN 3802 RV1 TAB RPT
Function: Test, Adjust, & Balance
Date: 01/27/2023**

**PROJECT
WALGREENS #3802 - RICHARDSON, TX**

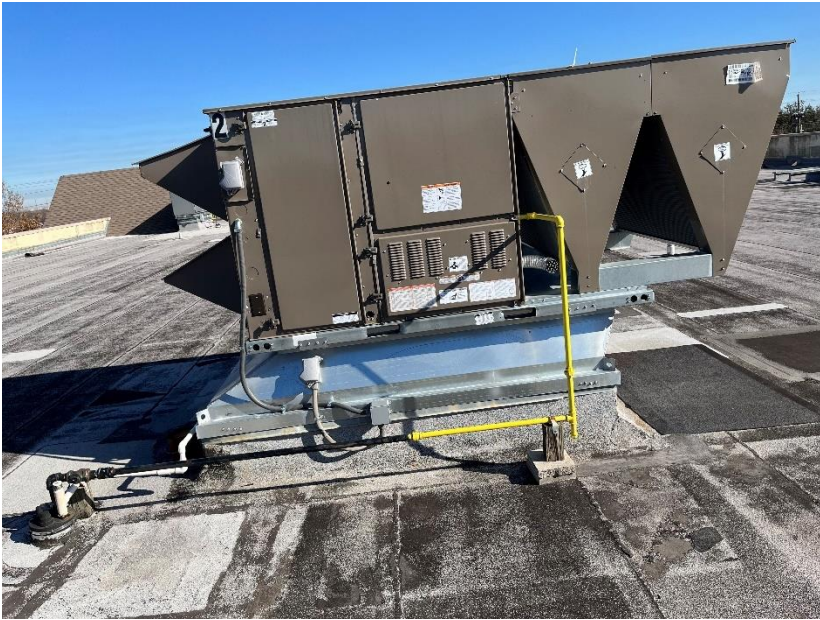
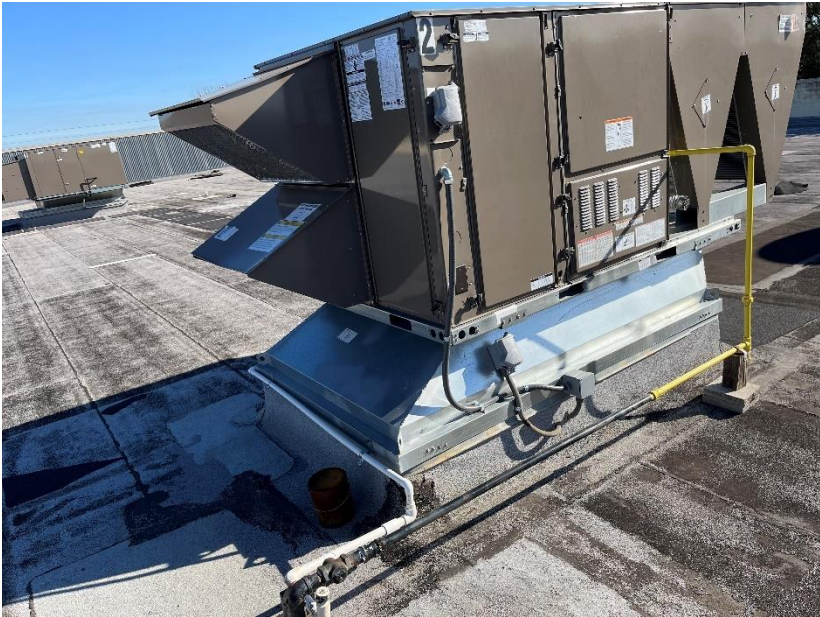
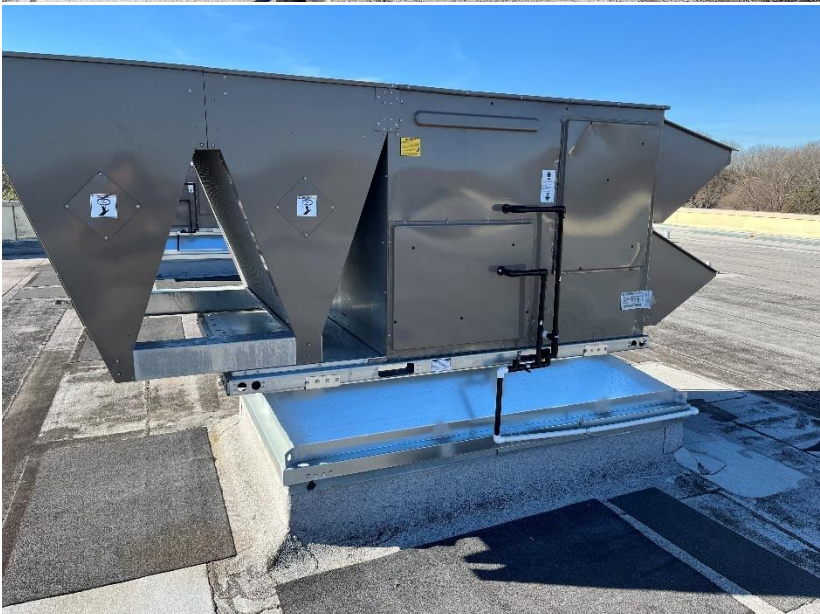
RTU-2 EXISTING CURB TO NEW CURB TRANSITION TO NEW RTU UNIT.

Further investigation took place for RTU-2 (Sales Floor) to determine cause of low flow conditions. Duct pressures were taken on the supply & return duct downstream. As indicated in previous report the overall static pressure is higher than typical measure at the unit itself. Additional static pressure points were taken in the ductwork. The pressure dropped dramatically at the main truckline going to the grills & before the duct transitions going up to the RTU unit on the roof. Below is a schematic(s) of the supply duct from the RTU unit through the new curb adapter down to the main trunkline of the supply distribution system. The multiple transitions & duct sizes in a very short distance will cause system affect which will adversely affect overall total airflow for the system. Also duct pressure will increase expediential trying to overcome the airflow losses caused by system affect. The unit is not capable of overcoming the losses before the motor is at maximum Brake Horsepower (BHP). If desired to increase airflow for the system, it would require rework of the supply duct system to have better transition from unit to main trunkline & any turning vanes installed for any short non radius transitions if possible. This may be deemed difficult due to space limitations & the drastic angular setup of the curb transition to the original curb arrangement. The return also has

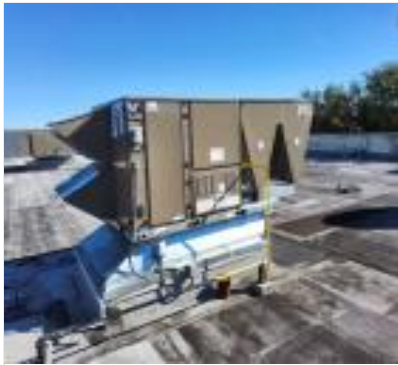
RTU-2

Notes: Airflow appears to be low due to restrictive curb adapter. The static pressures on the return and supply side of the unit are elevated. Motor is at the FLA rating

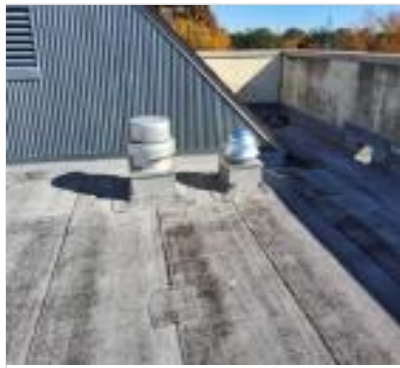
EF-4&5

The existing fan EF-4 backdraft damper remains failed Open & does not function. It does have an impact on current airflow measured. The only downside is if the fan gets turned off periodically, the backdraft damper remains open. If desired to increase airflow, removing motorized damper may improve overall airflow since currently the damper/motor assembly affects actual free area.

Fan rotation is correct	Pass
Pulleys are aligned and belts are tensioned properly	DIRECT DRIVE
Speed controller installed and functional (direct drive)	YES
Fan is secured to the curb	Pass
Back draft damper is installed and functional	Fail
No exterior damage to the fan	Pass
No unusual noise or vibration	Pass
Controls are functional	Pass
Additional Comments:	EF-5 has been abandoned by design EF-4 has a back draft damper that has failed or is not powered so it stuck in the open position.

It was determined that EF-5 which originally served the Photo Area & is being Capped off & is not to be utilized.
