Report: FINAL TAB REPORT
Function: Test, Adjust, & Balance
Date: 11/16/2022

11-14 TACO BELL - LEXINGTON, SC

1064 SOUTH LAKE DR

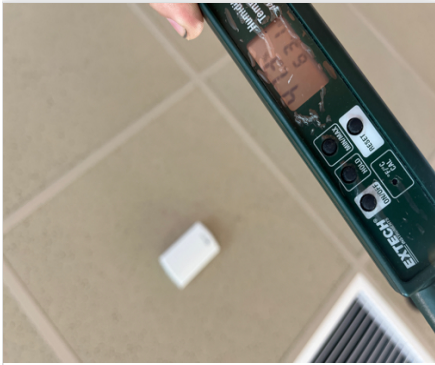
Issue Name : AC1 & AC2 / TEMP. SENSORS

Description : TEMP. SENSORS ARE NOT COMMUNICATING WITH THERMOSTATS. BOTH SENSORS ARE WIRED BUT DO NOT REGISTER ON THERMOSTATS WHEN HEAT IS APPLIED. GC IS AWARE OF THIS ISSUE. WHILE ON SITE AC1 DINING ROOM THERMOSTAT 71F / DINING SPACE 63F AC2 KITCHEN THERMOSTAT 72F / KITCHEN SPACE 75F

Is space free of drafting?	YES
Is space comfortable in all areas?	NO / AC1 DINING ROOM IS 63F THERMOSTAT IS READING 71F. I CANNOT GET THE THERMOSTAT AND TEMP. SENSOR TO COMMUNICATE WITH EACH OTHER, TEMP. SENSORS ARE WIRED. GC IS AWARE OF THIS ISSUE. AC2 THERMOSTAT AND TEMP SENSOR ARE NOT COMMUNICATING. KITCHEN THERMOSTAT IS READING 72F AND KITCHEN SPACE IS 75F
Is the space free of ventilation noise?	YES
If deviations from design were necessary to resolve 1-3 what were they? Otherwise put "NA".	YES / AC2 SGRD5 & SGRD9 DIFFUSERS ARE NOT INSTALLED AIR WAS DISTRIBUTED TO SGRD7, SGRD10, SGRD11, SGRD12 DUE TO THIS ISSUE AC2 / SGRD13 OFFICE DAMPER IS NOT INSTALLED GRILL CANNOT BE DAMPERED TO DESIGN CFM. OFFICE IS NOT UNCOMFORTABLE

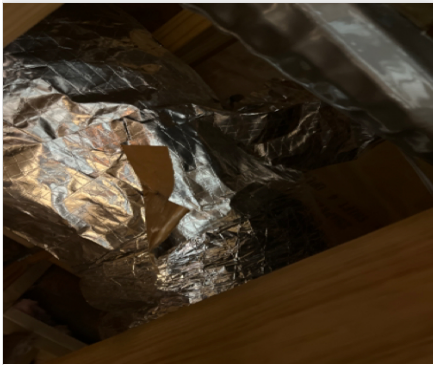
Issue Name : AC2 / SGRD13 DAMPER NOT INSTALLED

Description : AC2 SGRD13 DAMPER IS NOT INSTALLED, UNABLE TO BALANCE OFFICE DIFFUSER TO DESIGN CFM.

Notes: [1] AC2 SGRD5 & SGRD9 DIFFUSERS ARE NOT INSTALLED AIR WAS DISTRIBUTED TO SGRD7, SGRD10, SGRD11, SGRD12 DUE TO THIS ISSUE [2] SGRD13 OFFICE DAMPER IS NOT INSTALLED GRILL CANNOT BE DAMPERED TO DESIGN CFM. OFFICE IS NOT UNCOMFORTABLE

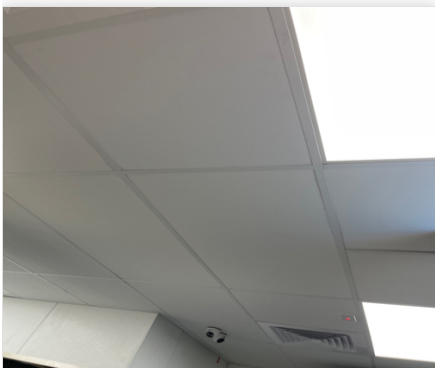
Issue Name : AC2 / SGRD9 NOT INSTALLED

Description : AC2 KITCHEN UNIT SGRD9 IS NOT INSTALLED. DIFFUSER SGRD7, SGRD10, SGRD11, SGRD12 WERE INCREASED DUE TO THIS ISSUE.

All diffusers and grilles are installed and match design?	YES / AC1 NO / AC2 SGRD5 & SGRD9 DIFFUSERS ARE NOT INSTALLED AIR WAS DISTRIBUTED TO SGRD7, SGRD10, SGRD11, SGRD12
All hood filters installed and accounted for?	YES
Hoods are wired and have power?	YES
Hood is free of alarms?	N/A
Thermostats have power?	YES
Have trades/general contractor been notified about any issues and are they created on FaciliBuild?	NO / STORE IS OPEN LOCATION GC AND TRADES ARE NOT ON SITE.

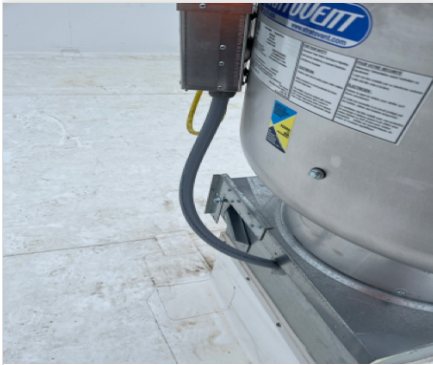
Issue Name : EF1 / CONDUIT

Description : EF1 CONDUIT IS NOT LONG ENOUGH TO LEAN FAN BACK OFF OF CURB.

Rotation is correct?	YES
Belts are tight?	FANS ARE DD
Grease cup installed on hood fan?	NO / EF1
Hinge kit installed installed on hood fan?	YES / EF1
Lean fan back. Is grease duct installation adequate and is duct ran all the way to the base of the fan?	EF1 / CANNOT LEAN FAN BACK DUE TO CONDUIT NOT BEING LONG ENOUGH TO LEAN FAN BACK

Flex conduit is long enough so that fan can be completely tilted back?	EF1 / CANNOT LEAN FAN BACK DUE TO CONDUIT NOT BEING LONG ENOUGH TO LEAN FAN BACK
There is no major leakage around base of fan?	NO LEAKAGE OBSERVED
Is the motor operating below the motor FLA rating?	YES
For restroom fan(s) is the back draft damper installed and can it fully open?	YES
Unit free of noticeable noise and vibration?	YES

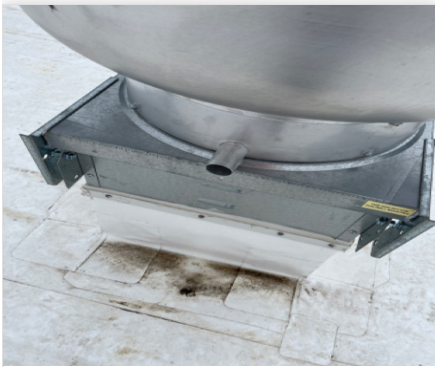
Issue Name : EF1 / GREASE TRAP

Description : EF1 GREASE TRAP IS NOT INSTALLED

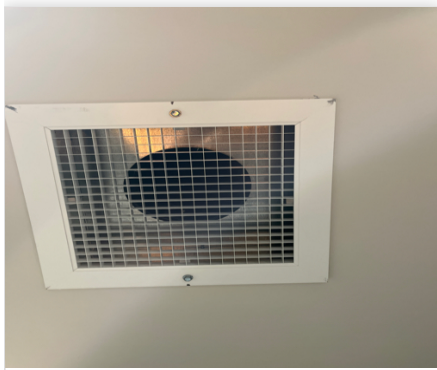
Issue Name : EF2 / DAMPERS

Description : EF2 RR FAN, DAMPERS NOT INSTALLED. WOMENS RR IS HIGH OF DESIGN DUE TO THIS ISSUE. FAN TOTAL IS WITHIN DESIGN CFM.

Notes: [1] DAMPERS WERE NOT INSTALLED UNABLE TO BALANCE EF2-2 TO DESIGN CFM. FAN TOTAL IS WITHIN DESIGN CFM.
