National TAB
1329 E. KEMPER ROAD
SUITE 4210
CINCINNATI, OH 45246

Report: FINAL TAB REPORT
Function: Test, Adjust, & Balance
Date: 11/16/2022

11-14 TACO BELL - LEXINGTON, SC

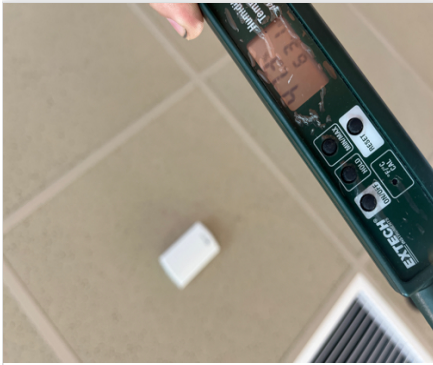
Issue Name : AC1 & AC2 / TEMP. SENSORS

Description : TEMP. SENSORS ARE NOT COMMUNICATING WITH THERMOSTATS. BOTH SENSORS ARE WIRED BUT DO NOT REGISTER ON THERMOSTATS WHEN HEAT IS APPLIED. GC IS AWARE OF THIS ISSUE. WHILE ON SITE AC1 DINING ROOM THERMOSTAT 71F / DINING SPACE 63F AC2 KITCHEN THERMOSTAT 72F / KITCHEN SPACE 75F

Is space free of drafting?	YES
Is space comfortable in all areas?	NO / AC1 DINING ROOM IS 63F THERMOSTAT IS READING 71F. I CANNOT GET THE THERMOSTAT AND TEMP. SENSOR TO COMMUNICATE WITH EACH OTHER, TEMP. SENSORS ARE WIRED. GC IS AWARE OF THIS ISSUE. AC2 THERMOSTAT AND TEMP SENSOR ARE NOT COMMUNICATING. KITCHEN THERMOSTAT IS READING 72F AND KITCHEN SPACE IS 75F
Is the space free of ventilation noise?	YES
If deviations from design were necessary to resolve 1-3 what were they? Otherwise put "NA".	YES / AC2 SGRD5 & SGRD9 DIFFUSERS ARE NOT INSTALLED AIR WAS DISTRIBUTED TO SGRD7, SGRD10, SGRD11, SGRD12 DUE TO THIS ISSUE AC2 / SGRD13 OFFICE DAMPER IS NOT INSTALLED GRILL CANNOT BE DAMPERED TO DESIGN CFM. OFFICE IS NOT UNCOMFORTABLE

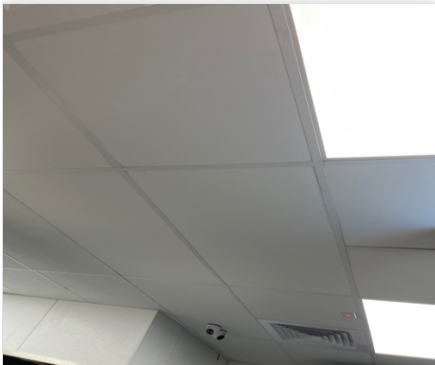
Issue Name : AC2 / SGRD9 NOT INSTALLED

Description : AC2 KITCHEN UNIT SGRD9 IS NOT INSTALLED. DIFFUSER SGRD7, SGRD10, SGRD11, SGRD12 WERE INCREASED DUE TO THIS ISSUE.

All diffusers and grilles are installed and match design?	YES / AC1 NO / AC2 SGRD5 & SGRD9 DIFFUSERS ARE NOT INSTALLED AIR WAS DISTRIBUTED TO SGRD7, SGRD10, SGRD11, SGRD12
All hood filters installed and accounted for?	YES
Hoods are wired and have power?	YES
Hood is free of alarms?	N/A
Thermostats have power?	YES
Have trades/general contractor been notified about any issues and are they created on FaciliBuild?	NO / STORE IS OPEN LOCATION GC AND TRADES ARE NOT ON SITE.

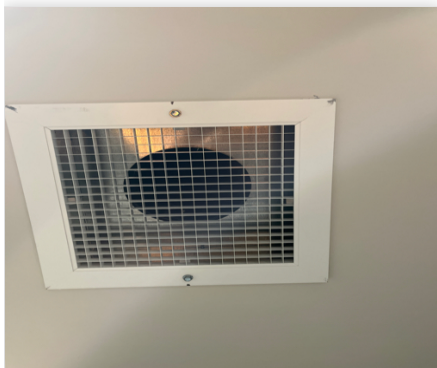
Issue Name : EF2 / DAMPERS

Description : EF2 RR FAN, DAMPERS NOT INSTALLED. WOMENS RR IS HIGH OF DESIGN DUE TO THIS ISSUE. FAN TOTAL IS WITHIN DESIGN CFM.

Notes: [1] DAMPERS WERE NOT INSTALLED UNABLE TO BALANCE EF2-2 TO DESIGN CFM. FAN TOTAL IS WITHIN DESIGN CFM.
