**Report: TAB Report**  
**Function: Test, Adjust, & Balance**  
**Date: 01/21/2026**  
**Completed By: National TAB**

**PROJECT**  
**01-19-26 QT #0785 BUFORD, GA**

2900 BUFORD DR

# National TAB

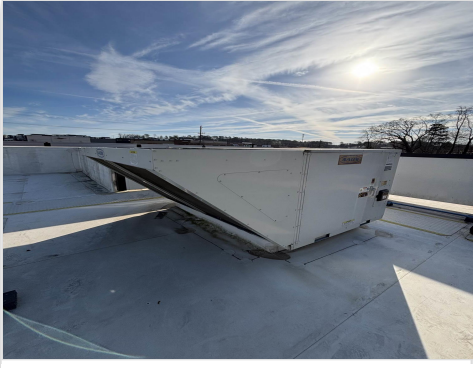
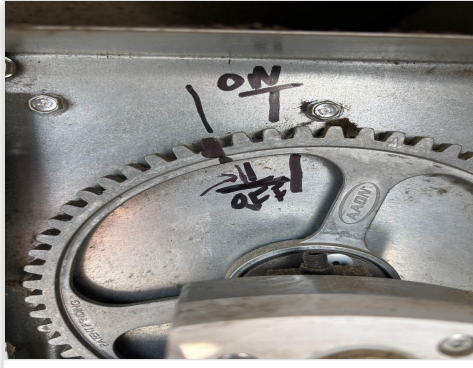
**Unit Data - PHOTO LOG**

AREA:SALES FLOOR

Unit Data	
	Actual
MFG	AAON
Serial Num	202107-ANEK21691
Model Num	RN-013-8-0-EA0A-152
Num OA Filters 1	1
OA Filter Size 1	22X45
Num Final Filter 1	4
Final Filter Size 1	20X25X2

Test Data		
	Design	Actual
SF CFM	4200	4302
SF RPM	-	1261
OA CFM (Hoods On)	800	784
OA CFM (Hoods Off)	350	364
RL Voltage	-	139 VFD
RL Amperage	-	7.16 VFD
VFD Max SetPt	-	43 Hz
VFD Min SetPt	-	24 Hz
OA Damper Position (Hoods On)	-	46%
OA Damper Position (Hoods Off)	-	26%

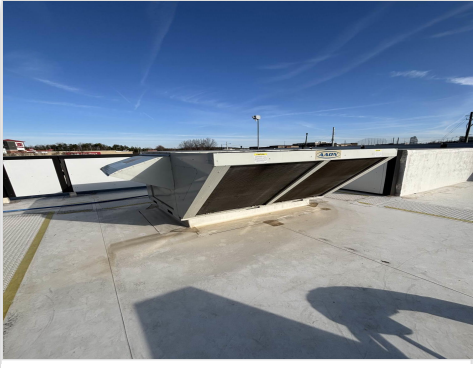
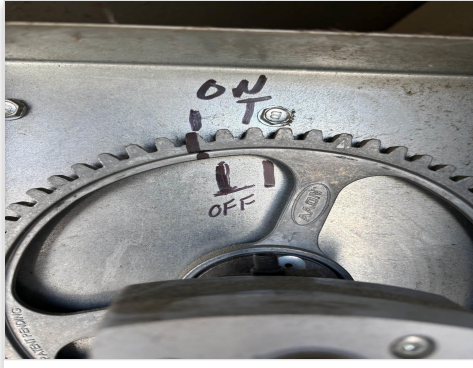
**Unit Data - PHOTO LOG**

AREA:SALES FLOOR

Unit Data	
	Actual
MFG	AAON
Serial Num	202107-ANEK21692
Model Num	RN-013-8-0-EA0A-152
Num OA Filters 1	1
OA Filter Size 1	22X45
Num Final Filter 1	4
Final Filter Size 1	20X25X2

Test Data		
	Design	Actual
SF CFM	4200	4183
SF RPM	-	1261
OA CFM (Hoods On)	800	825
OA CFM (Hoods Off)	350	337
RL Voltage	-	139 VFD
RL Amperage	-	7.15 VFD
VFD Max SetPt	-	43 Hz
VFD Min SetPt	-	24 Hz
OA Damper Position (Hoods On)	-	46%
OA Damper Position (Hoods Off)	-	26%

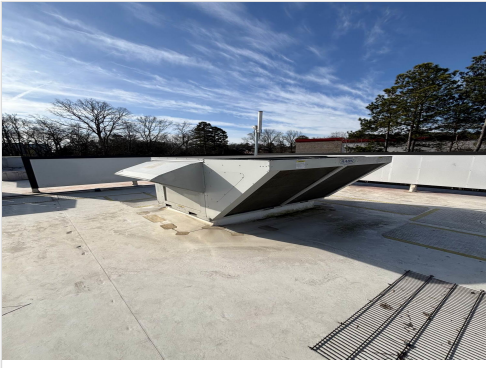
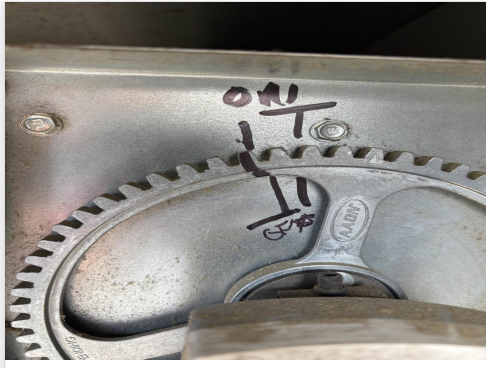
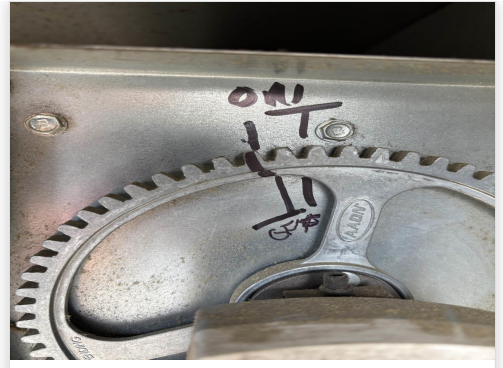
## Unit Data - PHOTO LOG

AREA:BOH/KITCHEN

Unit Data	
	Actual
MFG	AAON
Serial Num	202107-ANEK21693
Model Num	RN-013-8-0-EA0A-152
Num OA Filters 1	1
OA Filter Size 1	22X45
Num Final Filter 1	4
Final Filter Size 1	20X25X2

Test Data		
	Design	Actual
SF CFM	4200	4069
SF RPM	-	1480
OA CFM (Hoods On)	800	798
OA CFM (Hoods Off)	350	358
RL Voltage	-	171 VFD
RL Amperage	-	8.27 VFD
VFD Max SetPt	-	48 Hz
VFD Min SetPt	-	24 Hz
OA Damper Position (Hoods On)	-	46%
OA Damper Position (Hoods Off)	-	26%

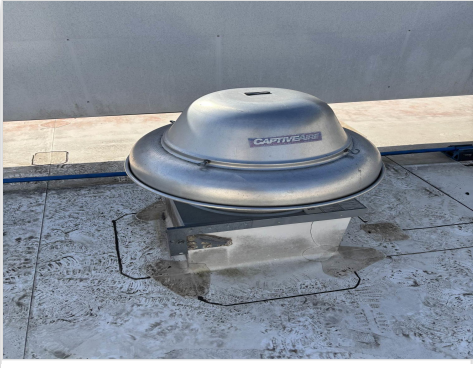
**Unit Data - PHOTO LOG**

AREA:RESTROOMS/JANITOR

Unit Data		
	Design	Actual
MFG	NA	CAPTIVEAIRE
Model Num	NA	DR50HFA
Serial Num	-	4991234
Type	-	DOWBLAST
Configuration	-	VERTICAL

Test Data		
	Design	Actual
CFM	750	727
Fan Rotation	-	CCW
System SetPt	-	LOW
RL Voltage	-	[1]
RL Amperage	-	[1]
Total ESP	-	0.34"
Fan Inlet SP	-	-0.34"
Fan Discharge SP	-	ATM

[1] UNABLE TO READ VOLTS AND AMPS SAFELY

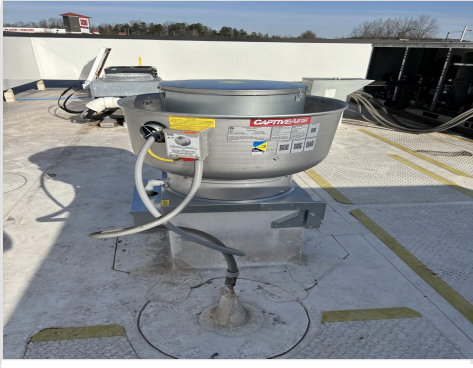
## Unit Data - PHOTO LOG

AREA:KITCHEN HD

Unit Data		
	Design	Actual
MFG	NA	CAPTIVEAIRE
Model Num	NA	DU50HFA
Serial Num	-	8225572
Type	UPBLAST	UPBLAST
Configuration	VERTICAL	VERTICAL

Test Data		
	Design	Actual
CFM	1350	1298
Fan RPM	-	1180
Fan Rotation	-	CCW
Motor RPM	-	1180
System SetPt	-	52.6 Hz (65% on MSC))
RL Voltage	-	208
RL Amperage	-	1.8
Total ESP	-	0.43"
Fan Inlet SP	-	-0.43"
Fan Discharge SP	-	ATM

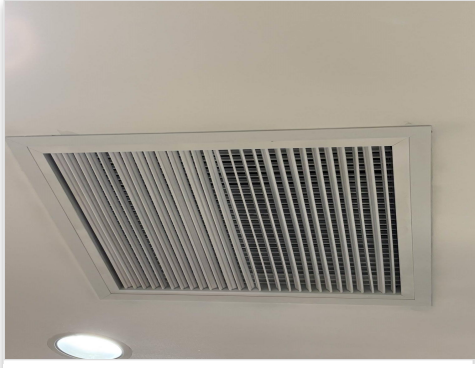
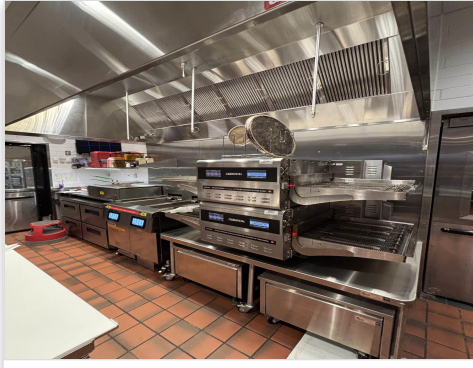
**Unit Data - PHOTO LOG**

AREA:GRIDDLE

Unit Data		
	Design	Actual
MFG	CAPTIVEAIRE	CAPTIVEAIRE
Model Num	6030ND-2-F	6030ND-2-F
Job / Serial Num	-	8225572
Type	TYPE I CANOPY	TYPE I CANOPY
Hood length	108"	108"
Hood Width	60"	60"

Test Data Exhaust		
	Design	Actual
Filter Type	-	CAPTRATE SOLO FILTER
Filter Size 1	-	16X20
Filter Qty 1	-	6
Filter AK factor size 1	-	2.08
Filter Total AK Area	-	12.48
Filter1 FPM	-	96
Filter2 FPM	-	108
Filter3 FPM	-	107
Filter4 FPM	-	109
Filter5 FPM	-	111
Filter6 FPM	-	97
Filter Ave FPM(corr)	-	104
CFM	1350	1298
