**National TAB
1329 E. KEMPER ROAD
SUITE 4210
CINCINNATI, OH 45246**

**Report: TAB REPORT
Function: Test, Adjust, & Balance
Date: 01/16/2023**

01-09-23 FREDDY'S - CHESAPEAKE, VA

Section	Page #
Summary	3
Balance Schedule	4
Site Pictures	5
Checklist Data	9
AHU/RTU	11
FAN - Exhaust	15
Kitchen Hood Type I	19
GRD Layout	21

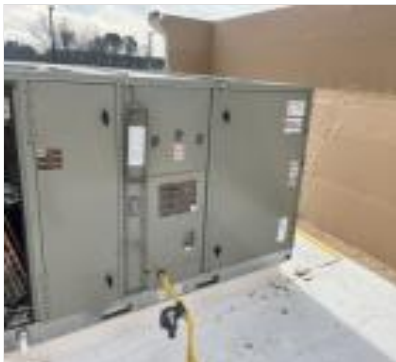
RTU-1

Asset: RTU1

AREA: DINING

Unit Data		
	Design	Actual
MFG	TRANE	TRANE
Serial Num	-	221010789D
Model Num	YHD150G3R	YHD150G3R
Type	RTU	RTU
Configuration	VERTICAL	Vertical
Num OA Filters 1	-	1
OA Filter Size 1	-	58X17
Num Final Filter 1	-	4
Final Filter Size 1	-	20X20X2
Num Final Filter 2	-	4
Final Filter Size 2	-	20X25X2

Test Data		
	Design	Actual
SF CFM	5000	5020
SF RPM	-	682
RA CFM	4128	4190
OA CFM	872	830
RL Voltage	-	209/208/210
RL Amperage	-	7.5/7.3/6.8
SF Rotation	-	CW
RA Damper Position	-	Marked
Min OA Damper Position	-	Marked
Min OA Damper Type	-	SBD
OA Enthalpy Setpt	-	"E"

Performance Data		
	Design	Actual
MA Plenum SP	-	-0.2018"
Fan Suction SP	-	-0.4313"
Fan Discharge SP	-	0.3487"
Total ESP	1.0"	0.5505"
Fan Total SP	-	0.78"

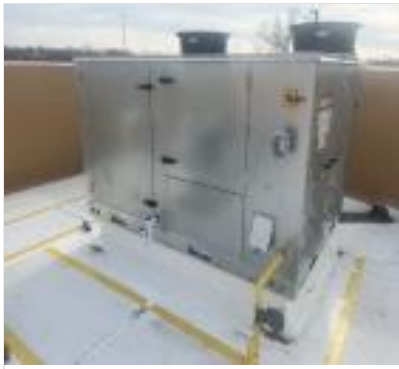
DOAS-1

Asset: DOAS1

AREA:KITCHEN

Unit Data		
	Design	Actual
MFG	CAPTIVEAIRE	CAPTIVEAIRE
Serial Num	-	5019898
Model Num	CASRTU3-I.250-18-20T-DOAS	CASRTU3-I.250-18-20T-DOAS
Type	DOAS	DOAS
Configuration	VERTICAL	Vertical
Num OA Filters 1	-	4
OA Filter Size 1	-	16X25X2
Num Final Filter 1	-	8
Final Filter Size 1	-	20X25X2

Test Data		
	Design	Actual
SF CFM	2375	2194
SF RPM	-	3
RA CFM	0	0
OA CFM	2375	2194
RL Voltage	-	209/209/210
RL Amperage	-	4.2 "VFD"
SF Rotation	-	CW
RA Damper Position	-	0%
Min OA Damper Position	-	100%
Min OA Damper Type	-	OBD

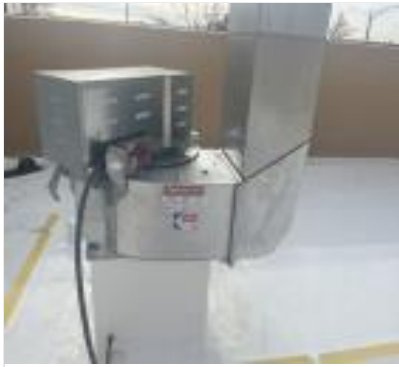
KEF-1

Asset: KEF1

AREA:HOOD 1

Unit Data		
	Design	Actual
MFG	CAPTIVEAIRE	CAPTIVEAIRE
Model Num	CASRE18DD	CASRE18DD
Serial Num	-	5019898
Type	UTILITY	Utility Upblast
Configuration	VERTICAL	Vertical

Test Data		
	Design	Actual
CFM	1600	1641
Fan RPM	1105	1106
Fan Rotation	-	CCW
Motor RPM	-	1106
System SetPt	-	51.7
RL Voltage	-	155.4/155.7/155.5
RL Amperage	-	3.2 "VFD"
Total ESP	1.4"	0.7737"
Fan Inlet SP	-	-0.7737"
Fan Discharge SP	-	ATM

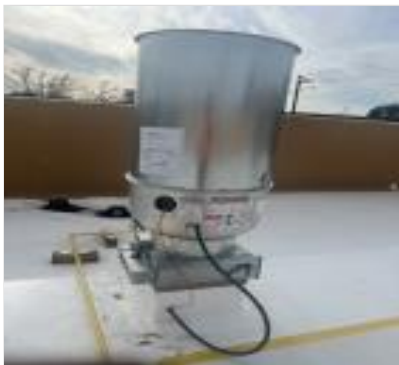
KEF-2

Asset: KEF2

AREA:HOOD 2

Unit Data		
	Design	Actual
MFG	CAPTIVEAIRE	CAPTIVEAIRE
Model Num	DU50HFA	DU50HFA
Serial Num	-	5019898
Type	UPBLAST	Upblast
Configuration	VERTICAL	Vertical

Test Data		
	Design	Actual
CFM	775	806
Fan RPM	1532	900
Fan Rotation	-	CCW
Motor RPM	-	900
System SetPt	-	50%
RL Voltage	-	122.3
RL Amperage	-	3.0 "VFD"
Total ESP	1.250"	0.4398"
Fan Inlet SP	-	-0.4398"
Fan Discharge SP	-	ATM

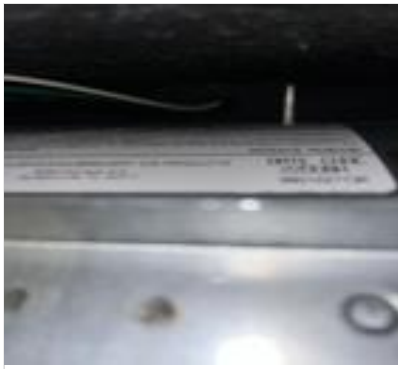
EF-1

Asset: EF1

AREA:WOMEN RR

Unit Data		
	Design	Actual
MFG	COOK	COOK
Model Num	GC-146	GC-146
Serial Num	-	NA
Type	CEILING	Ceiling
Configuration	VERTICAL	Vertical

Test Data		
	Design	Actual
CFM	75	77
Fan RPM	900	NA
Fan Rotation	-	CCW
System SetPt	-	Low speed
RL Voltage	-	122.2
RL Amperage	-	1.2
Total ESP	0.25"	NA

Notes: Unable to see motor information.

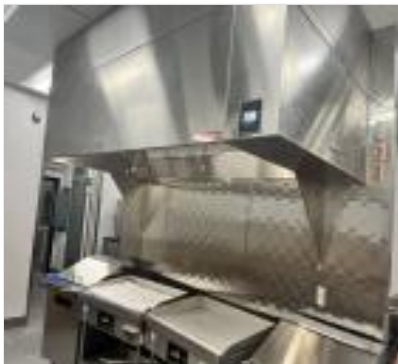
HOOD-1

Asset: HD1

Unit Data		
	Design	Actual
MFG	CAPTIVEAIRE	CAPTIVEAIRE
Model Num	5424 ND-2	5424 ND-2
Job / Serial Num	-	5019898
Type	TYPE I CANOPY	Type I High Proximity
Hood length	96	96"
Hood Width	54	54"

Test Data Exhaust		
	Design	Actual
Filter Type	CAPTRATE SOLO	Captrate Solo
Filter Size 1	16X16	16X16
Filter Qty 1	5	5
Filter AK factor size 1	1.62	1.62
Filter Total AK Area	8.1	8.1
Filter1 FPM	-	203.1
Filter2 FPM	-	201
Filter3 FPM	-	209.8
Filter4 FPM	-	204
Filter5 FPM	-	194.9
Filter Ave FPM(corr)	-	202.56
CFM	1600	1641

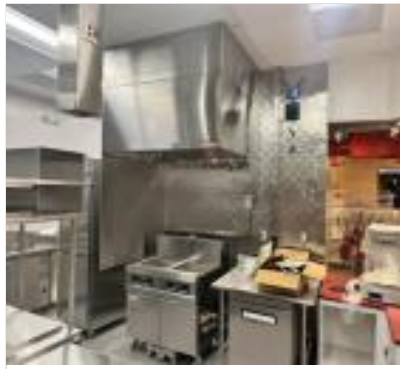
HOD-2

Asset: HD2

Design	Actual
MFG	CAPTIVEAIRE	CAPTIVEAIRE
Model Num	5424 ND-2	5424 ND-2
Job / Serial Num	-	5019898
Type	TYPE I CANOPY	Type I High Proximity
Hood length	60	60"
Hood Width	54	54"

Design	Actual
Filter Type	CAPTRATE SOLO	Captrate Solo
Filter Size 1	16X16	16X16
Filter Qty 1	3	3
Filter AK factor size 1	1.62	1.62
Filter Total AK Area	4.86	4.86
Filter1 FPM	-	166.2
Filter2 FPM	-	155.8
Filter3 FPM	-	175.3
Filter Ave FPM(corr)	-	165.77
CFM	775	806
