Report: TAB Report
Function: Test, Adjust, & Balance
Date: 06/23/2025
Completed By: National TAB

PROJECT
06-16-25 WAWA #5807 SEMMES, AL

2137 N. SCHILLINGER RD

SEMMES , AL 36575

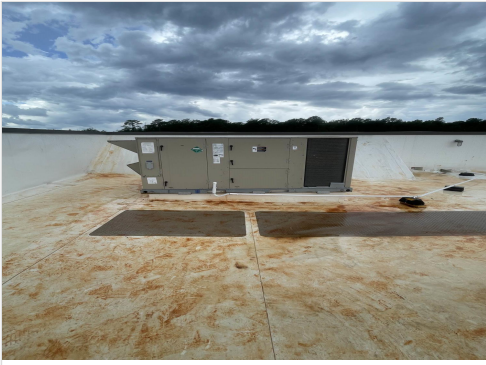
Unit Data - PHOTO LOG

Asset: RTU1

AREA:BACK OF HOUSE

Unit Data		
	Design	Actual
MFG	LENNNOX	LENNNOX
Serial Num	-	5624K03758
Model Num	LCT150H4E	LCT150H4E
Type	RTU	RTU
Configuration	VERTICAL	VERTICAL
Num OA Filters 1	-	2
OA Filter Size 1	-	14"X23"
Num Final Filter 1	-	4
Final Filter Size 1	-	20"X25"X2"

Return diffusers below design.

Verified outside air set point and reading is accurate.

Performed troubleshooting by closing OA damper completely and reading returns then incrementally opening OA damper to original set point.

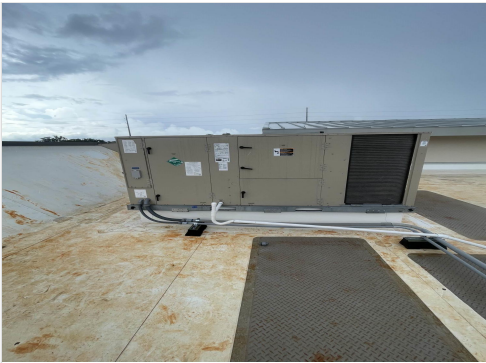
Unit Data - PHOTO LOG

Asset: RTU2

AREA:SALES

Unit Data		
	Design	Actual
MFG	LENNOX	LENNOX
Serial Num	-	5624L01987
Model Num	LCT102H4E	LCT102H4E
Type	RTU	RTU
Configuration	VERTICAL	VERTICAL
Num OA Filters 1	-	2
OA Filter Size 1	-	14"X23"
Num Final Filter 1	-	4
Final Filter Size 1	-	20"X25"2"

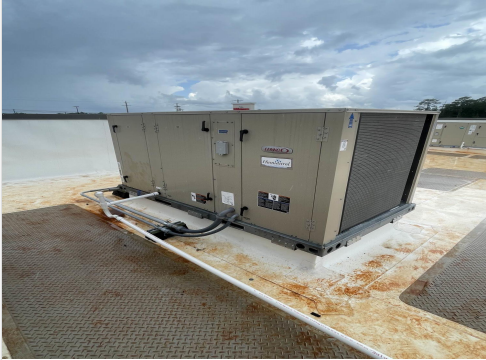
Unit Data - PHOTO LOG

Asset: RTU3

AREA:FRONT OF HOUSE

Unit Data		
	Design	Actual
MFG	LENNOX	LENNOX
Serial Num	-	5624L05433
Model Num	LCT072H4E	LCT072H4E
Type	RTU	RTU
Configuration	VERTICAL	VERTICAL
Num OA Filters 1	-	1
OA Filter Size 1	-	15"X32"
Num Final Filter 1	-	4
Final Filter Size 1	-	20"X20"X2"
