Report: Prelim Report
Function: Test, Adjust, & Balance
Date: 06/18/2025
Completed By: National TAB

PROJECT
06-16-25 WAWA #5807 SEMMES, AL

Project: 06-16-25 WAWA #5807 SEMMES, AL

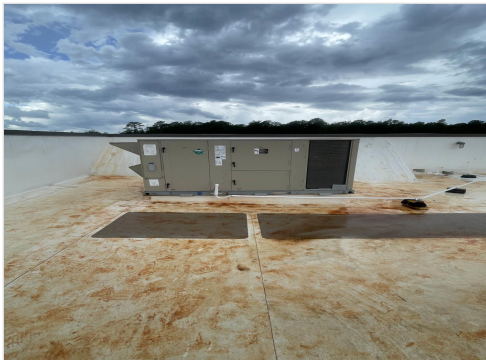
Unit Data - PHOTO LOG

Asset: RTU1

AREA:BACK OF HOUSE

Unit Data		
	Design	Actual
MFG	LENNNOX	LENNNOX
Serial Num	-	5624K03758
Model Num	LCT150H4E	LCT150H4E
Type	RTU	RTU
Configuration	VERTICAL	VERTICAL
Num OA Filters 1	-	2
OA Filter Size 1	-	14"X23"
Num Final Filter 1	-	4
Final Filter Size 1	-	20"X25"X2"

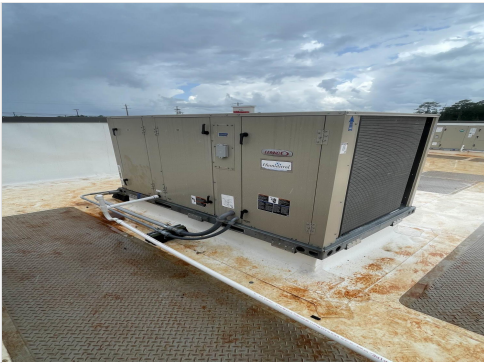
Unit Data - PHOTO LOG

Asset: RTU3

AREA:FRONT OF HOUSE

Unit Data		
	Design	Actual
MFG	LENNOX	LENNOX
Serial Num	-	5624L05433
Model Num	LCT072H4E	LCT072H4E
Type	RTU	RTU
Configuration	VERTICAL	VERTICAL
Num OA Filters 1	-	1
OA Filter Size 1	-	15"X32"
Num Final Filter 1	-	4
Final Filter Size 1	-	20"X20"X2"
