Report: TAB Report
Function: Test, Adjust, & Balance
Date: 06/23/2025
Completed By: National TAB

PROJECT
06-16-25 WAWA #5807 SEMMES, AL

Project: 06-16-25 WAWA #5807 SEMMES, AL

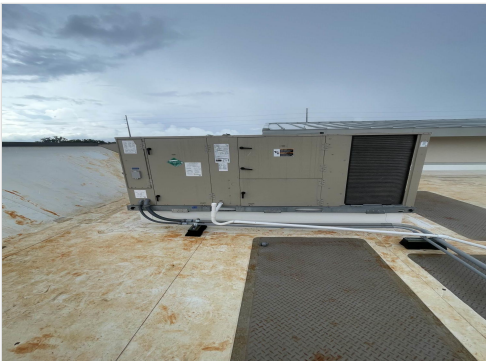
Unit Data - PHOTO LOG

Asset: RTU2

Unit Data		
	Design	Actual
MFG	LENNOX	LENNOX
Serial Num	-	5624L01987
Model Num	LCT102H4E	LCT102H4E
Type	RTU	RTU
Configuration	VERTICAL	VERTICAL
Num OA Filters 1	-	2
OA Filter Size 1	-	14"X23"
Num Final Filter 1	-	4
Final Filter Size 1	-	20"X25"2"

Test Data		
	Design	Actual
SF CFM	3400	3516
SF RPM	-	1335
MOTOR RPM	-	1335
RA CFM	3020	3168
OA CFM	380	348
RL Voltage	-	213/213.3/213.7
RL Amperage	-	3.7/3.85/3.62
SF System SetPt	-	75%
RA Damper Position	-	80%
OA Damper Position	-	20%
OA Damper Type	-	ECONOMIZER
