Report: TAB Report
Function: Test, Adjust, & Balance
Date: 06/23/2025
Completed By: National TAB

PROJECT
06-16-25 WAWA #5807 SEMMES, AL

Project: 06-16-25 WAWA #5807 SEMMES, AL

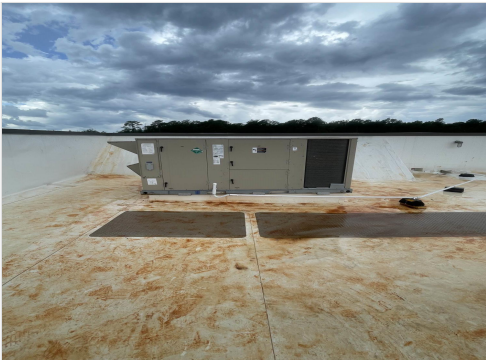
Unit Data - PHOTO LOG

Asset: RTU1

Unit Data		
	Design	Actual
MFG	LENNNOX	LENNNOX
Serial Num	-	5624K03758
Model Num	LCT150H4E	LCT150H4E
Type	RTU	RTU
Configuration	VERTICAL	VERTICAL
Num OA Filters 1	-	2
OA Filter Size 1	-	14"X23"
Num Final Filter 1	-	4
Final Filter Size 1	-	20"X25"X2"

- Return diffusers below design.
- Verified outside air set point and reading is accurate.
- Performed troubleshooting by closing OA damper completely and reading returns then incrementally opening OA damper to original set point.

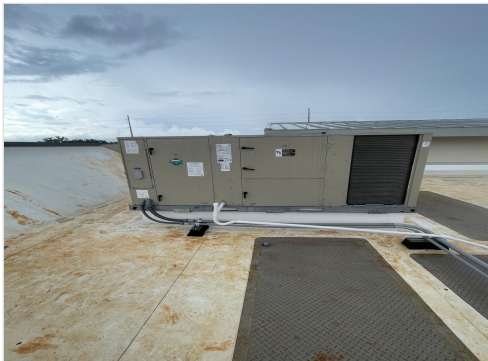
Unit Data - PHOTO LOG

Asset: RTU2

Unit Data		
	Design	Actual
MFG	LENNOX	LENNOX
Serial Num	-	5624L01987
Model Num	LCT102H4E	LCT102H4E
Type	RTU	RTU
Configuration	VERTICAL	VERTICAL
Num OA Filters 1	-	2
OA Filter Size 1	-	14"X23"
Num Final Filter 1	-	4
Final Filter Size 1	-	20"X25"2"

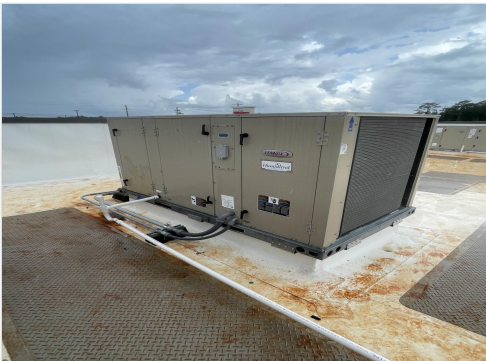
Unit Data - PHOTO LOG

Asset: RTU3

Unit Data		
	Design	Actual
MFG	LENNOX	LENNOX
Serial Num	-	5624L05433
Model Num	LCT072H4E	LCT072H4E
Type	RTU	RTU
Configuration	VERTICAL	VERTICAL
Num OA Filters 1	-	1
OA Filter Size 1	-	15"X32"
Num Final Filter 1	-	4
Final Filter Size 1	-	20"X20"X2"

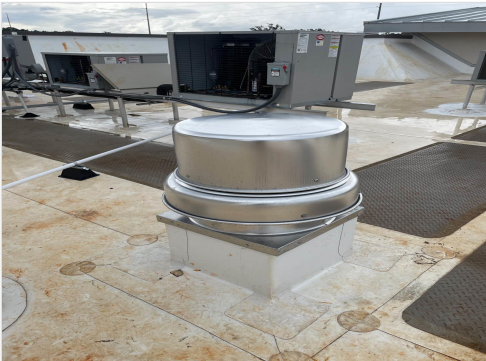
Unit Data - PHOTO LOG

Asset: EF1

Unit Data		
	Design	Actual
MFG	GREENHECK	GREENHECK
Model Num	GB-098-6	GB-098-6
Serial Num	-	26006490
Type	DOWNBLAST	DOWNBLAST
Configuration	VERTICAL	VERTICAL

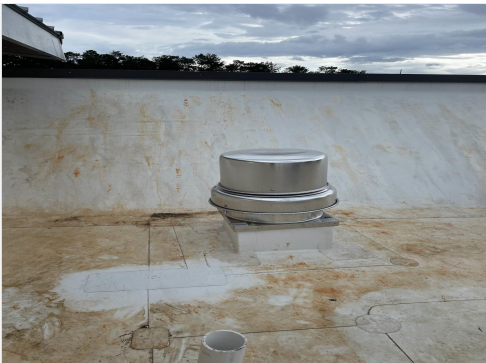
Unit Data - PHOTO LOG

Asset: EF2

Unit Data		
	Design	Actual
MFG	GREENHECK	GREENHECK
Model Num	GB-098-6	GB-098-6
Serial Num	-	26006561
Type	DOWNBLAST	DOWNBLAST
Configuration	VERTICAL	VERTICAL

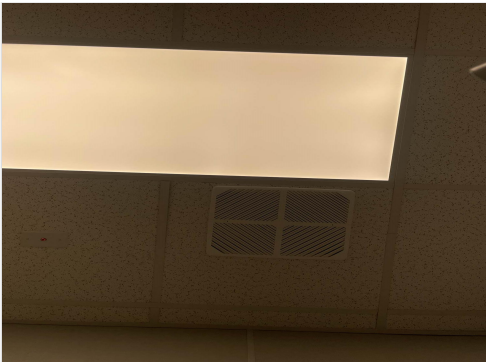
Unit Data - PHOTO LOG

Asset: EF3

Unit Data		
	Design	Actual
MFG	GREENHECK	GREENHECK
Model Num	SP-B200	SP-B200
Serial Num	-	165782962-0050
Type	CEILING	CEILING
Configuration	VERTICAL	VERTICAL
