Report: TAB REPORT
Function: Test, Adjust, & Balance
Date: 11/29/2023

11-06-23 CARMAX #7178 - WAUKESHA, WI

Project Summary

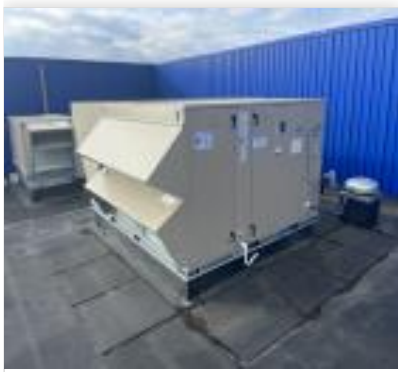
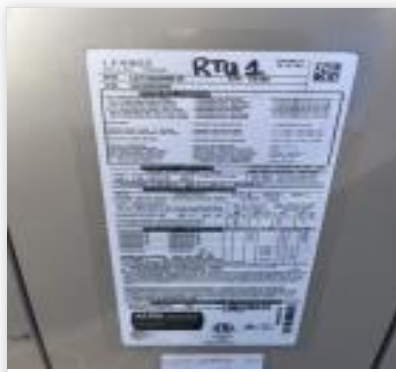
RTU-1
11/29/2023

Unit Data		
	Design	Actual
MFG	LENNOX	LENNOX
Serial Num	-	5623H03940
Model Num	LGH180H4M	LGH180H4M
Type	RTU	RTU
Configuration	VERTICAL	VERTICAL
Num OA Filters 1	-	3
OA Filter Size 1	-	23X13
Num Final Filter 1	-	6
Final Filter Size 1	-	24X24X2

Motor Data		
	Design	Actual
Motor MFG	-	INTERLINK
Frame	-	56HZ
Horsepower	3.0	3.0
Motor Rpm	-	1750
Phase	3	3
Rated Voltage	480	480
Rated Amperage	-	4.0

Drive Data		
	Design	Actual
Motor Sheave Size	-	4"
Motor Bore Size	-	7/8"
Motor Sheave SetPt	-	4.5 TURNS OPEN
Fan Sheave Size	-	BK72
Fan Sheave Bore	-	1-3/16"
Belt CL Distance	-	20.5"
Num of Belts	-	1
Belt Size	-	BX55
Belt Alignment	-	VERIFIED

Test Data		
	Design	Actual
SF CFM	5750	5851
SF RPM	-	758
RA CFM	5100	5228
OA CFM	650	623
RL Voltage	-	486/487/486
RL Amperage	-	3.8/3.9/4.0
SF Rotation	-	CORRECT
RA Damper Position	-	HIGH: 78% LOW: 71%
Min OA Damper Position	-	HIGH: 22% LOW: 29%
Min OA Damper Type	-	ECONOMIZER

Performance Data		
	Design	Actual
MA Plenum SP	-	-0.39"
Fan Suction SP	-	-0.68"
Fan Discharge SP	-	0.52"
Total ESP	0.8"	0.91"
Fan Total SP	-	1.20"

General		
	Design	Actual
Fan Rotation Correct	-	YES
Unit Filters Clean	-	YES
Condensate Drain Installed	-	YES

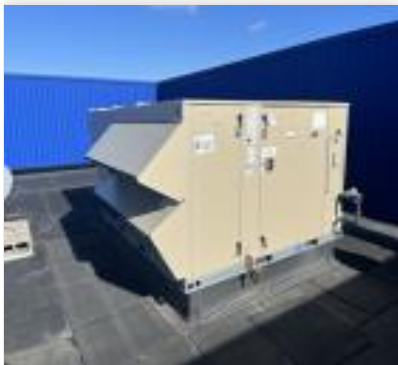
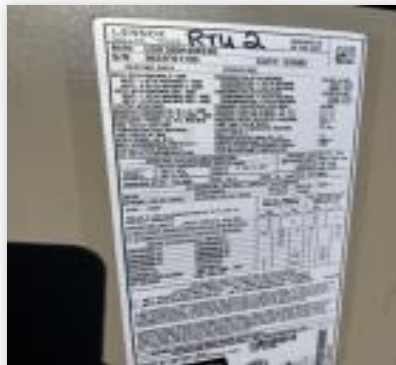
RTU-2

Unit Data		
	Design	Actual
MFG	LENNOX	LENNOX
Serial Num	-	5622F01133
Model Num	LGH180H4M	LGH180H4M
Type	RTU	RTU
Configuration	VERTICAL	VERTICAL
Num OA Filters 1	-	3
OA Filter Size 1	-	23X13
Num Final Filter 1	-	6
Final Filter Size 1	-	24X24X2

Motor Data		
	Design	Actual
Motor MFG	-	INTERLINK
Frame	-	56 HZ
Horsepower	3.0	3.0
Motor Rpm	-	1750
Phase	3	3
Rated Voltage	480	480
Rated Amperage	-	4.0

Drive Data		
	Design	Actual
Motor Sheave Size	-	3.75"
Motor Bore Size	-	7/8"
Motor Sheave SetPt	-	1.5 TURNS OPEN
Fan Sheave Size	-	BK95
Fan Sheave Bore	-	1-3/16"
Belt CL Distance	-	20.75"
Num of Belts	-	1
Belt Size	-	BX59
Belt Alignment	-	VERIFIED

Test Data		
	Design	Actual
SF CFM	5750	5682
SF RPM	-	702
RA CFM	5100	4997
OA CFM	650	685
RL Voltage	-	484/484/484
RL Amperage	-	3.1/3.2/3.2
SF Rotation	-	CORRECT
RA Damper Position	-	HIGH: 77% LOW: 73%
Min OA Damper Position	-	HIGH: 23% LOW: 27%
Min OA Damper Type	-	ECONOMIZER

Performance Data		
	Design	Actual
MA Plenum SP	-	-0.36"
Fan Suction SP	-	-0.54"
Fan Discharge SP	-	0.32"
Total ESP	0.8"	0.68"
Fan Total SP	-	0.86"

General		
	Design	Actual
Fan Rotation Correct	-	YES
Unit Filters Clean	-	YES
Condensate Drain Installed	-	YES

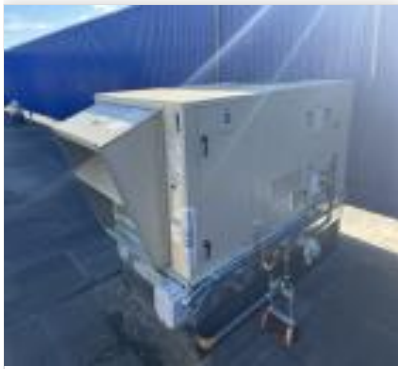
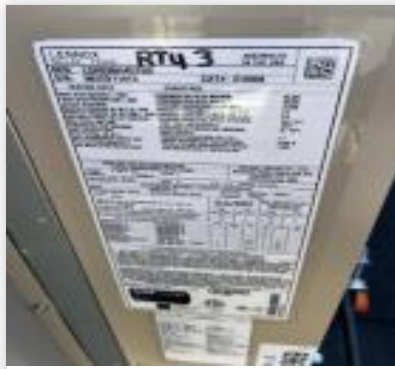
RTU-3

Unit Data		
	Design	Actual
MFG	LENNOX	LENNOX
Serial Num	-	5622G11413
Model Num	LGH036H4E	LGH036H4E
Type	RTU	RTU
Configuration	VERTICAL	VERTICAL
Num OA Filters 1	-	1
OA Filter Size 1	-	29X14.5
Num Final Filter 1	-	4
Final Filter Size 1	-	16X20X2

Motor Data		
	Design	Actual
Motor MFG	-	GENTEQ
Horsepower	1/2	0.5
Motor Rpm	-	NL
Phase	1	1
Rated Voltage	115	115
Rated Amperage	-	2.2

Drive Data		
	Design	Actual
Motor Sheave Size	-	DD
Motor Bore Size	-	DD
Motor Sheave SetPt	-	HIGH: 68% LOW: 44%
Fan Sheave Size	-	DD
Fan Sheave Bore	-	DD
Belt CL Distance	-	DD
Num of Belts	-	DD
Belt Size	-	DD
Belt Alignment	-	DD

Test Data		
	Design	Actual
SF CFM	1100	1156
SF RPM	-	DD
RA CFM	960	1010
OA CFM	140	146
RL Voltage	-	119
RL Amperage	-	1.2
SF Rotation	-	CORRECT
RA Damper Position	-	HIGH: 82% LOW: 72%
Min OA Damper Position	-	HIGH: 18% LOW: 28%
Min OA Damper Type	-	ECONOMIZER

Performance Data		
	Design	Actual
MA Plenum SP	-	-0.11"
Fan Suction SP	-	-0.24"
Fan Discharge SP	-	0.48"
Total ESP	0.6"	0.59"
Fan Total SP	-	0.72"

General		
	Design	Actual
Fan Rotation Correct	-	YES
Unit Filters Clean	-	YES
Condensate Drain Installed	-	YES

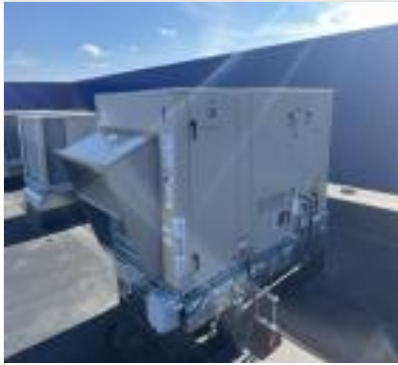
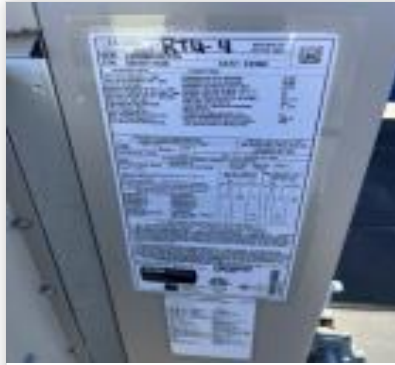
RTU-4

Unit Data		
	Design	Actual
MFG	LENNOX	LENNOX
Serial Num	-	5622G11456
Model Num	LGH060H4E	LGH060H4E
Type	RTU	RTU
Configuration	VERTICAL	VERTICAL
OA Filter Size 1	-	29X14.25
Num Final Filter 1	-	4
Final Filter Size 1	-	20X20X2

Motor Data		
	Design	Actual
Motor MFG	-	GENTEQ
Frame	-	NL
Horsepower	1.0	1.0
Motor Rpm	-	NL
Phase	1	1
Rated Voltage	115	115
Rated Amperage	-	3.7

Drive Data		
	Design	Actual
Motor Sheave Size	-	DD
Motor Bore Size	-	DD
Motor Sheave SetPt	-	HIGH: 70% LOW: 42%
Fan Sheave Size	-	DD
Fan Sheave Bore	-	DD
Belt CL Distance	-	DD
Num of Belts	-	DD
Belt Size	-	DD
Belt Alignment	-	DD

Test Data		
	Design	Actual
SF CFM	1600	1558
SF RPM	-	DD
RA CFM	1300	1242
OA CFM	300	316
RL Voltage	-	120
RL Amperage	-	2.4
SF Rotation	-	CORRECT
RA Damper Position	-	HIGH: 79% LOW: 67%
Min OA Damper Position	-	HIGH: 21% LOW: 33%
Min OA Damper Type	-	ECONOMIZER

Performance Data		
	Design	Actual
MA Plenum SP	-	-0.19"
Fan Suction SP	-	-0.33"
Fan Discharge SP	-	0.50"
Total ESP	0.6"	0.69"
Fan Total SP	-	0.83"

General		
	Design	Actual
Fan Rotation Correct	-	YES
Unit Filters Clean	-	YES
Condensate Drain Installed	-	YES

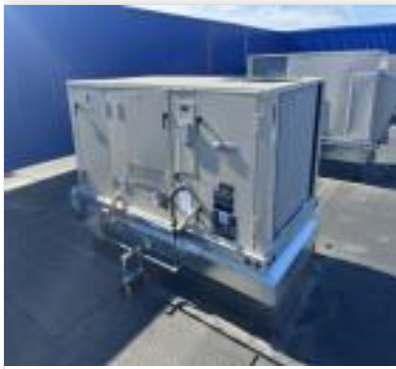
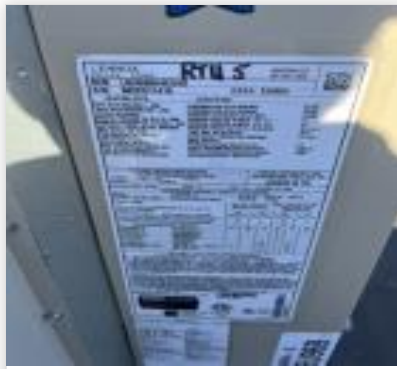
RTU-5

Unit Data		
	Design	Actual
MFG	LENNOX	LENNOX
Serial Num	-	5622G11416
Model Num	LGH036H4E	LGH036H4E
Type	RTU	RTU
Configuration	VERTICAL	VERTICAL
Num OA Filters 1	-	1
OA Filter Size 1	-	29X14.25
Num Final Filter 1	-	4
Final Filter Size 1	-	16X20X2

Motor Data		
	Design	Actual
Motor MFG	-	GENTEQ
Frame	-	NL
Horsepower	1/2	0.5
Motor Rpm	-	NL
Phase	3	1
Rated Voltage	480	115
Rated Amperage	-	2.2

Drive Data		
	Design	Actual
Motor Sheave Size	-	DD
Motor Bore Size	-	DD
Motor Sheave SetPt	-	HIGH: 69% LOW: 42%
Fan Sheave Size	-	DD
Fan Sheave Bore	-	DD
Belt CL Distance	-	DD
Num of Belts	-	DD
Belt Size	-	DD
Belt Alignment	-	DD

Test Data		
	Design	Actual
SF CFM	1100	1164
SF RPM	-	DD
RA CFM	920	992
OA CFM	180	172
RL Voltage	-	120
RL Amperage	-	1.1
SF Rotation	-	CORRECT
RA Damper Position	-	HIGH: 78% LOW: 67%
Min OA Damper Position	-	HIGH: 22% LOW: 33"
Min OA Damper Type	-	ECONOMIZER

Performance Data		
	Design	Actual
MA Plenum SP	-	-0.10"
Fan Suction SP	-	-0.25"
Fan Discharge SP	-	0.40"
Total ESP	0.6"	0.50"
Fan Total SP	-	0.65"

General		
	Design	Actual
Fan Rotation Correct	-	YES
Unit Filters Clean	-	YES
Condensate Drain Installed	-	YES

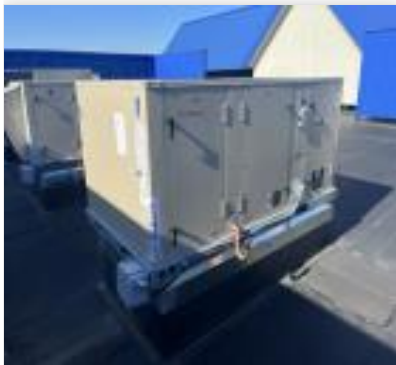
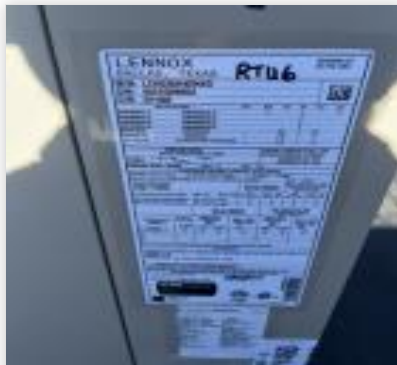
RTU-6

Unit Data		
	Design	Actual
MFG	LENNOX	LENNOX
Serial Num	-	5622G08952
Model Num	LGH036H4E	LGH036H4E
Type	RTU	RTU
Configuration	VERTICAL	VERTICAL
Num OA Filters 1	-	1
OA Filter Size 1	-	29X14.25
Num Final Filter 1	-	4
Final Filter Size 1	-	16X20X2

Motor Data		
	Design	Actual
Motor MFG	-	GENTEQ
Horsepower	1/2	0.50
Motor Rpm	-	NL
Phase	3	1
Rated Voltage	480	115
Rated Amperage	-	2.2

Drive Data		
	Design	Actual
Motor Sheave Size	-	DD
Motor Bore Size	-	DD
Motor Sheave SetPt	-	HIGH: 62% LOW: 40%
Fan Sheave Size	-	DD
Fan Sheave Bore	-	DD
Belt CL Distance	-	DD
Num of Belts	-	DD
Belt Size	-	DD
Belt Alignment	-	DD

Test Data		
	Design	Actual
SF CFM	975	1012
SF RPM	-	DD
RA CFM	975	1012
OA CFM	0	0
RL Voltage	-	119
RL Amperage	-	1.2
SF Rotation	-	CORRECT
RA Damper Position	-	NA
Min OA Damper Position	-	NA
Min OA Damper Type	-	NONE
OA Enthalpy Setpt	-	NA

Performance Data		
	Design	Actual
MA Plenum SP	-	-0.11"
Fan Suction SP	-	-0.27"
Fan Discharge SP	-	0.30"
Total ESP	0.8"	0.41"
Fan Total SP	-	0.57"

General		
	Design	Actual
Fan Rotation Correct	-	YES
Unit Filters Clean	-	YES
Condensate Drain Installed	-	YES

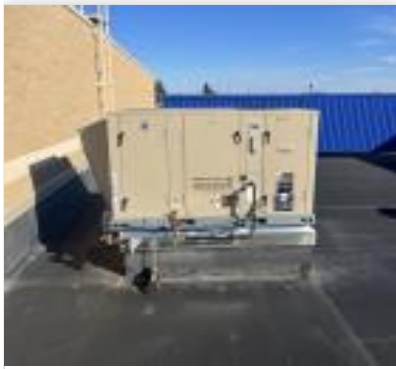
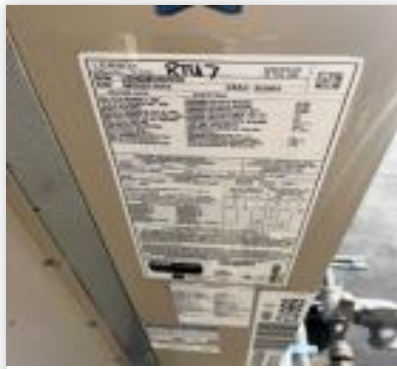
RTU-7

Unit Data		
	Design	Actual
MFG	LENNOX	LENNOX
Serial Num	-	5622G11414
Model Num	LGH036H4E	LGH036H4E
Type	RTU	RTU
Configuration	VERTICAL	VERTICAL
Num OA Filters 1	-	1
OA Filter Size 1	-	29X14.25
Num Final Filter 1	-	4
Final Filter Size 1	-	16X20X2

Motor Data		
	Design	Actual
Motor MFG	-	GENTEQ
Horsepower	1/2	0.5
Motor Rpm	-	NL
Phase	1	1
Rated Voltage	115	115
Rated Amperage	-	2.2

Drive Data		
	Design	Actual
Motor Sheave Size	-	DD
Motor Bore Size	-	DD
Motor Sheave SetPt	-	67%
Fan Sheave Size	-	DD
Fan Sheave Bore	-	DD
Belt CL Distance	-	DD
Num of Belts	-	DD
Belt Size	-	DD
Belt Alignment	-	DD

Test Data		
	Design	Actual
SF CFM	1100	1171
SF RPM	-	DD
RA CFM	940	1022
OA CFM	160	149
RL Voltage	-	120
RL Amperage	-	1.6
SF Rotation	-	CORRECT
RA Damper Position	-	81%
Min OA Damper Position	-	19%
Min OA Damper Type	-	ECONOMIZER

Performance Data		
	Design	Actual
MA Plenum SP	-	-0.26"
Fan Suction SP	-	-0.37"
Fan Discharge SP	-	0.32"
Total ESP	0.6"	0.58"
Fan Total SP	-	0.69"

General		
	Design	Actual
Fan Rotation Correct	-	YES
Unit Filters Clean	-	YES
Condensate Drain Installed	-	YES

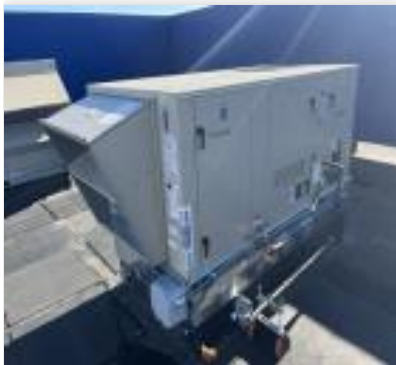
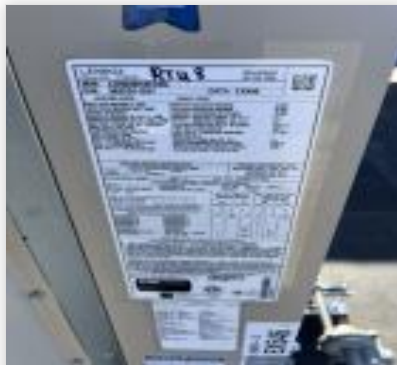
RTU-8

Unit Data		
	Design	Actual
MFG	LENNOX	LENNOX
Serial Num	-	5622G11257
Model Num	LGH048H4E	LGH048H4E
Type	RTU	RTU
Configuration	VERTICAL	VERTICAL
Num OA Filters 1	-	1
OA Filter Size 1	-	29X14.25
Num Final Filter 1	-	4
Final Filter Size 1	-	16X20X2

Motor Data		
	Design	Actual
Motor MFG	-	GENTEQ
Horsepower	3/4	0.50
Motor Rpm	-	NL
Phase	3	1
Rated Voltage	480	115
Rated Amperage	-	3.1

Drive Data		
	Design	Actual
Motor Sheave Size	-	DD
Motor Bore Size	-	DD
Motor Sheave SetPt	-	HIGH: 62% LOW: 42%
Fan Sheave Size	-	DD
Fan Sheave Bore	-	DD
Belt CL Distance	-	DD
Num of Belts	-	DD
Belt Size	-	DD
Belt Alignment	-	DD

Test Data		
	Design	Actual
SF CFM	1400	1425
SF RPM	-	DD
RA CFM	1250	1264
OA CFM	150	161
RL Voltage	-	119
RL Amperage	-	2.1
SF Rotation	-	CORRECT
RA Damper Position	-	HIGH: 80% LOW: 73%
Min OA Damper Position	-	HIGH: 20% LOW: 27%
Min OA Damper Type	-	ECONOMIZER

Performance Data		
	Design	Actual
MA Plenum SP	-	-0.22"
Fan Suction SP	-	-0.42"
Fan Discharge SP	-	0.32"
Total ESP	0.6"	0.54"
Fan Total SP	-	0.74"

General		
	Design	Actual
Fan Rotation Correct	-	YES
Unit Filters Clean	-	YES
Condensate Drain Installed	-	YES

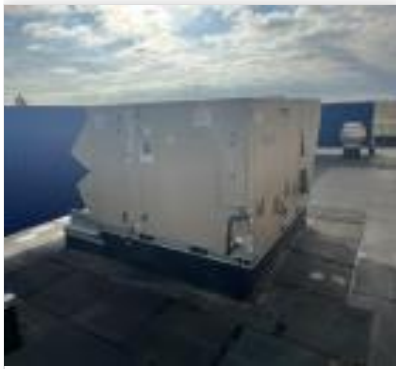
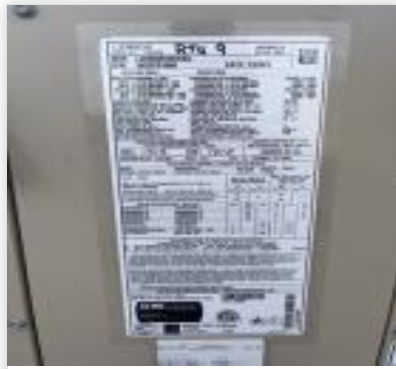
RTU-9

Unit Data		
	Design	Actual
MFG	LENNOX	LENNOX
Serial Num	-	5622F01088
Model Num	LGH240H4B	LGH240H4B
Type	RTU	RTU
Configuration	VERTICAL	VERTICAL
Num OA Filters 1	-	3
OA Filter Size 1	-	23X13
Num Final Filter 1	-	6
Final Filter Size 1	-	24X24X2

Motor Data		
	Design	Actual
Motor MFG	-	INTERLINK
Frame	-	56HZ
Horsepower	5.0	5.0
Motor Rpm	-	1750
Phase	3	3
Rated Voltage	480	460
Rated Amperage	-	7.6

Drive Data		
	Design	Actual
Motor Sheave Size	-	1VP65
Motor Bore Size	-	1-1/8"
Motor Sheave SetPt	-	6 TURNS OPEN
Fan Sheave Size	-	11"
Fan Sheave Bore	-	1-3/16"
Belt CL Distance	-	21"
Num of Belts	-	1
Belt Size	-	BX65
Belt Alignment	-	VERIFIED

Test Data		
	Design	Actual
SF CFM	5000	5205
SF RPM	-	840
RA CFM	0	0
OA CFM	5000	7127
RL Voltage	-	489/489/489
RL Amperage	-	6.2/5.7/5.9
SF Rotation	-	CORRECT
RA Damper Position	-	0%
Min OA Damper Position	-	100%
Min OA Damper Type	-	ECONOMIZER
OA Enthalpy Setpt	-	5.0

Performance Data		
	Design	Actual
MA Plenum SP	-	-0.50"
Fan Suction SP	-	-0.89"
Fan Discharge SP	-	0.38"
Total ESP	1.0"	0.88"
Fan Total SP	-	1.27"

General		
	Design	Actual
Fan Rotation Correct	-	YES
Unit Filters Clean	-	YES
Condensate Drain Installed	-	YES

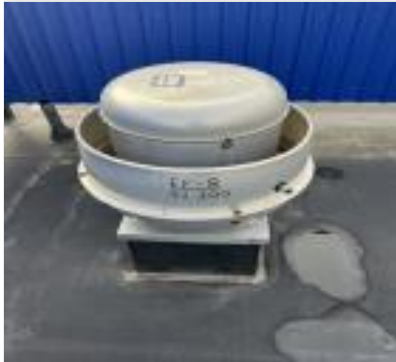
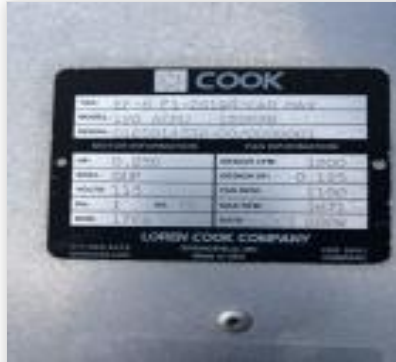
EF-8

Unit Data		
	Design	Actual
MFG	NA	COOK
Model Num	NA	120 ACRU
Serial Num	-	012S914536-00
Type	-	UPBLAST
Configuration	VERTICAL	VERTICAL

Motor Data		
	Design	Actual
Motor MFG	-	MARATHON
Frame	-	48Z
Horsepower	-	0.25
Motor Rpm	-	1755
Phase	-	1
Voltage (rated)	-	115
Amperage (rated)	-	6.1

Test Data		
	Design	Actual
CFM	800	834
Fan RPM	-	1334
Fan Rotation	-	CORRECT
Motor RPM	-	1761
System SetPt	-	4 TURNS OPEN
Total ESP	-	0.305"
Fan Inlet SP	-	-0.305"
Fan Discharge SP	-	ATM
