Report: TAB Report
Function: Test, Adjust, & Balance
Date: 02/02/2026
Completed By: National TAB

02-02-26 WAWA #8241 ALLENTOWN, PA

Project: 02-02-26 WAWA #8241 ALLENTOWN, PA

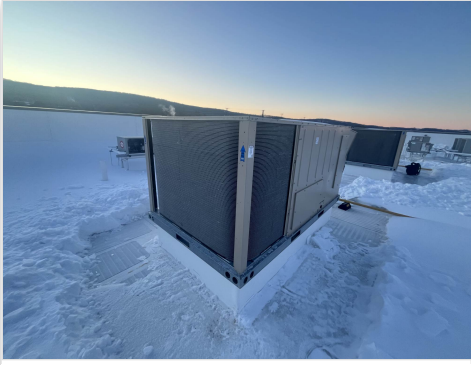
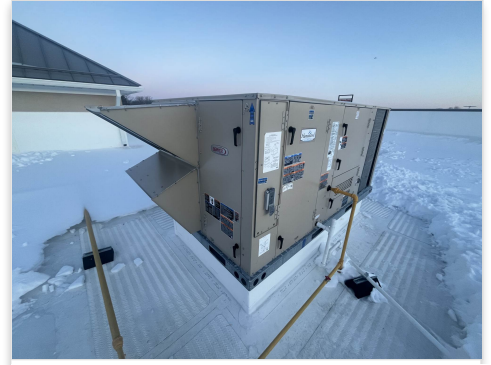
Asset: RTU-1

Unit Data		
	Design	Actual
MFG	LENNOX	LENNOX
Serial Num	-	5625G04689
Model Num	LGT102H4E	LGT102H5ES2Y
Type	RTU	RTU
Configuration	VERTICAL	VERTICAL
Num OA Filters 1	-	2
OA Filter Size 1	-	25X16
Num Final Filter 1	-	4
Final Filter Size 1	-	20X25X2

Test Data		
	Design	Actual
SF CFM	3400	3384
SF RPM	-	1139
MOTOR RPM	-	1139
RA CFM	2720	2711
OA CFM	680	673
RL Voltage	-	210.3/211.4/210.9
RL Amperage	-	2.7/2.7/2.6
SF System SetPt	-	64%
RA Damper Position	-	MECHANICAL LINKAGE
OA Damper Position	-	25%
OA Damper Type	-	ECONOMIZER989

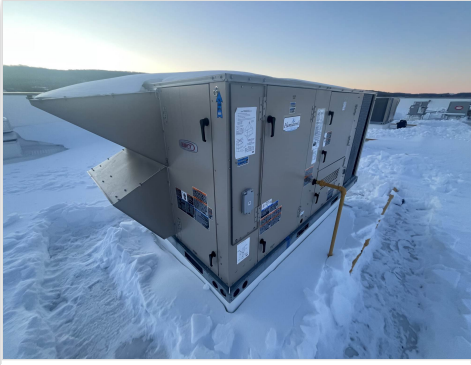
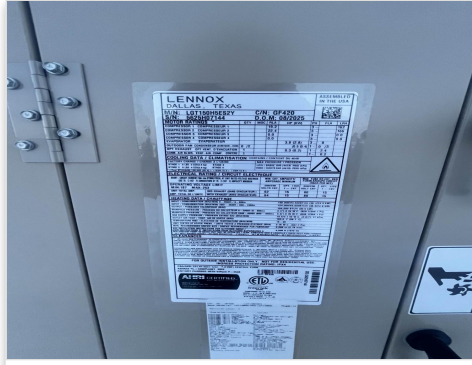
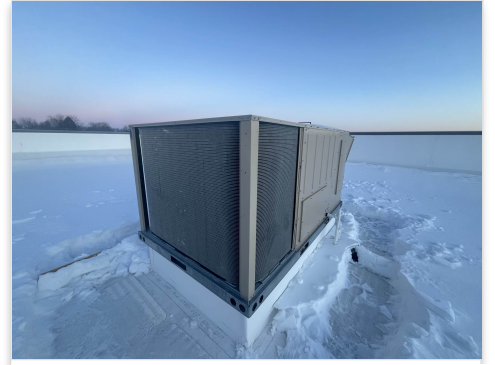
Asset: RTU-2

Unit Data		
	Design	Actual
MFG	LENNOX	LENNOX
Serial Num	-	5625H07144
Model Num	LCT150H4E	LGT150H5ES2Y
Type	RTU	RTU
Configuration	VERTICAL	VERTICAL
Num OA Filters 1	-	2
OA Filter Size 1	-	25X16
Num Final Filter 1	-	4
Final Filter Size 1	-	25X20

Test Data		
	Design	Actual
SF CFM	5000	5105
SF RPM	-	1638
MOTOR RPM	-	1638
RA CFM	4180	4282
OA CFM	820	823
RL Voltage	-	209.9/210.5/210.8
RL Amperage	-	7.1/6.9/7.1
SF System SetPt	-	92%
RA Damper Position	-	MECHANICAL LINKAGE
OA Damper Position	-	26%
OA Damper Type	-	ECONOMIZER

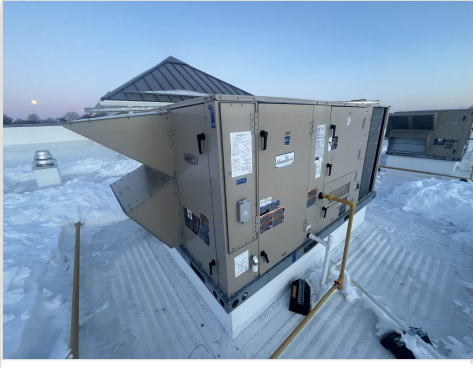
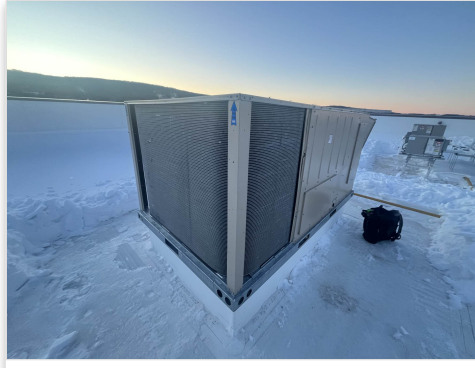
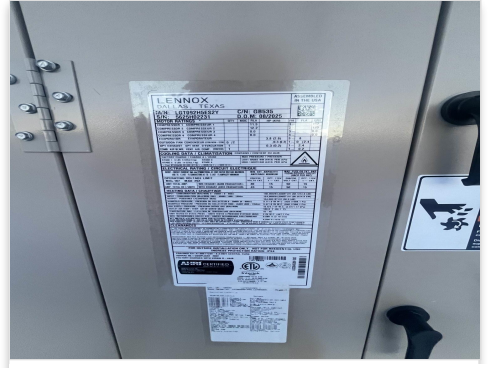
Asset: RTU-3

Unit Data		
	Design	Actual
MFG	LENNOX	LENNOX
Serial Num	-	5625H02231
Model Num	LGT092H4E	LGT092H45ES2Y
Type	RTU	RTU
Configuration	VERTICAL	VERTICAL
Num OA Filters 1	-	2
OA Filter Size 1	-	25X16
Num Final Filter 1	-	4
Final Filter Size 1	-	20X25X2

Test Data		
	Design	Actual
SF CFM	3000	2993
SF RPM	-	1103
MOTOR RPM	-	1103
RA CFM	2400	2411
OA CFM	600	582
RL Voltage	-	209.5/210.3/210.0
RL Amperage	-	2.5/2.5/2.5
SF System SetPt	-	62%
RA Damper Position	-	MECHANICAL LINKAGE
OA Damper Position	-	27%
OA Damper Type	-	ECONOMIZER

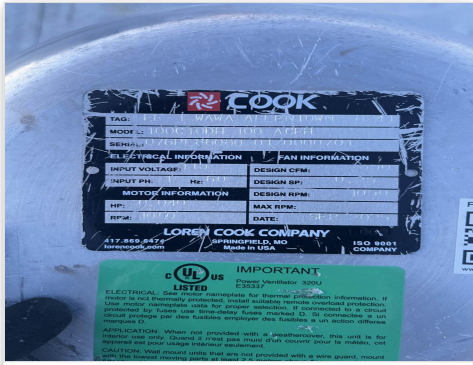
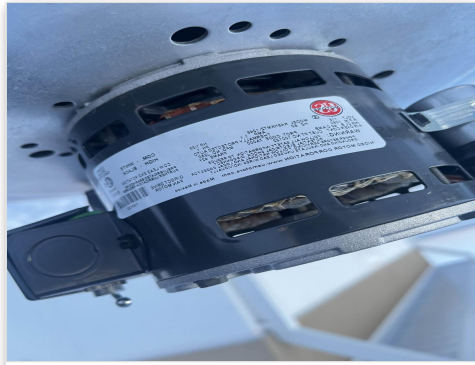
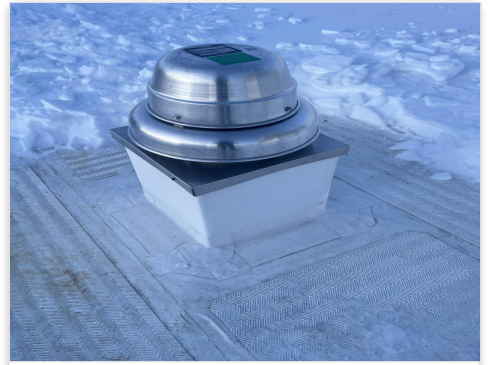
Asset: EF-1

Unit Data		
	Design	Actual
MFG	PENNBARRY	COOK
Model Num	DX10R	100C10DH
Serial Num	-	076PL86080-01/0000701
Type	DOWNBLAST	DOWNBLAST
Configuration	VERTICAL	VERTICAL

Test Data		
	Design	Actual
CFM	350	353
Fan RPM	-	1050
Fan Rotation	-	CCW
Motor RPM	-	1050
System SetPt	-	FULL SPEED
RL Voltage	-	121.1
RL Amperage	-	1.1
Total ESP	0.25"	0.18"
Fan Inlet SP	-	-0.18"
Fan Discharge SP	-	ATM

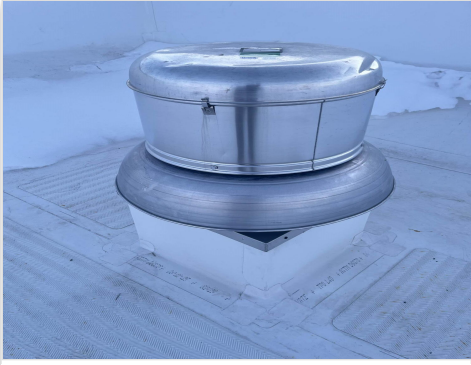
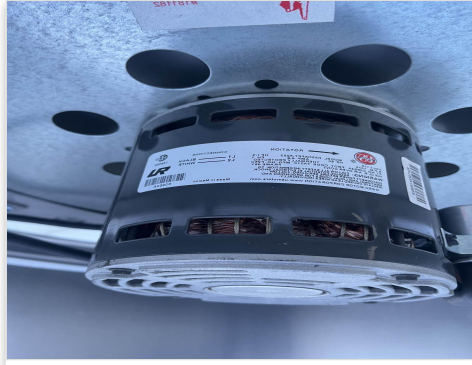
Asset: EF-2

Unit Data		
	Design	Actual
MFG	PENNBARRY	COOK
Model Num	DX16S	50C10D
Serial Num	-	076SL86080-00/0000701
Type	DOWNBLAST	DOWNBLAST
Configuration	VERTICAL	VERTICAL

Test Data		
	Design	Actual
CFM	1400	1399
Fan RPM	-	1075
Fan Rotation	-	CCW
Motor RPM	-	1075
System SetPt	-	FULL SPEED
RL Voltage	-	116.3
RL Amperage	-	4.3
Total ESP	0.375"	0.61"
Fan Inlet SP	-	-0.61"
Fan Discharge SP	-	ATM
