Report: TAB Report
Function: Test, Adjust, & Balance
Date: 02/02/2026
Completed By: National TAB

PROJECT
02-02-26 WAWA #8241 ALLENTOWN, PA

Project: 02-02-26 WAWA #8241 ALLENTOWN, PA

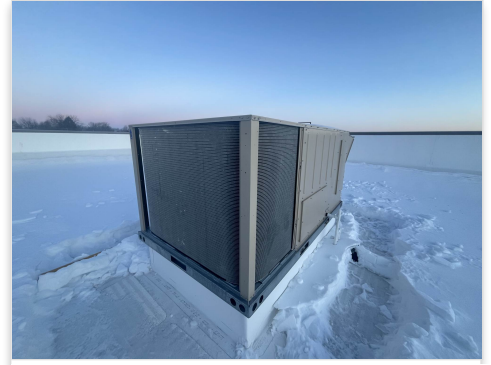
Unit Data - PHOTO LOG

Asset: RTU-2

Unit Data		
	Design	Actual
MFG	LENNOX	LENNOX
Serial Num	-	5625H07144
Model Num	LCT150H4E	LGT150H5ES2Y
Type	RTU	RTU
Configuration	VERTICAL	VERTICAL
Num OA Filters 1	-	2
OA Filter Size 1	-	25X16
Num Final Filter 1	-	4
Final Filter Size 1	-	25X20

Test Data		
	Design	Actual
SF CFM	5000	5105
SF RPM	-	1638
MOTOR RPM	-	1638
RA CFM	4180	4282
OA CFM	820	823
RL Voltage	-	209.9/210.5/210.8
RL Amperage	-	7.1/6.9/7.1
SF System SetPt	-	92%
RA Damper Position	-	MECHANICAL LINKAGE
OA Damper Position	-	26%
OA Damper Type	-	ECONOMIZER
