**National TAB  
1329 E. KEMPER ROAD  
SUITE 4210  
CINCINNATI, OH 45246**

**Report: PRELIM  
Function: Test, Adjust, & Balance  
Date: 03/30/2023**

**PROJECT  
03-27-23 FOOD LION #2856 - LINCOLNTON,  
NC**

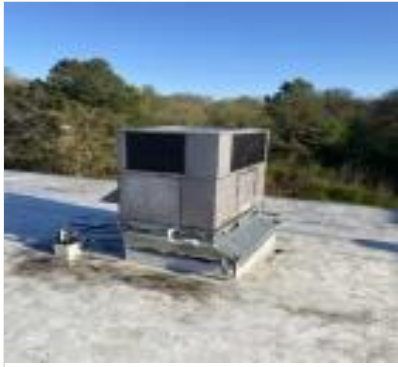
All diffusers and grilles are installed and match design?	NO, GRILLES ON RTU-2 AND RTU-3 ARE SWAPPED BETWEEN SUPPLY AND RETURN
All hood filters installed and accounted for?	YES
Hoods are wired and have power?	YES
Hood is free of alarms?	YES
Thermostats have power?	YES
Have trades/general contractor been notified about any issues and are they created on FaciliBuild?	YES

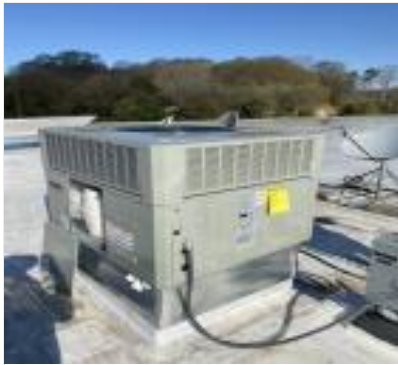
RTU-3

Notes: NO OA HOOD, IT IS ALL RETURN. UNIT IS WIRED FOR HIGH SPEED AND IS STILL LOW ON FLOW: 586 CFM ACTUAL / 800 CFM DESIGN

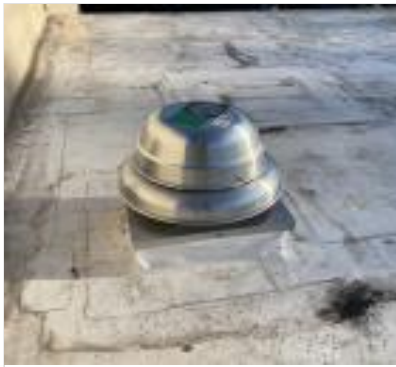
EF-4

**Description :** WHILE OBTAINING AMPS FROM THE UNIT, SWITCH WIRES TOUCHED THE METAL FRAME OF THE SWITCH AND SPARKED AND TURNED THE UNIT OFF ALONG WITH EF-2. WHEN THE UNIT TURNED OFF, EF-5 WHICH WAS INITIALLY NOT OPERATIONAL, TURNED ON. CONTACTED ELECTRICIAN AND IT COULD BE THAT EFS ARE WIRED TO EXISTING BREAKERS, ALSO TURNED OFF LIGHTS IN EXISTING RECEIVING ROOM

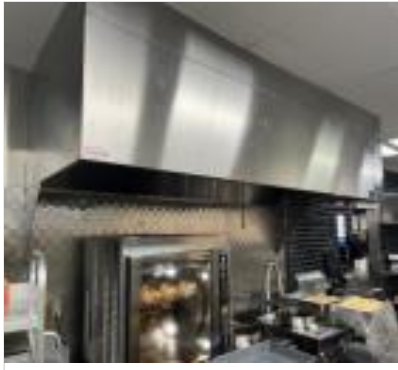
HD-1

List equipment turned on for testing	FRYERS AND OVEN
List smoke candle type used	45 SECOND
Smoke test capture - Perimeter of hood	YES
Smoke test capture - Top of cooking surface	YES
