Report: TAB REPORT
Function: Test, Adjust, & Balance
Date: 02/08/2023

PROJECT
02-06-23 FIVE GUYS - LORAIN, OH

5350 N. LEAVITT RD

LORAIN, OH

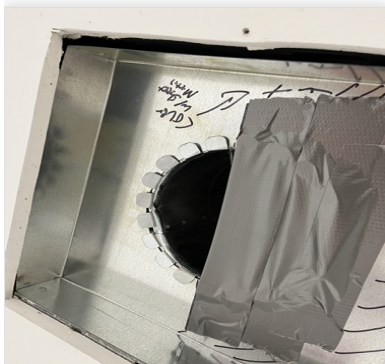
- **02/08/2023** National TAB - Tyler Youells
 - TAPED over the opening to obtain design cfm. MC to install sheet metal exactly the size of the tape to ensure grille stays within design.
