**National TAB  
1329 E. KEMPER ROAD  
SUITE 4210  
CINCINNATI, OH 45246**

**Report: TAB REPORT  
Function: Test, Adjust, & Balance  
Date: 02/08/2023**

**PROJECT  
02-06-23 FIVE GUYS - LORAIN, OH**

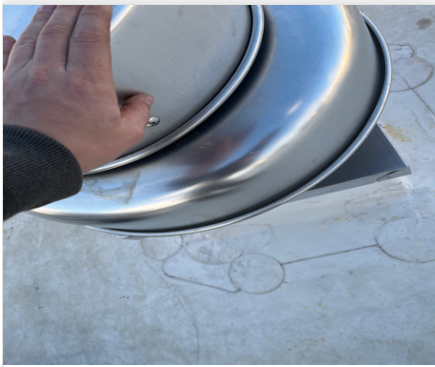
Ef3vibrating.jpeg

**Issue Name :** EF-3 fan blade is out of balance

**Description :** NOTE: Ef-3 fan is also out of balance. This is causing vibrations in the roof and slightly into the space

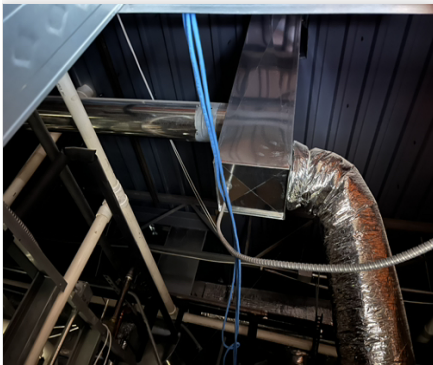
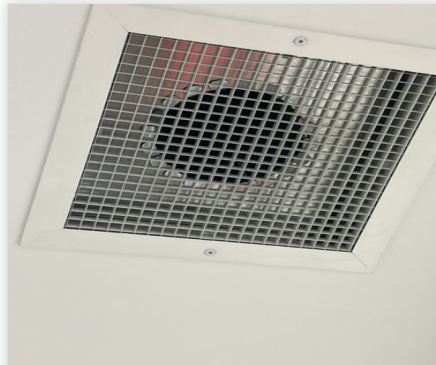
**Issue Name :** WOMENS EXHAUST GRILLE MISSING DAMPER

**Description :** The women's restroom does not have an accessible damper and is 153% of design. Men's restroom is at the low end of design. Recommend installing a face damper in the women's restroom to push more air to the men's restroom.

- **02/08/2023** National TAB - Tyler Youells
  - TAPED over the opening to obtain design cfm. MC to install sheet metal exactly the size of the tape to ensure grille stays within design.

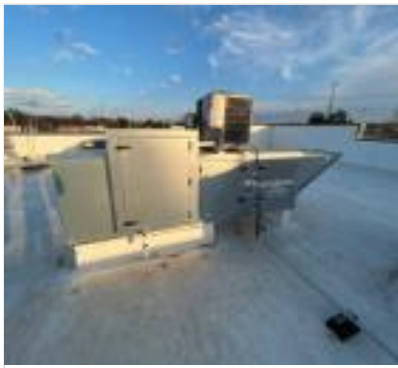
**Mpu1.jpeg**

MUA-1

SERVES BOTH HOODS

**Issue Name :** NOTE: MUA/MPU FAN IMBALANCE

**Description :** NOTE ONLY: There is a slight imbalance in the fan blade causing the unit to have minor vibrations. Recommend Captive Aire evaluates.
