**Report: TAB**

**Function: Test, Adjust, & Balance**

**Date: 02/14/2025**

**02-10-25 CHIPOTLE #29-4929 AVENEL  
(AVENEL, NJ)**

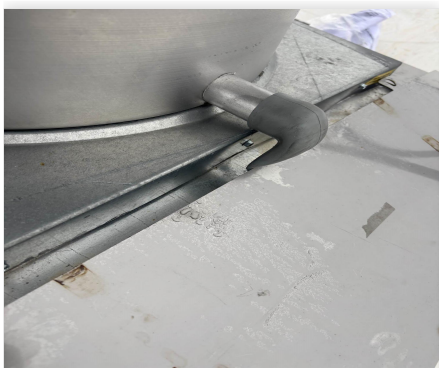
**Issue Name :** EF1: Flexible grease spout kinked in viroguard  
**Description :** Viroguard is sitting on and blocking flow through a flexible grease spout out of EF1. Install hard spout or modify Viroguard according to manufacturer guidance.

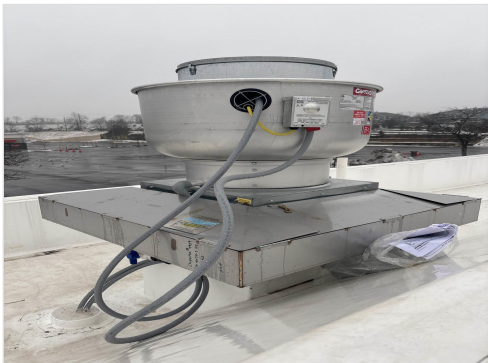
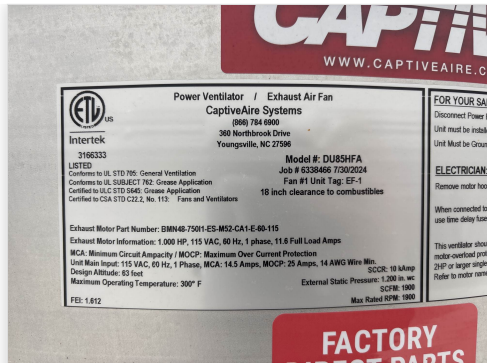
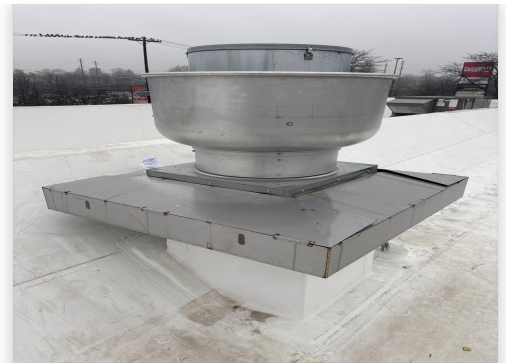
### Unit Data - PHOTO LOG

Unit Data		
	Design	Actual
MFG	CAPTIVEAIRE	CAPTIVEAIRE
Model Num	DU180HFA	DU85HFA
Serial Num	-	6338466
Type	UPBLAST	UPBLAST
Configuration	VERTICAL	VERTICAL

Test Data		
	Design	Actual
CFM	1900	1848
Fan RPM	-	1224
Fan Rotation	-	CCW
Motor RPM	-	1224
System SetPt	-	68%
RL Voltage	-	122.4
RL Amperage	-	7.84
Total ESP	1.2"	1.08"
Fan Inlet SP	-	-1.08"
Fan Discharge SP	-	ATM

Notes:  
Unit is DU85HFA instead of specced DU180HFA due to redesign for all electric appliances.

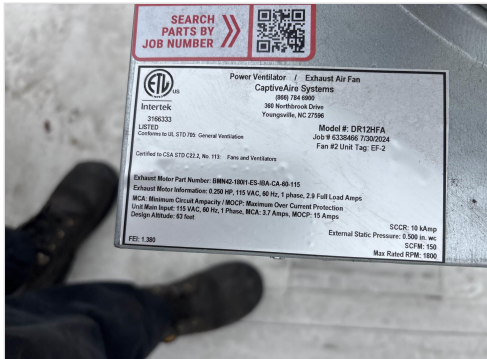
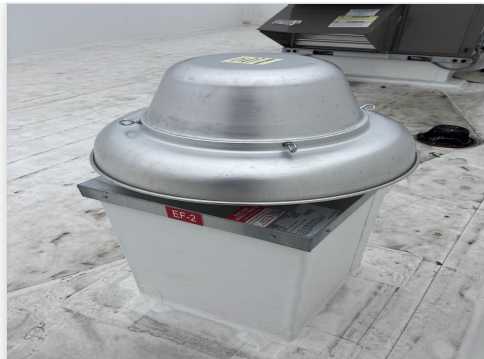
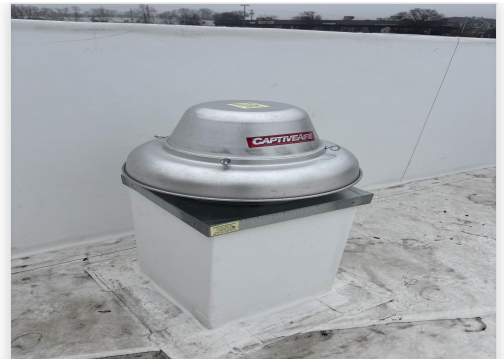
## Unit Data - PHOTO LOG

Unit Data		
	Design	Actual
MFG	CAPTIVEAIRE	CAPTIVEAIRE
Model Num	DR12HFA	DR12HFA
Serial Num	-	6338466
Type	DOWNBLAST	DOWNBLAST
Configuration	VERTICAL	VERTICAL

Test Data		
	Design	Actual
CFM	150	149
Fan RPM	-	1344
Fan Rotation	-	CCW
Motor RPM	-	1344
System SetPt	-	70%
RL Voltage	-	NA
RL Amperage	-	NA
Total ESP	.6"	0.34"
Fan Inlet SP	-	-0.34"
Fan Discharge SP	-	ATM

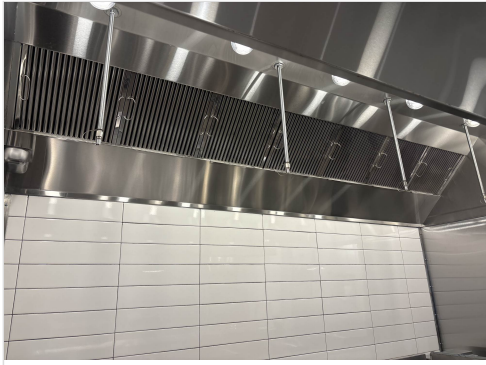
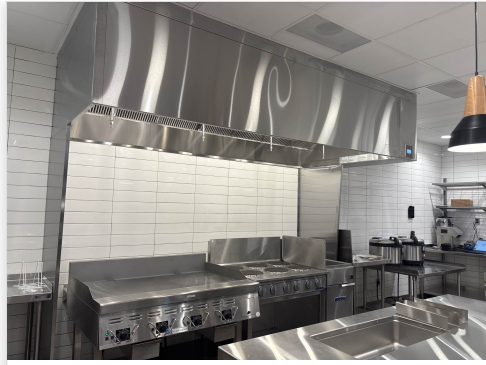
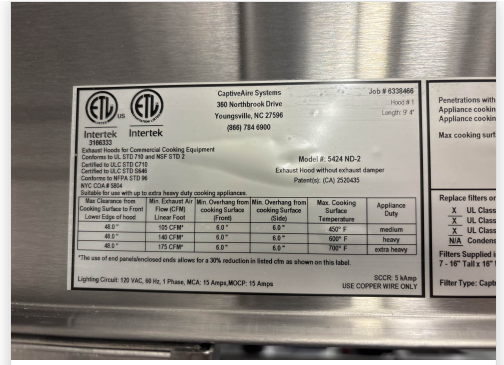
# Unit Data - PHOTO LOG

Unit Data		
	Design	Actual
MFG	CAPTIVEAIRE	CAPTIVEAIRE
Model Num	5424 ND-2	5424 ND-2
Job / Serial Num	-	6338466
Type	TYPE 1 CANOPY HOOD	TYPE 1 CANOPY HOOD
Hood length	112"	112"
Hood Width	54"	54"

Test Data Exhaust		
	Design	Actual
Filter Type	CAPTRATE SOLO	CAPTRATE SOLO
Filter Size 1	16x16	16x16
Filter Qty 1	7	7
Filter AK factor size 1	1.62	1.62
Filter Total AK Area	11.34	11.34
Filter1 FPM	-	160
Filter2 FPM	-	161
Filter3 FPM	-	181
Filter4 FPM	-	189
Filter5 FPM	-	172
Filter6 FPM	-	152
Filter7 FPM	-	123
Filter Ave FPM(corr)	-	163
CFM	1900	1848
