Report: TAB

Function: Test, Adjust, & Balance

Date: 02/14/2025

**02-10-25 CHIPOTLE #29-4929 AVENEL
(AVENEL, NJ)**

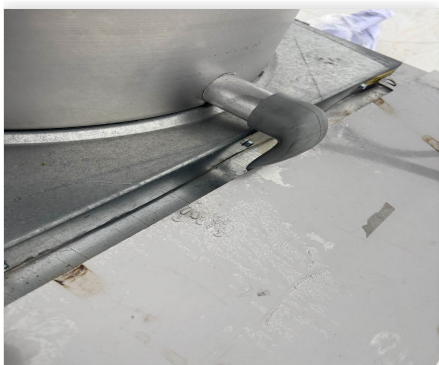
Issue Name : EF1: Flexible grease spout kinked in viroguard
Description : Viroguard is sitting on and blocking flow through a flexible grease spout out of EF1. Install hard spout or modify Viroguard according to manufacturer guidance.

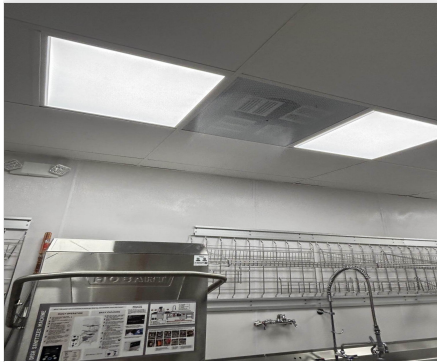
Issue Name : RTU1-1: No damper on this diffuser
Description : Diffuser 1 on RTU1 does not have an accessible damper installed at the face or the diffuser.
Created By : National TAB **Assigned To :** National TAB - Will Turnbough
Status : Open
Priority : High **Asset Tag :**
Originated Date : 02/14/2025 - Ryan Smith - National TAB

Diffuser RTU1-1 does not have a damper at the face or diffuser.

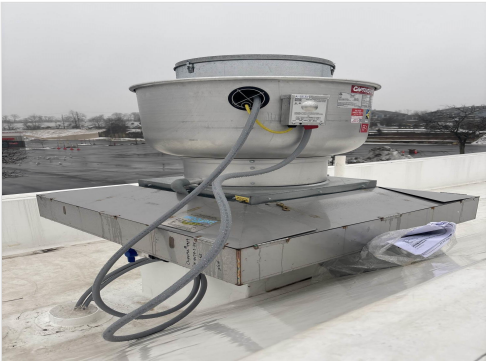
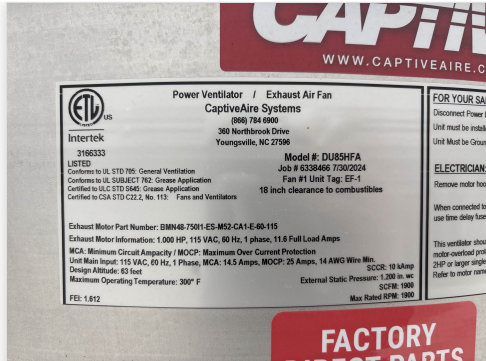
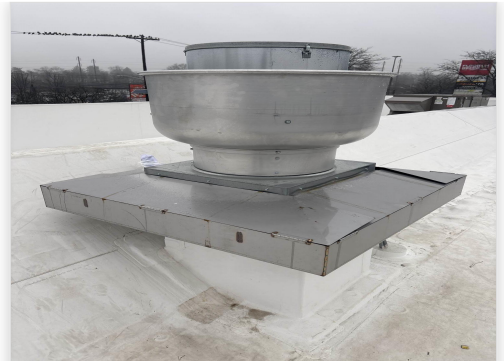
Unit Data - PHOTO LOG

Notes:
Unit is DU85HFA instead of specced DU180HFA due to redesign for all electric appliances.
