Report: TAB Report
Function: Test, Adjust, & Balance
Date: 02/09/2026
Completed By: National TAB

PROJECT
02-09-26 QT #0432 PHOENIX, AZ

Project: 02-09-26 QT #0432 PHOENIX, AZ

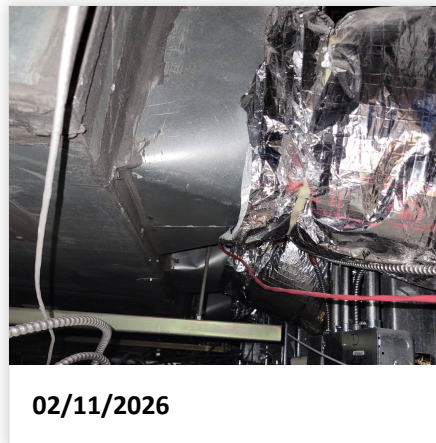
Issue Name : DAMPERS NOT INSTALLED
Description : No dampers have been installed so kitchen ducts can be balanced. Duct also not installed properly, there should be hard duct, then flex; only flex is installed.
Created By : National TAB **Assigned To :** National TAB - Dan Hertenstein
Status : Open
Priority : **Urgent** **Asset Tag :** RT-3
Originated Date : 02/11/2026 - Christine Weale - National TAB

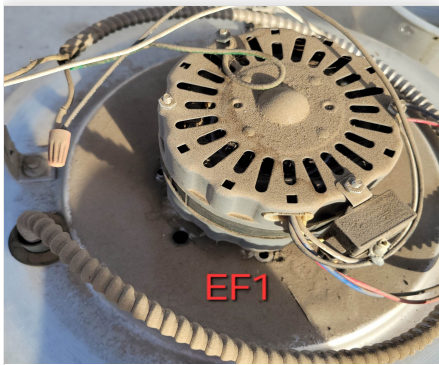
Issue Name : EF1 NOT RUNNING
Description : EF1 is not running at all, does not have a shut off switch, and does not have a motor speed controller installed.
Created By : National TAB **Assigned To :** National TAB - Dan Hertenstein
Status : Open
Priority : Urgent **Asset Tag :** EF1
Originated Date : 02/11/2026 - Christine Weale - National TAB

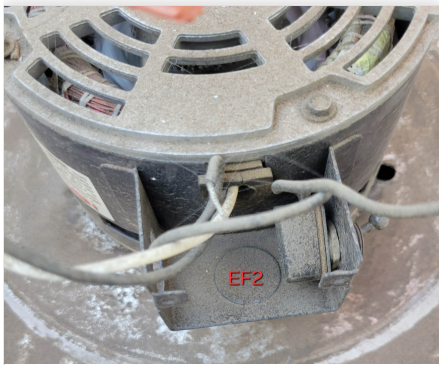
Issue Name : EF2 - NO MOTOR SPEED CONTROLLER
Description : EF2, exhaust for the men's RR, also does not have a motor speed controller installed. It is running too low and cannot be balanced.
Created By : National TAB **Assigned To :** National TAB - Dan Hertenstein
Status : Open
Priority : Urgent **Asset Tag :** EF2
Originated Date : 02/11/2026 - Christine Weale - National TAB

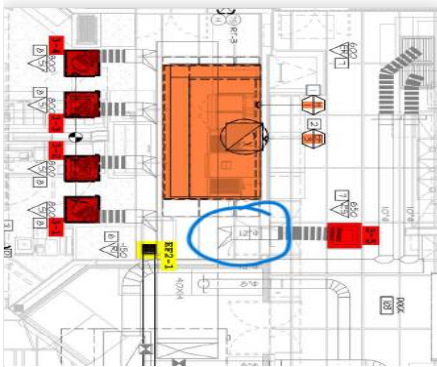
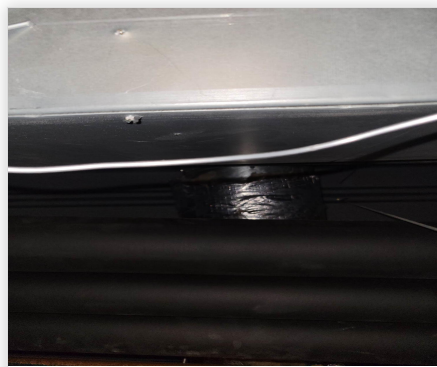
Issue Name : INACCESSBILE DAMPER
Description : SGRD3-5 is not installed per GRD and the duct goes over the supply and somewhere past the supply instead of coming from it, therefore damper is inaccessible (no tiles to move to see where it goes).
Created By : National TAB **Assigned To :** National TAB - Dan Hertenstein
Status : Open
Priority : Medium **Asset Tag :** SGRD3
Originated Date : 02/11/2026 - Christine Weale - National TAB

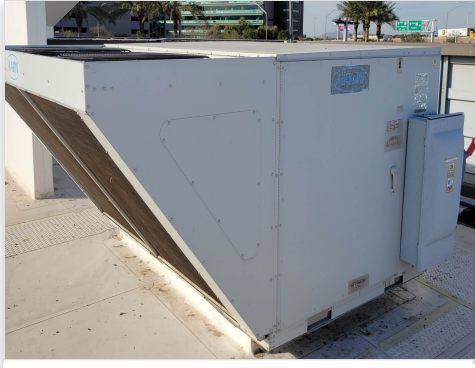
Asset: RT-1

Unit Data	
	Actual
MFG	AAON
Serial Num	201212-ANEL07924
Model Num	RN-015-8-0-EA0A-152
Num OA Filters 1	1
OA Filter Size 1	45X22
Num Final Filter 1	2
Final Filter Size 1	46X19.5X2

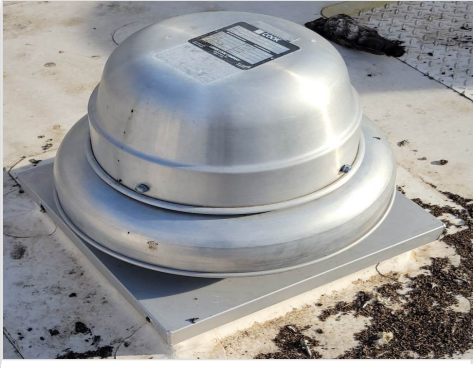
Asset: EF1

UNIT NOT RUNNING, FLOW WAS JUST AIR MOVING THROUGH DUCT, SEE 'REMARKS'. MOTOR MODEL#4YU34

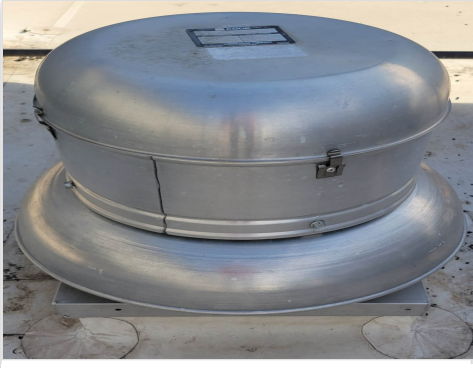
Asset: EF2

DIDN'T TAKE FINAL MEAS. SINCE UNIT CANNOT BE BALANCED. FINAL SET POINT NOT DONE UNTIL MSC IS INSTALLED.

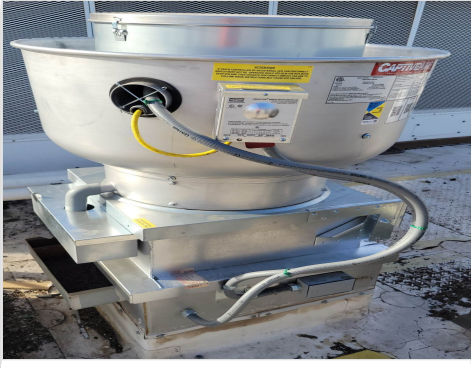
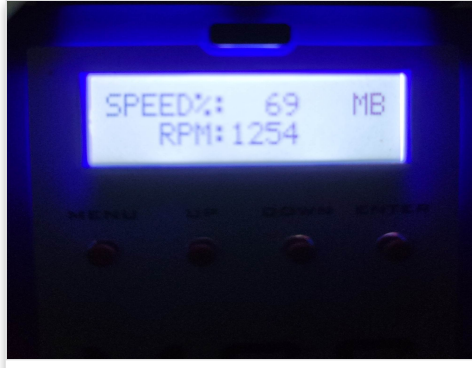
Asset: EF3

Unit Data		
	Design	Actual
MFG	NA	CAPTIVEAIRE
Model Num	NA	DU50HFA
Serial Num	-	8257627
Type	UPBLAST	UPBLAST
Configuration	VERTICAL	VERTICAL

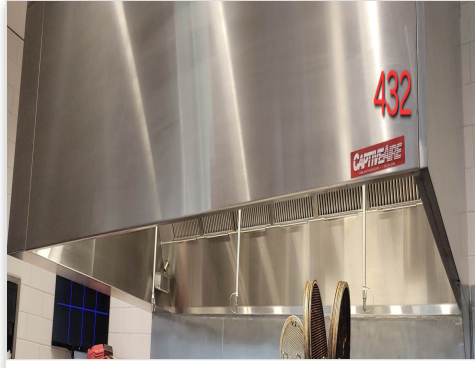
Asset: HD1

Design	Actual
MFG	CAPTIVEAIRE	CAPTIVEAIRE
Model Num	6030ND-2-F	6030ND-2-F
Job / Serial Num	-	8257627
Type	TYPE I CANOPY	TYPE I CANOPY
Hood length	108"	108"
Hood Width	60"	60"
