**Report: TAB REPORT**  
**Function: Test, Adjust, & Balance**  
**Date: 08/13/2024**

**PROJECT**  
**08-12-24 FREDDY'S - SIOUX CITY, IA**

TR HOSPITALITY GROUP

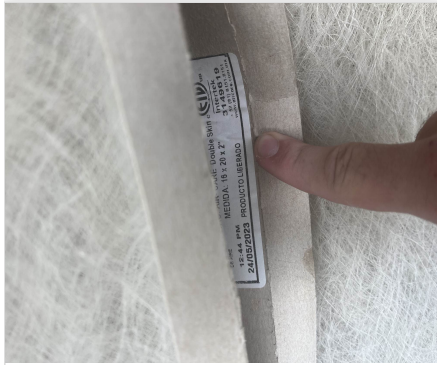
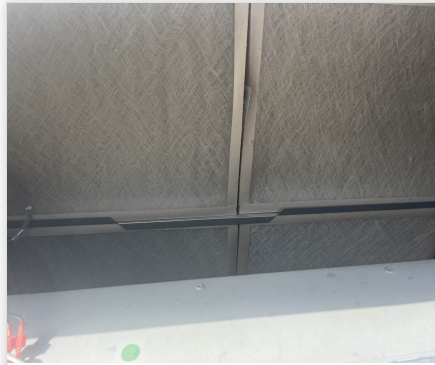
**Issue Name :** RTU1/RTU2 final filters needed  
**Description :** Final filters are needed for both RTU units. Currently the construction filters are installed. Each unit takes 4 - 16X20X2 filters  
**Created By :** National TAB                      **Assigned To :** National TAB - Jacob Davidson  
**Status :** Open  
**Priority :** Low                                      **Asset Tag :**  
**Originated Date :** 08/13/2024 - Jacob Davidson - National TAB

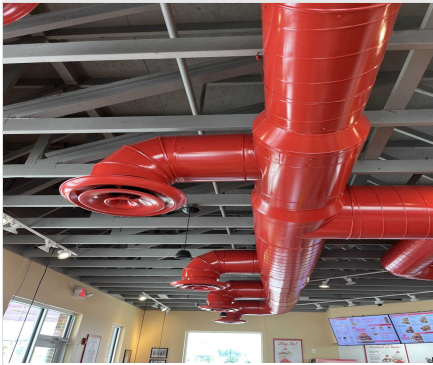
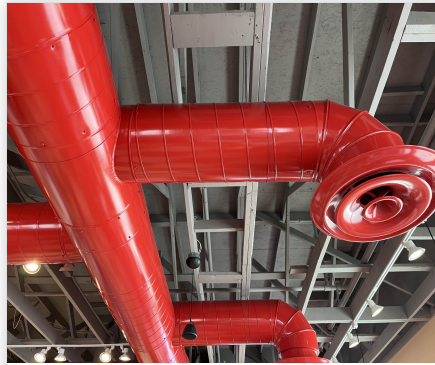
**Issue Name :** RTU1/RTU2 no balancing dampers are installed.  
**Description :** No balancing dampers are installed on RTU1 and RTU2. Without dampers, tech can only balance the systems to total design.  
**Created By :** National TAB                      **Assigned To :** National TAB - Jacob Davidson  
**Status :** Open  
**Priority :** High                                      **Asset Tag :**  
**Originated Date :** 08/12/2024 - Jacob Davidson - National TAB

- **08/13/2024 National TAB - Jacob Davidson**
  - There was one damper in the hallway but no dampers for the restrooms on RTU1.

DIFFUSERS NOT PRESENT IN RESTROOMS OR DINING ROOM. TECH WAS UNABLE TO BALANCE INDIVIDUAL DIFFUSERS.

Notes:  
DAMPERS WERE NOT INSTALLED IN DINING ROOM. TECH WAS UNABLE TO BALANCE INDIVIDUAL DIFFUSERS.

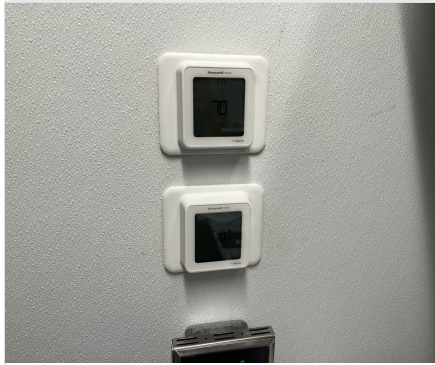
**Issue Name :** RTU1/RTU2 thermostats aren't programmable  
**Description :** Thermostats for dining RTUs are not programmable so tech is unable to set them for occupancy. Tech was only able to set time on them.  
**Created By :** National TAB                      **Assigned To :** National TAB - Jacob Davidson  
**Status :** Open  
**Priority :** Low                                      **Asset Tag :**  
**Originated Date :** 08/13/2024 - Jacob Davidson - National TAB

THERMOSTATS ARE NOT PROGRAMMABLE ON RTU1 AND RTU2
