Report: TAB REPORT
Function: Test, Adjust, & Balance
Date: 08/13/2024

PROJECT
08-12-24 FREDDY'S - SIOUX CITY, IA

Project: 08-12-24 FREDDY'S - SIOUX CITY, IA

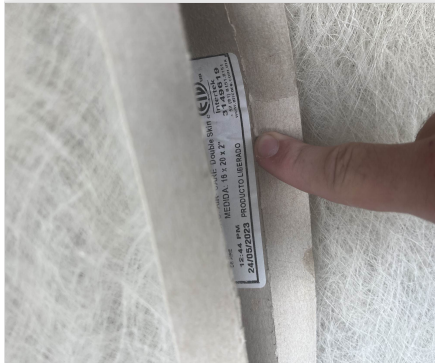
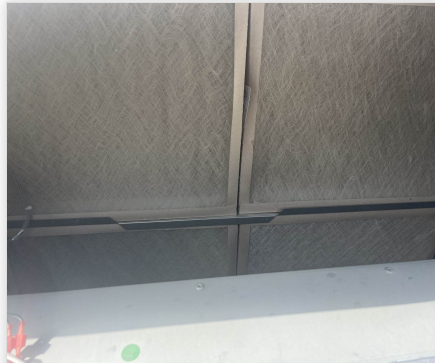
Issue Name : RTU1/RTU2 final filters needed
Description : Final filters are needed for both RTU units. Currently the construction filters are installed. Each unit takes 4 - 16X20X2 filters
Created By : National TAB **Assigned To :** National TAB - Jacob Davidson
Status : Open
Priority : Low **Asset Tag :**
Originated Date : 08/13/2024 - Jacob Davidson - National TAB

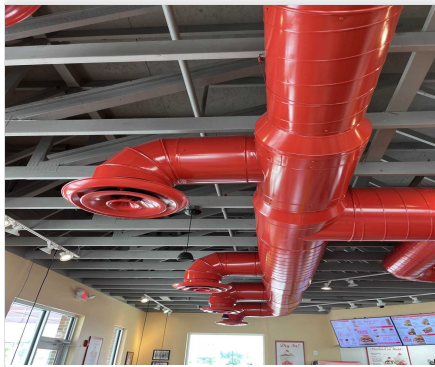
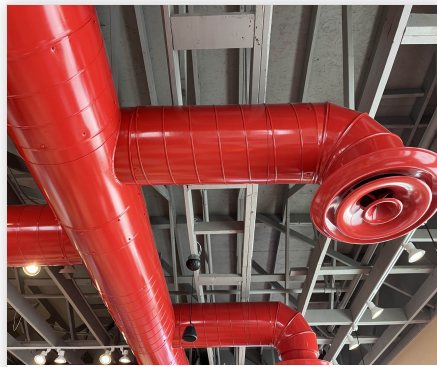
Issue Name : RTU1/RTU2 no balancing dampers are installed.
Description : No balancing dampers are installed on RTU1 and RTU2. Without dampers, tech can only balance the systems to total design.
Created By : National TAB **Assigned To :** National TAB - Jacob Davidson
Status : Open
Priority : High **Asset Tag :**
Originated Date : 08/12/2024 - Jacob Davidson - National TAB

- **08/13/2024 National TAB - Jacob Davidson**
 - There was one damper in the hallway but no dampers for the restrooms on RTU1.

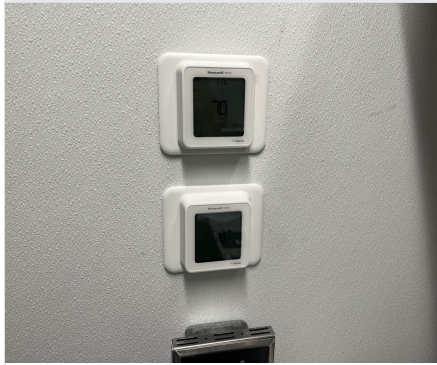
Issue Name : RTU1/RTU2 thermostats aren't programmable
Description : Thermostats for dining RTUs are not programmable so tech is unable to set them for occupancy. Tech was only able to set time on them.
Created By : National TAB **Assigned To :** National TAB - Jacob Davidson
Status : Open
Priority : Low **Asset Tag :**
Originated Date : 08/13/2024 - Jacob Davidson - National TAB
