Report: TAB REPORT
Function: Test, Adjust, & Balance
Date: 08/14/2025
Completed By: National TAB

PROJECT
08-11-25 CULVERS ROCKWALL REVIVE

2475 Ridge Road

Rockwall, TX 75087

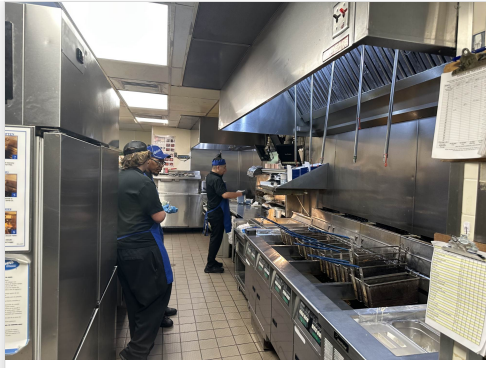
Asset: HD2

Unit Data		
	Design	Actual
MFG	NA	NA
Model Num	NA	NA
Job / Serial Num	-	N/A
Hood length	-	111"
Hood Width	-	3"

Test Data Exhaust		
	Design	Actual
Filter Size 1	-	16X16
Filter Size 2	-	16X20
Filter Qty 1	-	2
Filter Qty 2	-	4
Filter AK factor size 1	-	1.66
Filters AK factor size 2	-	2.10
Filter Total AK Area	-	11.72
Filter1 FPM	-	162
Filter2 FPM	-	164
Filter3 FPM	-	194
Filter4 FPM	-	205
Filter5 FPM	-	150
Filter6 FPM	-	149
Filter Ave FPM(corr)	-	170
CFM	-	1992

Notes:
FRYER
MUA WIDTH: 16"
