**Report: TAB PRACTICE**

**Function: Test, Adjust, & Balance**

**Date: 08/14/2025**

## 08-11-25 CULVERS ROCKWALL REVIVE

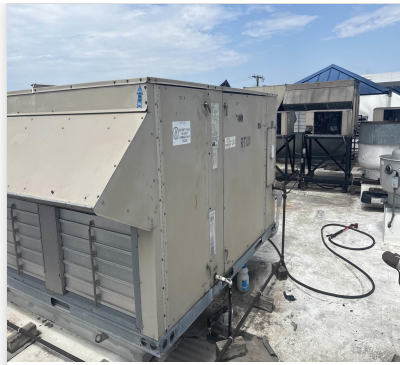
##### SUPPLY RTU-1

3845 CFM

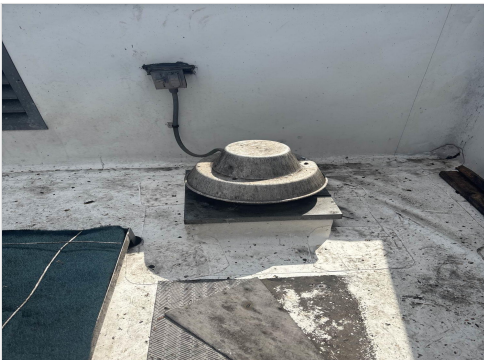
Asset: EF1

Unit Data		
	Design	Actual
MFG	NA	NA
Model Num	NA	NA
Serial Num	-	16377001
Type	-	DOWNBLAST
Configuration	-	VERTICAL

Test Data		
	Design	Actual
CFM	-	161
Fan RPM	-	NA
Fan Rotation	-	CW
Motor RPM	-	NA
System SetPt	-	NA
RL Voltage	-	NA
RL Amperage	-	0.74/0.78
Total ESP	-	0.006
Fan Inlet SP	-	0.006
Fan Discharge SP	-	ATM

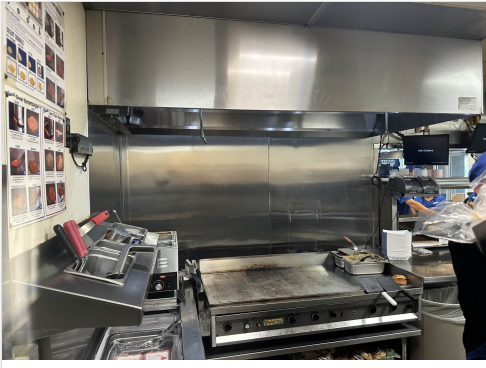
Asset: HD1

Unit Data		
	Design	Actual
MFG	NA	NA
Model Num	NA	NA
Job / Serial Num	-	N/A
Type	-	UPBLAST
Hood length	-	184"
Hood Width	-	48"

Test Data Exhaust		
	Design	Actual
Filter Size 1	-	16X16
Filter Qty 1	-	5
Filter AK factor size 1	-	1.66
Filter Total AK Area	-	8.3
Filter1 FPM	-	232
Filter2 FPM	-	295
Filter3 FPM	-	286
Filter4 FPM	-	260
Filter5 FPM	-	249
Filter Ave FPM(corr)	-	264
CFM	-	2191

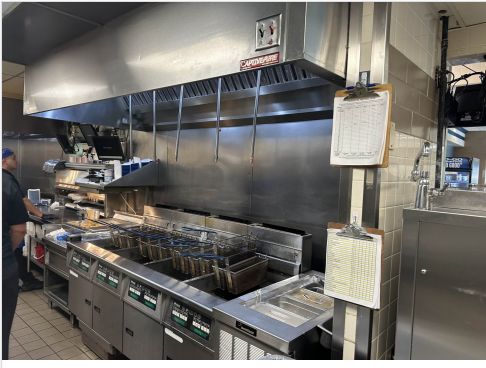
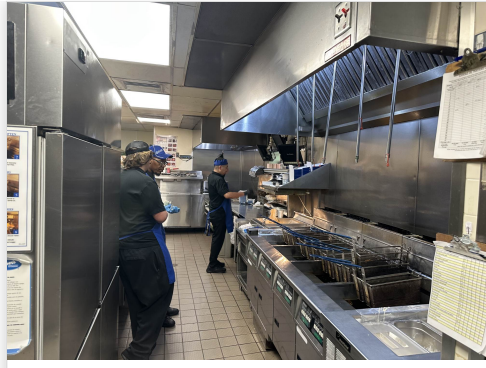
Asset: HD2

Unit Data		
	Design	Actual
MFG	NA	NA
Model Num	NA	NA
Job / Serial Num	-	N/A
Hood length	-	111"
Hood Width	-	3"

Test Data Exhaust		
	Design	Actual
Filter Size 1	-	16X16
Filter Size 2	-	16X20
Filter Qty 1	-	2
Filter Qty 2	-	4
Filter AK factor size 1	-	1.66
Filters AK factor size 2	-	2.10
Filter Total AK Area	-	11.72
Filter1 FPM	-	162
Filter2 FPM	-	164
Filter3 FPM	-	194
Filter4 FPM	-	205
Filter5 FPM	-	150
Filter6 FPM	-	149
Filter Ave FPM(corr)	-	170
CFM	-	1992

Notes:  
FRYER  
MUA WIDTH: 16"
