Report: TAB REPORT
Function: Test, Adjust, & Balance
Date: 08/14/2025
Completed By: National TAB

PROJECT
08-11-25 CULVERS ROCKWALL REVIVE

Project: 08-11-25 CULVERS ROCKWALL REVIVE

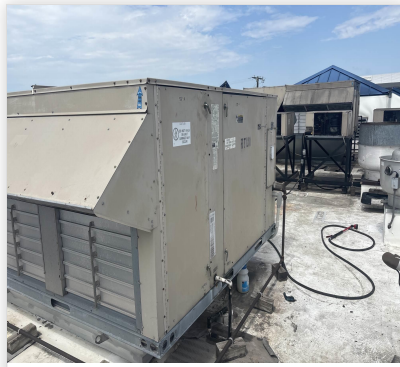
SUPPLY RTU-1

3845 CFM

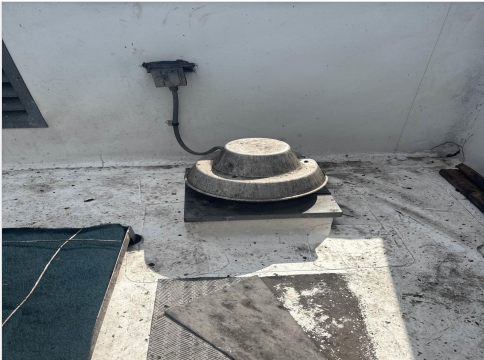
Asset: EF1

Unit Data		
	Design	Actual
MFG	NA	NA
Model Num	NA	NA
Serial Num	-	16377001
Type	-	DOWNBLAST
Configuration	-	VERTICAL

Test Data		
	Design	Actual
CFM	-	161
Fan RPM	-	NA
Fan Rotation	-	CW
Motor RPM	-	NA
System SetPt	-	NA
RL Voltage	-	NA
RL Amperage	-	0.74/0.78
Total ESP	-	0.006
Fan Inlet SP	-	0.006
Fan Discharge SP	-	ATM

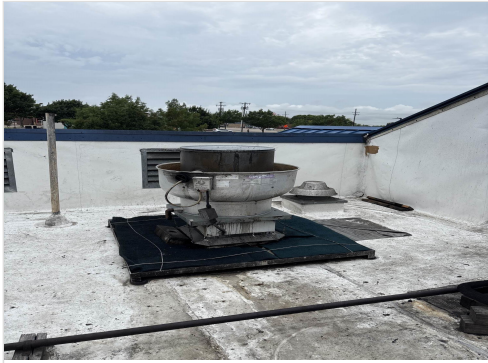
Asset: KEF1

Unit Data		
	Design	Actual
MFG	NA	CAPTIVE AIRE
Model Num	NA	DU180HFA
Serial Num	-	4745772
Type	-	UPBLAST
Configuration	-	VERTICAL

Test Data		
	Design	Actual
CFM	-	2191
Fan RPM	-	NA
Fan Rotation	-	CCW
Motor RPM	-	NA
RL Voltage	-	203/205/202
RL Amperage	-	3.4/3.18/3.24
Suction ESP	-	NA
Discharge ESP	-	ATM
Total ESP	-	NA

Notes:
GRIDDLE
Unable to lean fan back to get static pressure

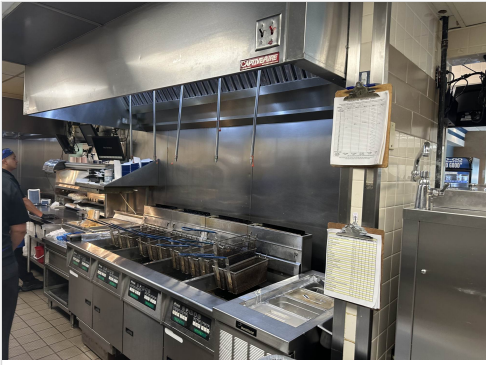
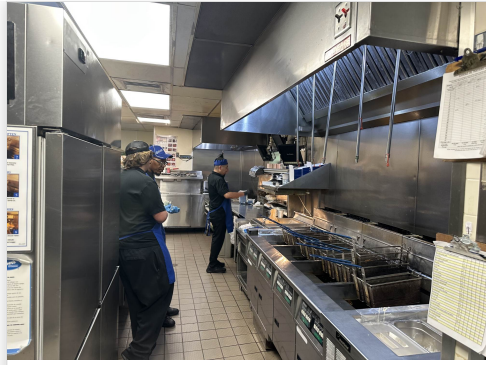
Asset: HD2

Design	Actual
MFG	NA	NA
Model Num	NA	NA
Job / Serial Num	-	N/A
Hood length	-	111"
Hood Width	-	3"

Design	Actual
Filter Size 1	-	16X16
Filter Size 2	-	16X20
Filter Qty 1	-	2
Filter Qty 2	-	4
Filter AK factor size 1	-	1.66
Filters AK factor size 2	-	2.10
Filter Total AK Area	-	11.72
Filter1 FPM	-	162
Filter2 FPM	-	164
Filter3 FPM	-	194
Filter4 FPM	-	205
Filter5 FPM	-	150
Filter6 FPM	-	149
Filter Ave FPM(corr)	-	170
CFM	-	1992
