**Report: Renew
Date: 3/22/2022**

FREDDY'S EPOCH - BARTLESVILLE, OK - RENEW 3F (2)

Project: FREDDY'S EPOCH - BARTLESVILLE, OK - RENEW 3F (2)

Project Summary

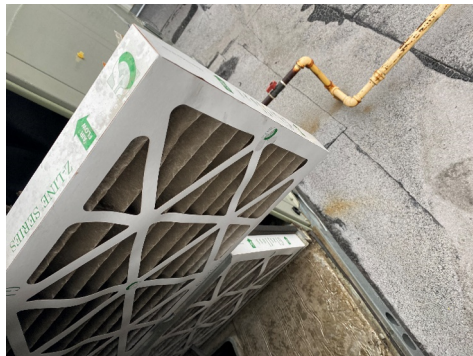
RTU-2 (FRONT KITCHEN/DINING)
DIRTY EVAPORATOR FILTERS

RTUs: There evaporator coil was rinsed off and cleaned. During warmer months a self-cleaning chemical is sprayed on the evaporator. The outside air filters were rinsed off to remove any dirty, so the unit stays at the designated outside air set point. Based on static pressures, amps, and fan rpm it shows that the total supply has not changed since the last test and balance.

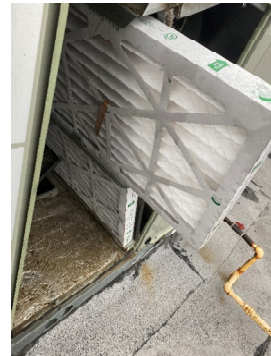
RTU-2 (FRONT KITCHEN/DINING)
CLEAN EVAPORATOR FILTERS

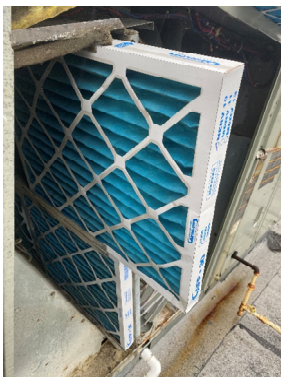
RTU-3 (DINING/RR)
DIRTY EVAPORATOR FILTERS

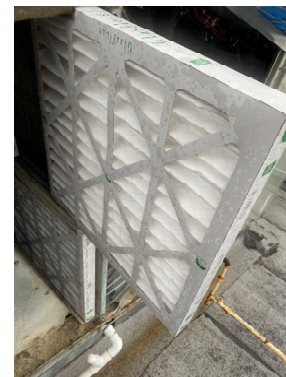
RTU-3 (DINING/RR)
CLEAN EVAPORATOR FILTERS

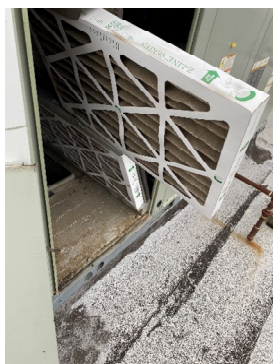
RTU-1 (DINING)
DIRTY EVAPORATOR FILTERS

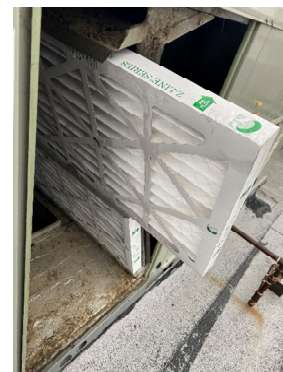
RTU-1 (DINING)
CLEAN EVAPORATOR FILTERS

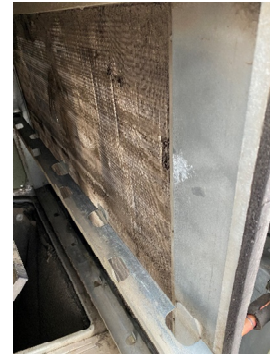
RTU-1 (DINING)
DIRTY EVAPORATOR

RTU-1 (DINING)
CLEAN EVAPORATOR

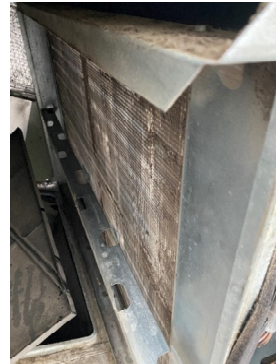
RTU-2 (FRONT KITCHEN/DINING)
DIRTY EVAPORATOR

RTU-2 (FRONT KITCHEN/DINING)
CLEAN EVAPORATOR

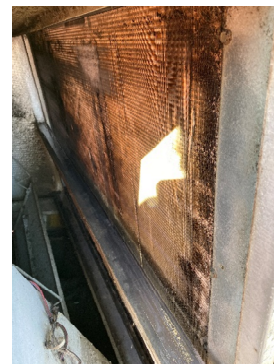
RTU-3 (DINING/RR)
DIRTY EVAPORATOR

RTU-3 (DINING/RR)
CLEAN EVAPORATOR

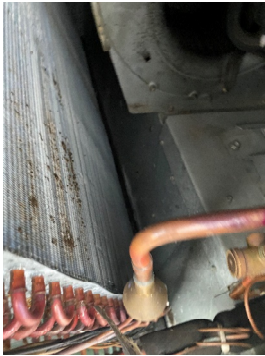
RTU-1 (DINING)
DRAIN PAN

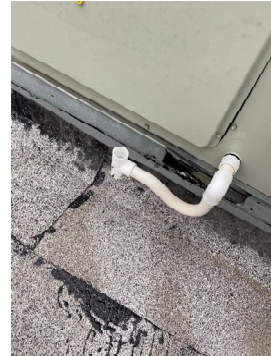
RTU-1 (DINING)
P-TRAP

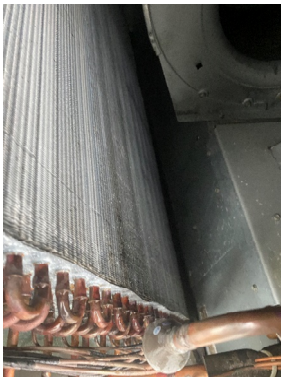
RTU-2 (DINING)
DRAIN PAN

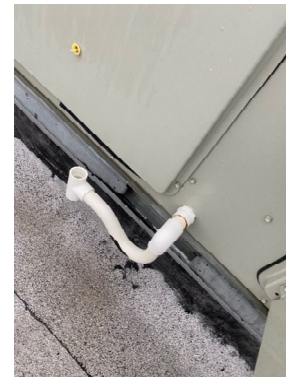
RTU-2 (DINING)
P-TRAP

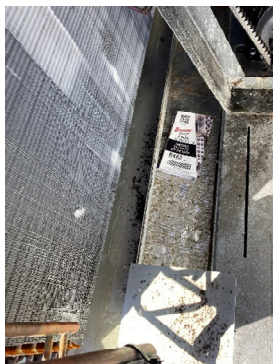
RTU-3 (KITCHEN)
DRAIN PAN

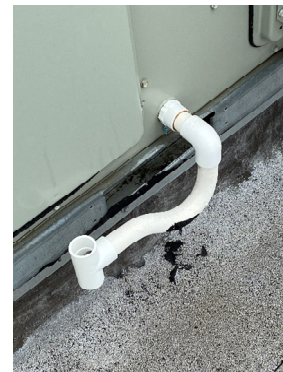
RTU-3 (KITCHEN)
P-TRAP

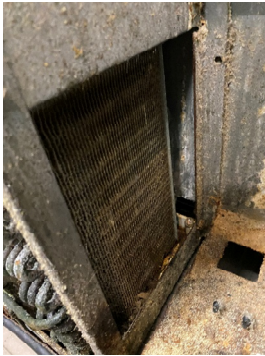
DXC-3 (MEAT COOLER 1)
DIRTY CONDENSER

Food equipment condensers were cleaned. The Walk-In evaporator were cleaned. All equipment is in good health unless stated in the Recommendation List.

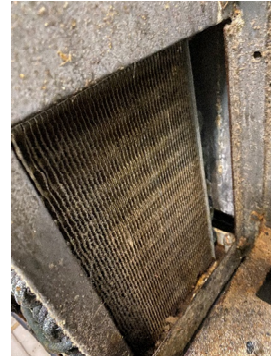
DXC-3 (MEAT COOLER 1)
CLEAN CONDENSER

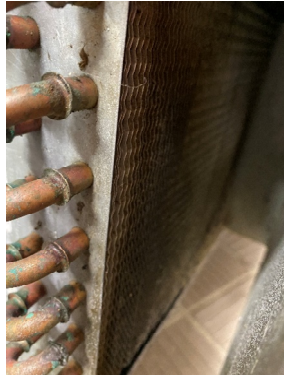
DXC-4 (MEAT COOLER 2)
DIRTY CONDENSER

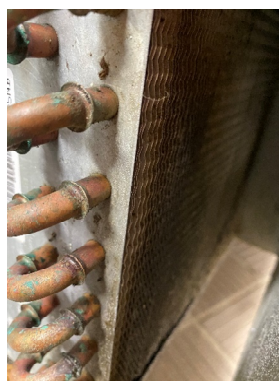
DXC-4 (MEAT COOLER 2)
CLEAN CONDENSER

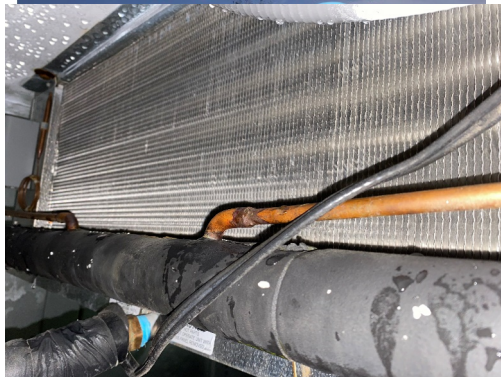
DXC-2 (WALK-IN FREEZER)
DIRTY EVAPORATOR

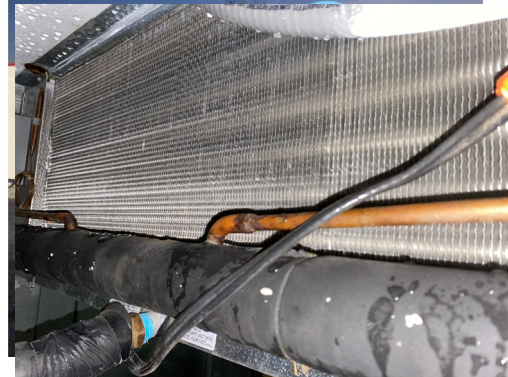
DXC-2 (WALK-IN FREEZER)
CLEAN EVAPORATOR

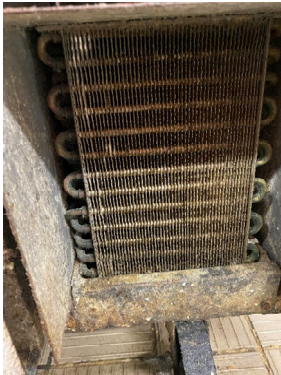
DXC-5 (PREP TABLE 1)
DIRTY CONDENSER

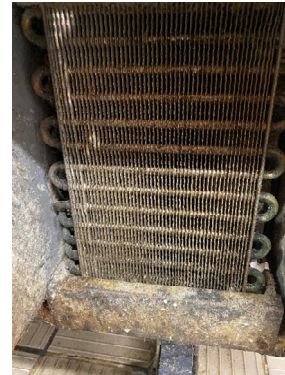
DXC-5 (PREP TABLE 1)
CLEAN CONDENSER

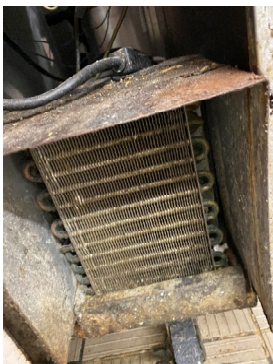
DXC-6 (PREP TABLE 2)
DIRTY CONDENSER

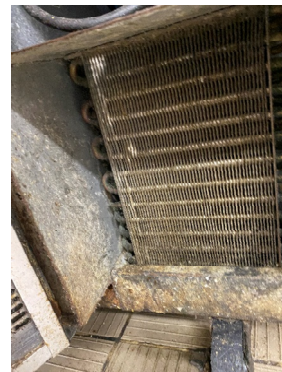
DXC-6 (PREP TABLE 2)
CLEAN CONDENSER

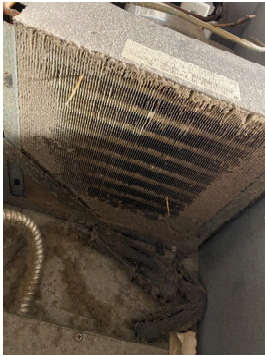
DXC-7 (FRYER FREEZER)
DIRTY CONDENSER

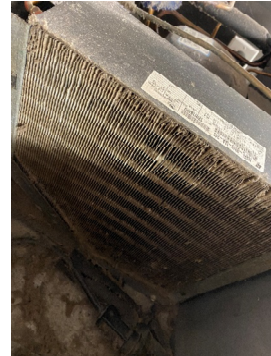
DXC-7 (FRYER FREEZER)
CLEAN CONDENSER

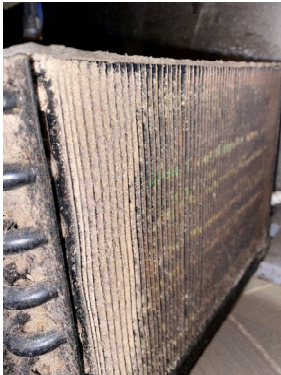
DXC-8 (SUNDAE PREP)
DIRTY CONDENSER

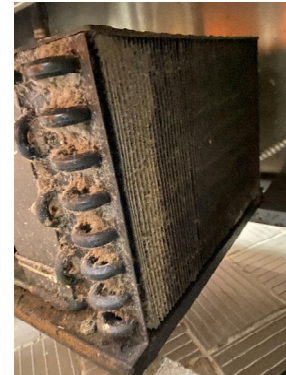
DXC-8 (SUNDAE PREP)
CLEAN CONDENSER

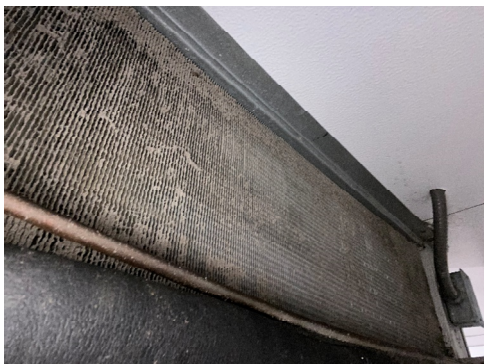
DXC-1 (WALK-IN COOLER)
DIRTY EVAPORATOR

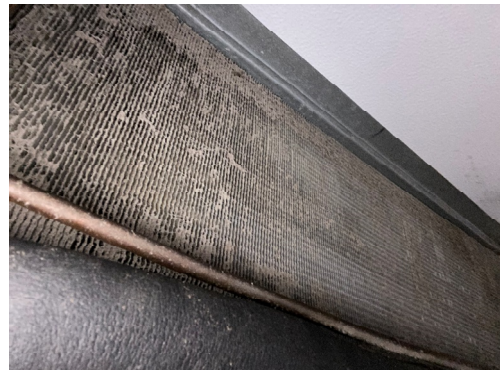
DXC-1 (WALK-IN COOLER)
CLEAN EVAPORATOR
