**Report: FINAL TAB REPORT  
Function: Test, Adjust, & Balance  
Date: 8/8/2022**

**PROJECT  
07-11 CULVERS - FULSHEAR, TX**

Project: 07-11 CULVERS - FULSHEAR, TX

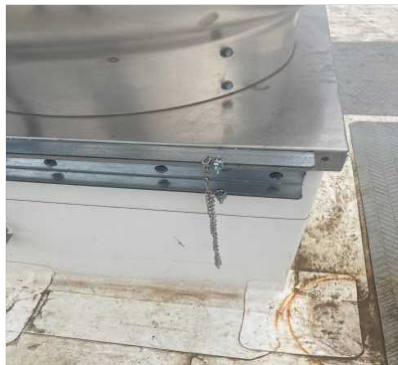
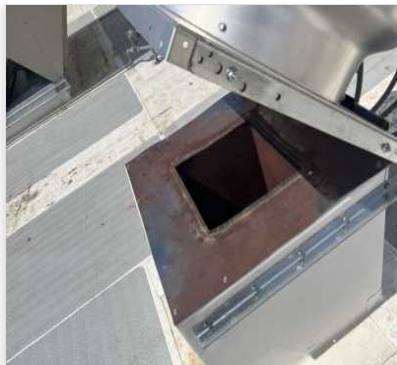
tension\_cable\_install...

Hinge kit on KEF(s) missing the tension wire to keep fan from hinging to far back (needs to be installed) - (closed - tension cable is installed)

YES BUT HINGE KITS ARE MISSING WIRE TO KEEP FROM HINGING ALL THE WAY.

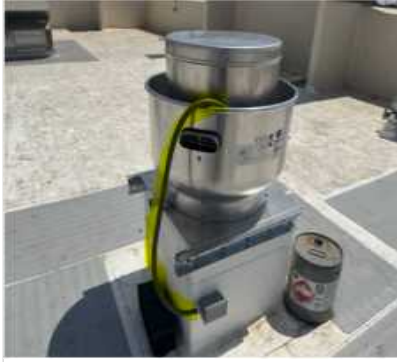
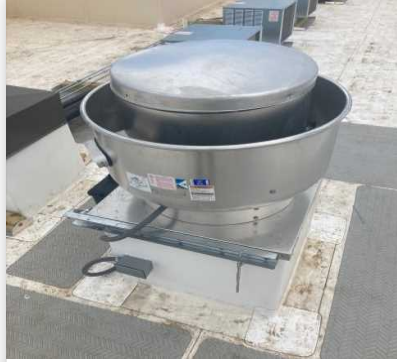
electrical\_whip\_issue...

PRV-2&3 ELECTRICAL CONDUIT RUN OVER FAN HOUSING. RECOMMEND RUNNING CONDUIT THROUGH CHASE ON SIDE OF HOUSING. (closed - electrical whip installed)

PRV-2&3 ELECTRICAL CONDUIT RUN OVER FAN HOUSING. RECOMMEND RUNNING CONDUIT THROUGH CHASE ON SIDE OF HOUSING. RTUS MISSING GAS PIPE GROMMET. GROMMET IS LOCATED IN FURNACE SECTION.
