Report: FINAL TAB REPORT
Function: Test, Adjust, & Balance
Date: 8/5/2022

PROJECT
07-11 CULVERS - FULSHEAR, TX

Project: 07-11 CULVERS - FULSHEAR, TX

Section	Page #
Summary & Scope	3
Balance Schedule	4
Remarks & Open Issues	5
Site Pictures	7
Checklist Data	11
AHU/RTU	13
FAN - Exhaust	18
Kitchen Hood Type I	24
GRD Layout	26

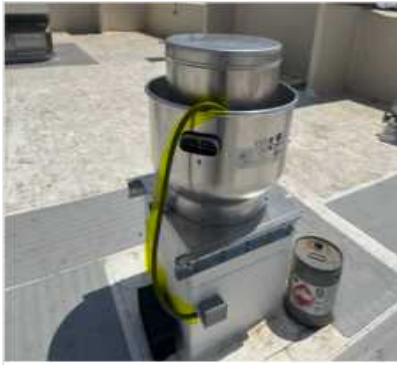
electrical_whip_issue.PNG

HIGH

PRV-2&3 ELECTRICAL CONDUIT RUN OVER FAN HOUSING. RECOMMEND RUNNING CONDUIT THROUGH CHASE ON SIDE OF HOUSING.

PRV-2&3 ELECTRICAL CONDUIT RUN OVER FAN HOUSING. RECOMMEND RUNNING CONDUIT THROUGH CHASE ON SIDE OF HOUSING. RTUS MISSING GAS PIPE GROMMET. GROMMET IS LOCATED IN FURNACE SECTION.

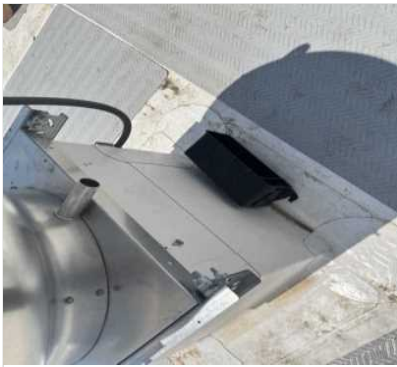
grease_cup_not_installed.jpg

HIGH

Grease cup on KEF not installed

Rotation is correct?	YES
Belts are tight?	YES
Grease cup installed on hood fan?	PRV-3 GREASE CUP NOT INSTALLED
