Report: FINAL TAB REPORT
Function: Test, Adjust, & Balance
Date: 8/8/2022

PROJECT
07-11 CULVERS - FULSHEAR, TX

Project: 07-11 CULVERS - FULSHEAR, TX

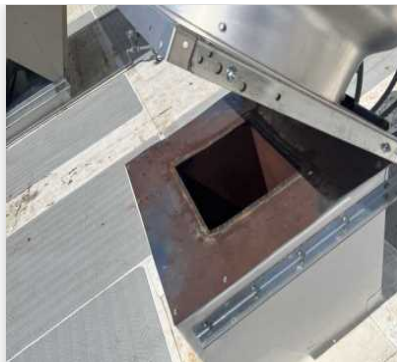
tension_wire_missing....

Hinge kit on KEF(s) missing the tension wire to keep fan from hinging to far back (needs to be installed) - (closed - tension cable is installed)

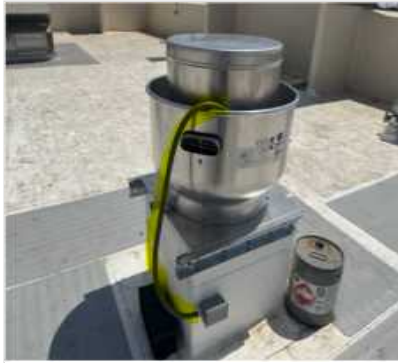
electrical_whip_issue...

PRV-2&3 ELECTRICAL CONDUIT RUN OVER FAN HOUSING. RECOMMEND RUNNING CONDUIT THROUGH CHASE ON SIDE OF HOUSING. (closed - electrical whip installed)

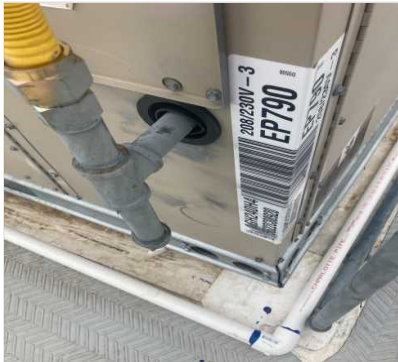
grommets_installed.jp...

RTUS MISSING GAS PIPE GROMMET. GROMMET IS LOCATED IN FURNACE SECTION

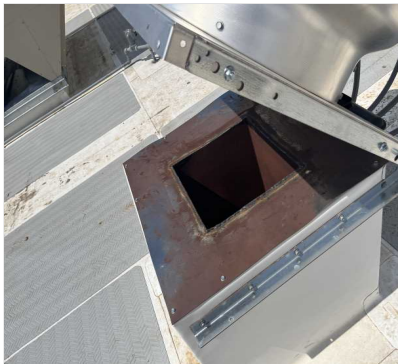
IMG_8467.jpeg

Hinge kit installed installed on hood fan?

YES BUT HINGE KITS ARE MISSING WIRE TO KEEP FROM HINGING ALL THE WAY.
