**Report: FINAL TAB REPORT**  
**Function: Test, Adjust, & Balance**  
**Date: 8/5/2022**

**PROJECT**  
**07-11 CULVERS - FULSHEAR, TX**

# National TAB

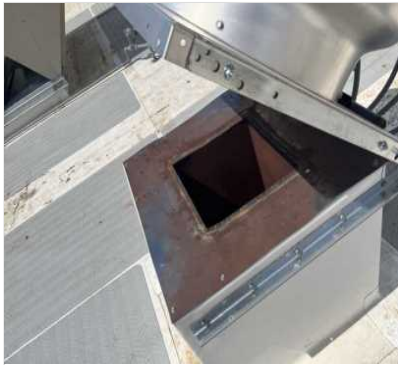
tension\_wire\_missing.jpeg

HIGH	Backdraft damper is not installed for the restroom exhaust fan
HIGH	Hinge kit on KEF(s) missing the tension wire to keep fan from hinging to far back (needs to be installed)

YES BUT HINGE KITS ARE MISSING WIRE TO KEEP FROM HINGING ALL THE WAY.

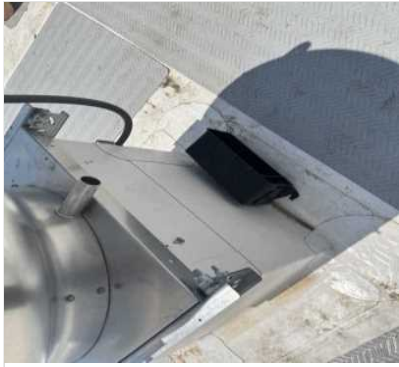
grease\_cup\_not\_installed.jpe  
g

HIGH	PRV-2&3 ELECTRICAL CONDUIT RUN OVER FAN HOUSING. RECOMMEND RUNNING CONDUIT THROUGH CHASE ON SIDE OF HOUSING.
HIGH	RTUS MISSING GAS PIPE GROMMET. GROMMET IS LOCATED IN FURNACE SECTION
HIGH	Grease cup on KEF not installed

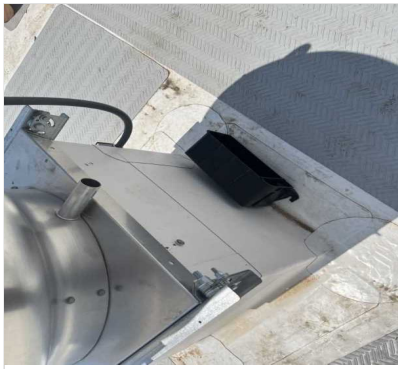
IMG\_8462.jpeg

Rotation is correct?	YES
Belts are tight?	YES
Grease cup installed on hood fan?	PRV-3 GREASE CUP NOT INSTALLED

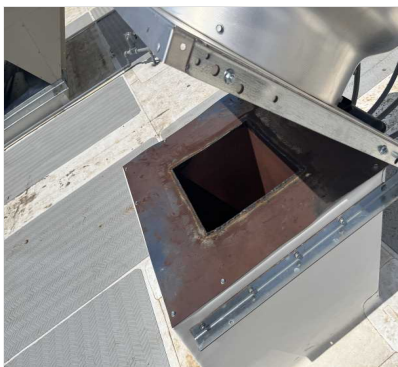
IMG\_8467.jpeg

Hinge kit installed installed on hood fan?
