**Report: FINAL TAB REPORT
Function: Test, Adjust, & Balance
Date: 8/10/2022**

**PROJECT
07-11 CULVERS - FULSHEAR, TX**

Project: 07-11 CULVERS - FULSHEAR, TX

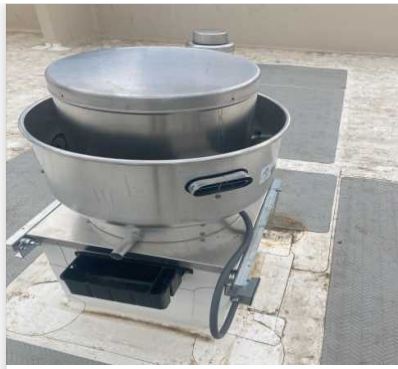
Grease cup on KEF not installed (closed - grease cup installed)

grease_cup_not_instal...

grease_cups_installed...
