**Report: FINAL TAB REPORT
Function: Test, Adjust, & Balance
Date: 8/9/2022**

**PROJECT
07-11 CULVERS - FULSHEAR, TX**

Project: 07-11 CULVERS - FULSHEAR, TX

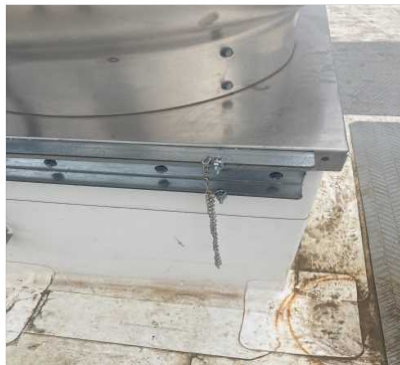
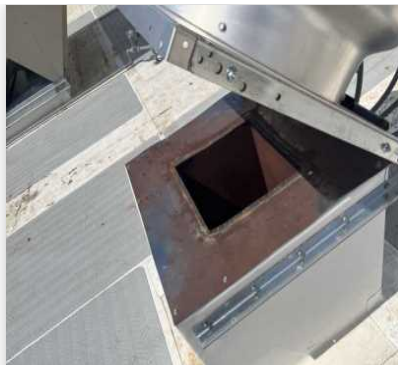
Hinge kit on KEF(s) missing the tension wire to keep fan from hinging to far back (needs to be installed) - (closed - tension cable is installed)

tension_cable_install...

tension_wire_missing....

YES BUT HINGE KITS ARE MISSING WIRE TO KEEP FROM HINGING ALL THE WAY.

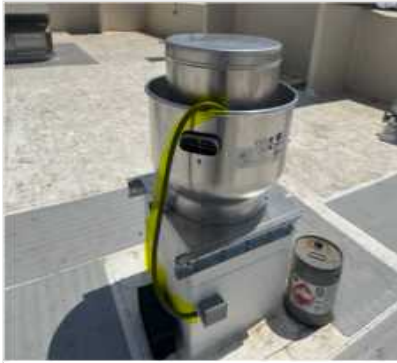
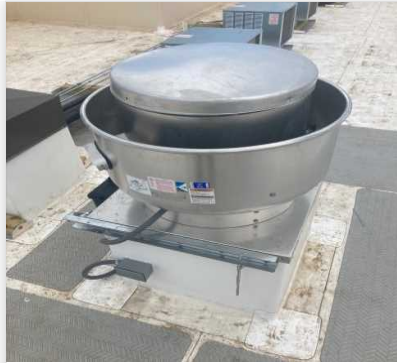
PRV-2&3 ELECTRICAL CONDUIT RUN OVER FAN HOUSING. RECOMMEND RUNNING CONDUIT THROUGH CHASE ON SIDE OF HOUSING. (closed - electrical whip installed)

electrical_whip_issue...

electrical_whip_rerou...

PRV-2&3 ELECTRICAL CONDUIT RUN OVER FAN HOUSING. RECOMMEND RUNNING CONDUIT THROUGH CHASE ON SIDE OF HOUSING. RTUS MISSING GAS PIPE GROMMET. GROMMET IS LOCATED IN FURNACE SECTION.

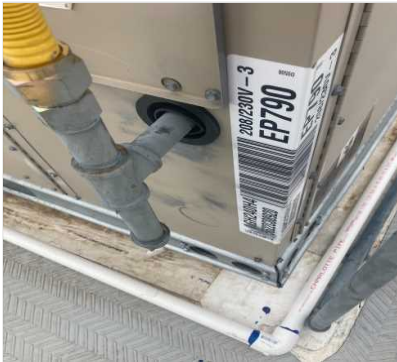
RTUS MISSING GAS PIPE GROMMET. GROMMET IS LOCATED IN FURNACE SECTION

grommets_installed.jp...

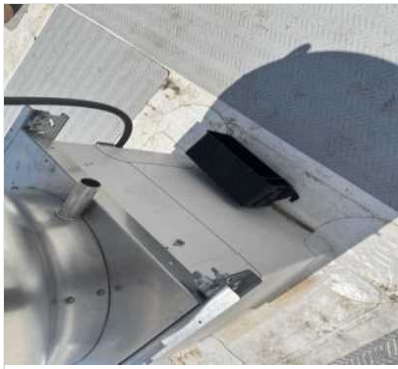
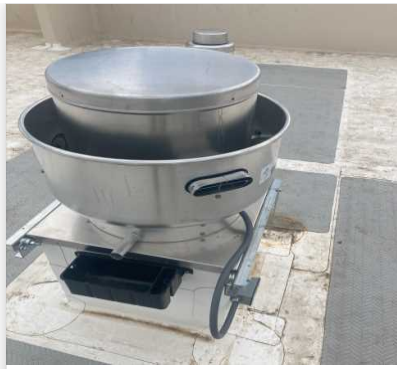
Grease cup on KEF not installed (closed - grease cup installed)

grease_cup_not_instal...

grease_cups_installed...

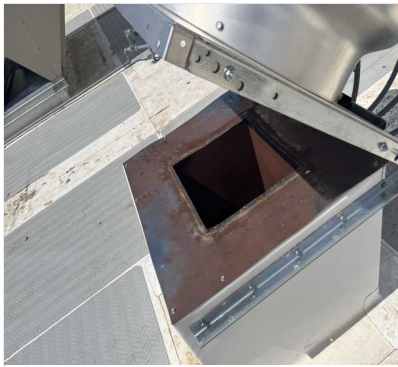
IMG_8467.jpeg

Hinge kit installed installed on hood fan?
