Report: TAB REPORT
Function: Test, Adjust, & Balance
Date: 11/29/2023

PROJECT
11-27-23 CULVERS-DELANO, MN

11-27-23 CULVERS-DELANO, MN

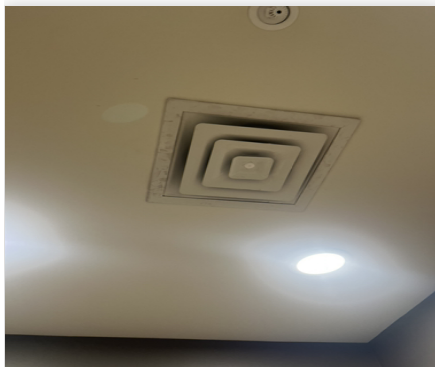
Incorrect
11/27/2023

Issue Name : PRV-1 (RR Exhaust) Incorrect Grilles Installed
Description : Installed Exhaust grilles in bathroom are supply grilles (SD-4). Plans call for EG-1 return grilles. Recommend correct grilles are installed.
Created By : National TAB **Assigned To :** National TAB - Michael McDonnell
Status : Open
Priority : Low **Asset Tag :**
Originated Date : 11/27/2023 - Michael McDonnell - National TAB

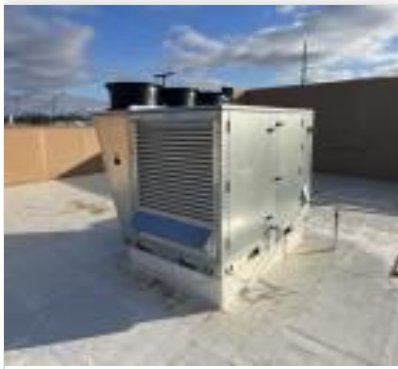
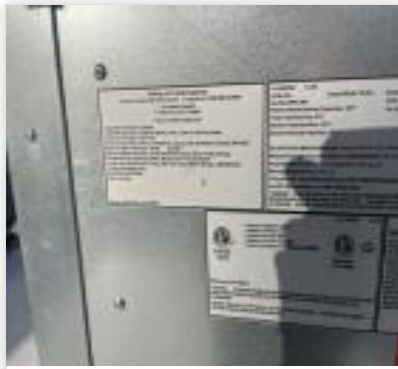
RTU-1-Dining
11/28/2023

RTU-1

Test Data		
	Design	Actual
SF CFM	6150	5960
SF RPM	-	1638
RA CFM	4275	3952
OA CFM	1875	2008
RL Voltage	-	183 @VFD
RL Amperage	-	23.3 @VFD
SF Rotation	-	CORRECT
Min OA Damper Position	-	4.2V
Min OA Damper Type	-	ECONOMIZER

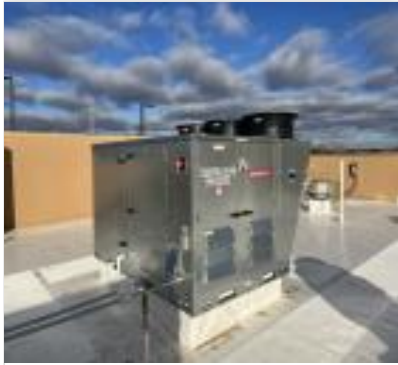
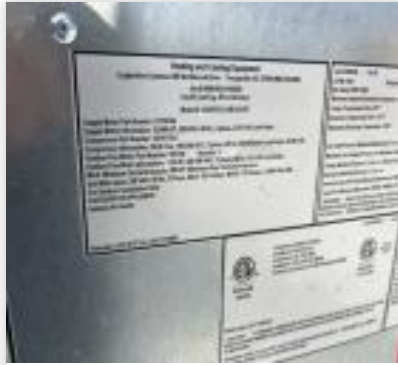
RTU-2-Kitchen
11/28/2023

RTU-2

Test Data		
	Design	Actual
SF CFM	6150	6043
SF RPM	-	1638
RA CFM	4300	4067
OA CFM	1850	1976
RL Voltage	-	180 @ VFD
RL Amperage	-	24.0
SF Rotation	-	CORRECT
Min OA Damper Position	-	4.1V
Min OA Damper Type	-	ECONOMIZER

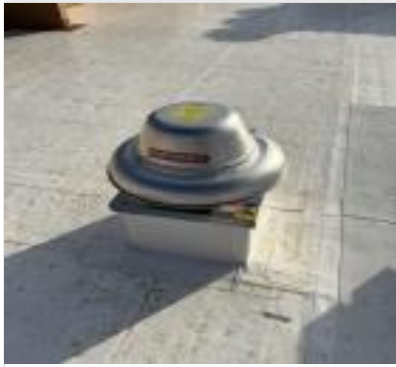
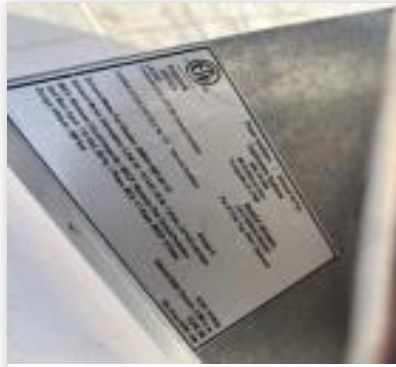
PRV-1-RR
11/28/2023

PRV-1

Restroom exhaust grilles do not match design. Supply diffusers are installed. See issue.

Test Data		
	Design	Actual
CFM	300	292
Fan RPM	-	773
Fan Rotation	-	CCW, CORRECT
Motor RPM	-	773
System SetPt	-	53%
RL Voltage	-	121
RL Amperage	-	2.0
Total ESP	0.5	0.163"
Fan Inlet SP	-	-0.163"
Fan Discharge SP	-	ATM

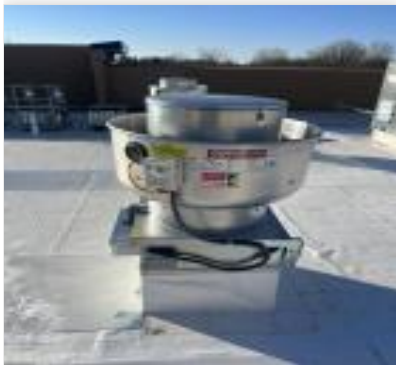
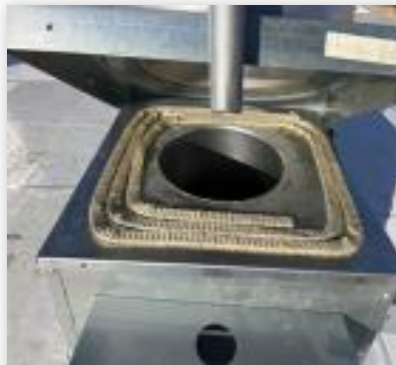
PRV-2-Griddle
11/29/2023

PRV-2

Test Data		
	Design	Actual
CFM	1500	1555
Fan RPM	1702	1209
Fan Rotation	-	CCW, CORRECT
Motor RPM	-	1209
System SetPt	-	64%
RL Voltage	-	121.6
RL Amperage	-	3.1
Total ESP	1.8"	0.861"
Fan Inlet SP	-	-0.861"
Fan Discharge SP	-	ATM

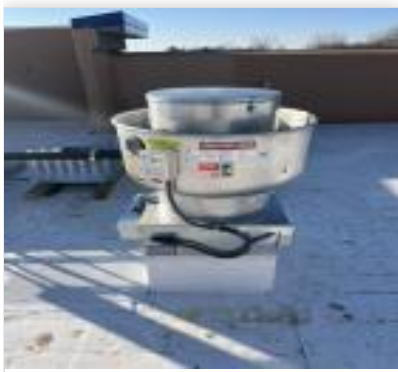
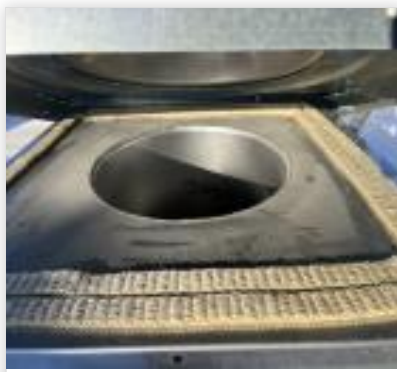
PRV-3-Fryer
11/29/2023

PRV-3

Test Data		
	Design	Actual
CFM	1500	1604
Fan RPM	-	1100
Fan Rotation	-	CCW, CORRECT
Motor RPM	-	1100
System SetPt	-	59%
RL Voltage	-	121.6
RL Amperage	-	2.4
Total ESP	-	0.645"
Fan Inlet SP	-	-0.645"
Fan Discharge SP	-	ATM

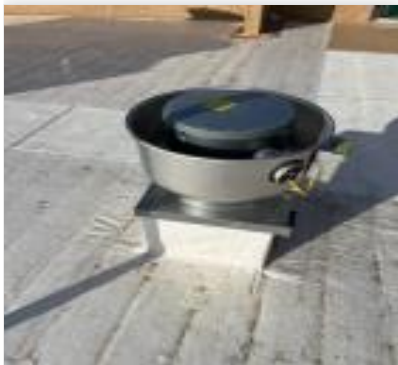
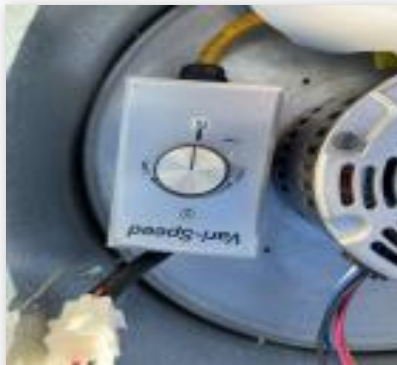
PRV-4-Dishwasher
11/29/2023

PRV4

Test Data		
	Design	Actual
CFM	350	362
Fan RPM	1486	DD
Fan Rotation	-	CCW, CORRECT
Motor RPM	-	DD
System SetPt	-	SPEED CONTROLLER MARKED
RL Voltage	-	121
RL Amperage	-	1.8
Total ESP	0.6"	0.342"
Fan Inlet SP	-	-0.342"
Fan Discharge SP	-	ATM

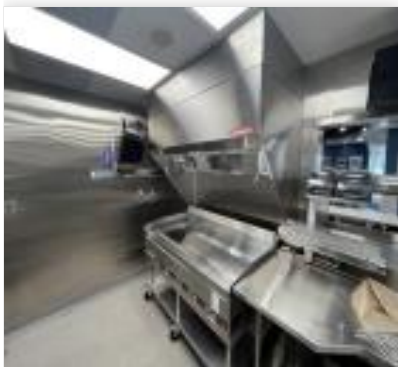
HD-1-Griddle
11/29/2023

HOOD 1

Test Data Exhaust		
	Design	Actual
Filter Type	-	CAPTRATE SOLO
Filter Size 1	-	16X16
Filter Qty 1	-	4
Filter AK factor size 1	-	1.62
Filter Total AK Area	-	6.48
Filter1 FPM	-	246
Filter2 FPM	-	231
Filter3 FPM	-	246
Filter4 FPM	-	237
Filter Ave FPM(corr)	-	240
CFM	1500	1555

[1] SPEED NOT CONTROLLED THROUGH HMI. SPEED CONTROLLER INSTALLED IN FAN HOUSING.

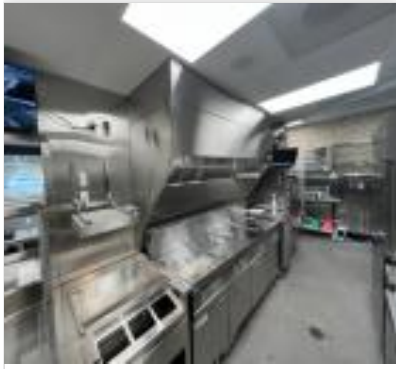
HD-2-Fryer
11/29/2023

HOOD 2

Test Data Exhaust		
	Design	Actual
Filter Type	-	CAPTRATE SOLO
Filter Size 1	-	16X16
Filter Qty 1	-	5
Filter AK factor size 1	-	1.62
Filter Total AK Area	-	8.1
Filter1 FPM	-	198
Filter2 FPM	-	200
Filter3 FPM	-	202
Filter4 FPM	-	194
Filter5 FPM	-	198
Filter Ave FPM(corr)	-	198
CFM	1500	1604

[1] SPEED NOT CONTROLLED THROUGH HMI. SPEED CONTROLLER INSTALLED IN FAN HOUSING.

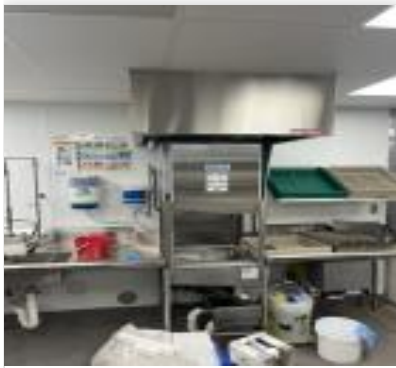
HD-3-DW
11/29/2023

HOOD3

Test Data		
	Design	Actual
Exhaust CFM	350	362

[1] FAN OPERATED BY SWITCH TO RIGHT OF HOOD
