**Report: TAB REPORT
Function: Test, Adjust, & Balance
Date: 01/25/2023**

**PROJECT
12-12 BRU BURGER - MONTGOMERY, OH**

Project: 12-12 BRU BURGER - MONTGOMERY, OH

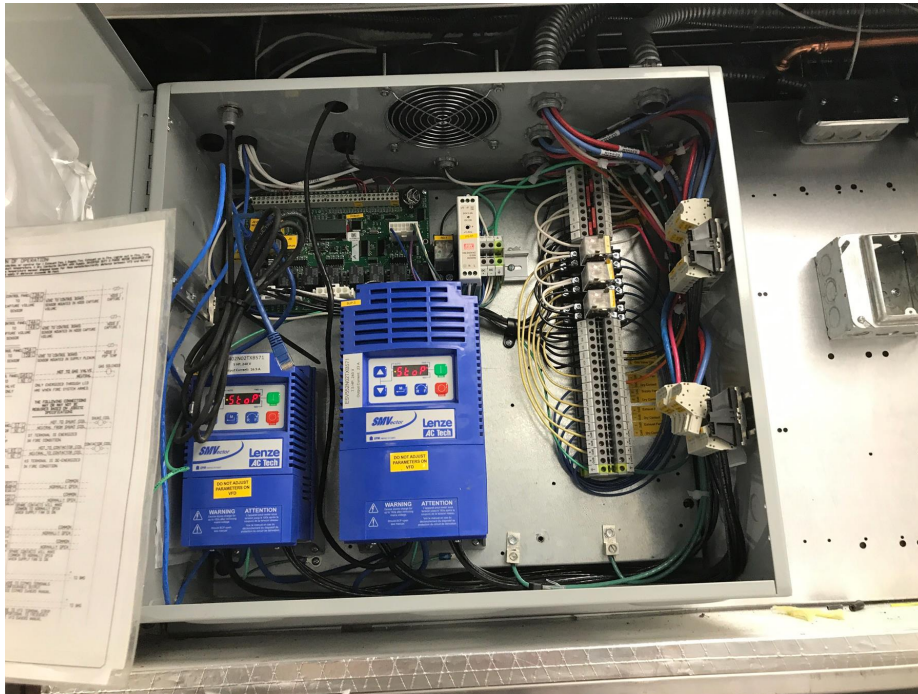
Other Notes:

Temp setting changed to preset due to location of room temp sensor.

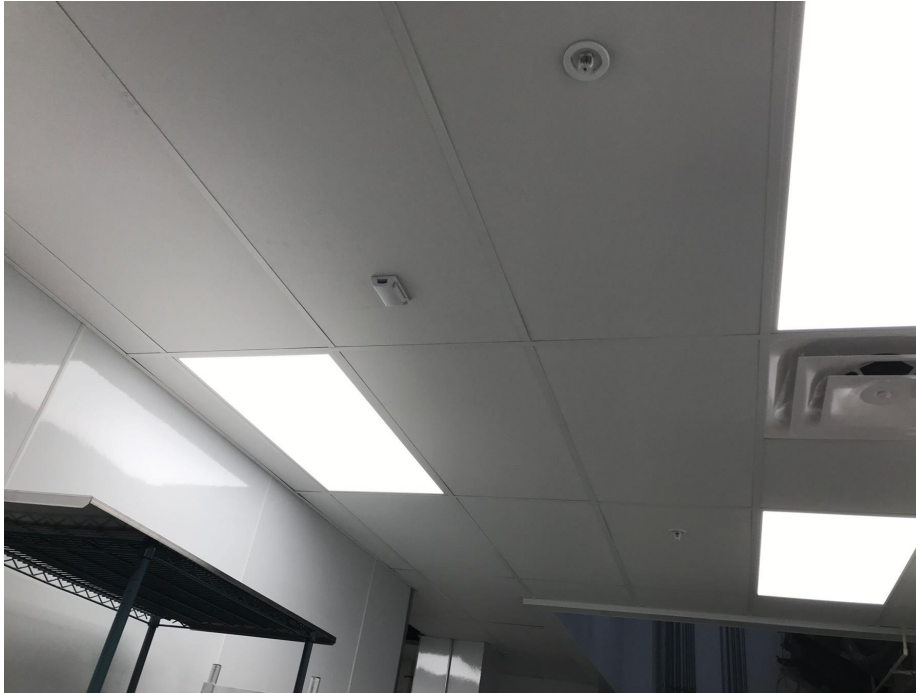
ALL TEMP SENSORS ARE WIRED IN	Design: Yes	Actual: Yes
Do any of the light circuits exceed 1400W?	Design: No	Actual: No
ALL LIGHTS WORK	Design: Yes	Actual: No

Other Notes:

No lightbulbs installed in any hood.

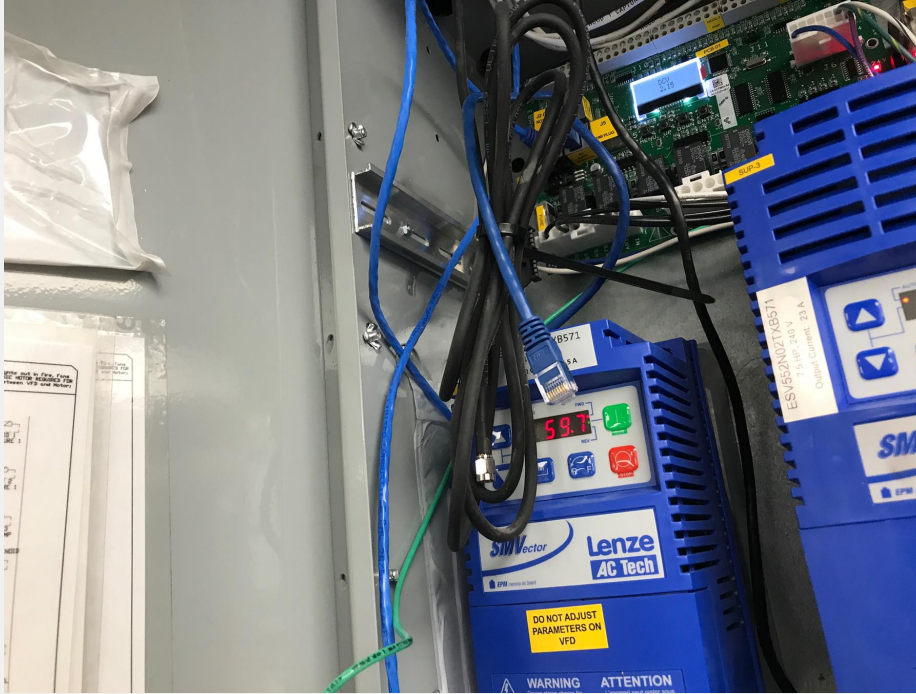
120V Line Ran from SF1 for MUA(s)	Design: Yes	Actual: Yes
Damper interlock wiring ran to MAU?	Design: Yes	Actual: No

BMS & Monitoring - NOT AVAILABLE!

Other Notes:

SCADA not installed.
