Report: TAB Report
Function: Test, Adjust, & Balance
Date: 10/16/2025
Completed By: National TAB

PROJECT
11-17-25 WAWA #6104 GREENVILLE, NC

Project: 11-17-25 WAWA #6104 GREENVILLE, NC

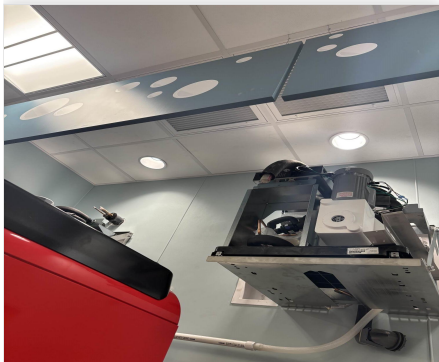
Project Issue Information

Issue Name : R3-1 & R3-2
Description : Diffusers are inaccessible
Created By : National TAB **Assigned To :** National TAB - Cody Mauro
Status : Open
Priority : High **Asset Tag :**
Originated Date : 10/14/2025 - Cody Mauro - National TAB
