Report: TAB Report
Function: Test, Adjust, & Balance
Date: 03/06/2026
Completed By: National TAB

PROJECT
03-16-26 QT #0490 PEORIA, AZ

Project: 03-16-26 QT #0490 PEORIA, AZ

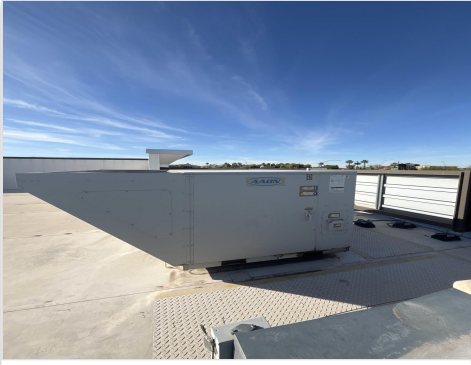
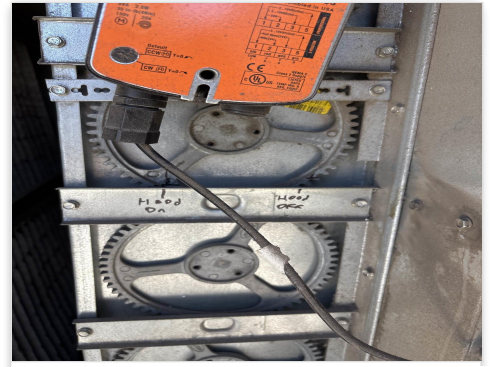
Unit Data - PHOTO LOG

Unit Data	
	Actual
MFG	AAON
Serial Num	201503-ANEL11751
Model Num	RN-015-8-0-EA0A-152
Num OA Filters 1	1
OA Filter Size 1	45x22
Num Final Filter 1	2
Final Filter Size 1	48X20

Test Data		
	Design	Actual
SF CFM	4200	4153
SF RPM	-	1232
OA CFM (Hoods On)	800	818
OA CFM (Hoods Off)	350	378
RL Voltage	-	128@VFD
RL Amperage	-	9.8@VFD
VFD Max SetPt	-	42HZ
VFD Min SetPt	-	24HZ
OA Damper Position (Hoods On)	-	46%
OA Damper Position (Hoods Off)	-	28%

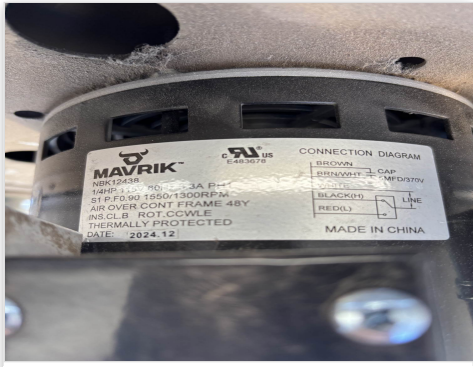
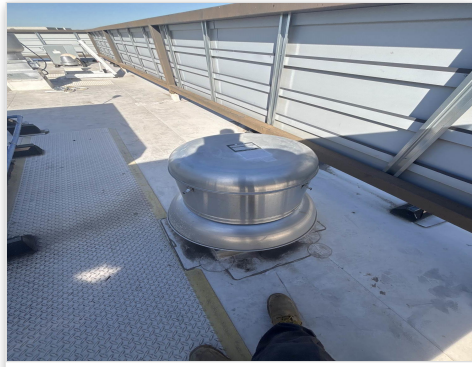
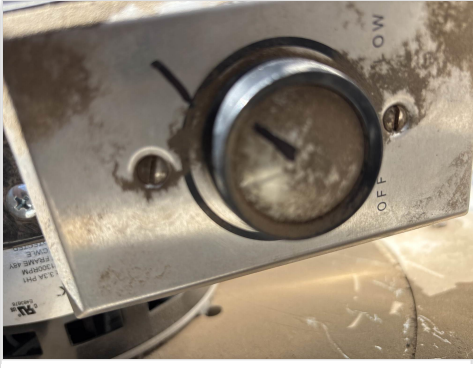
Unit Data - PHOTO LOG

Unit Data		
	Design	Actual
MFG	NA	COOK
Model Num	NA	120 ACE 120C13D
Serial Num	-	100SF66088- 00/0001901
Type	-	DOWNBLAST
Configuration	-	VERTICAL

Test Data		
	Design	Actual
CFM	525	546
Fan RPM	-	NA
Fan Rotation	-	NA
Motor RPM	-	NA
System SetPt	-	DIAL
RL Voltage	-	NA
RL Amperage	-	NA
Total ESP	-	0.41"
Fan Inlet SP	-	-0.41"
Fan Discharge SP	-	ATMS

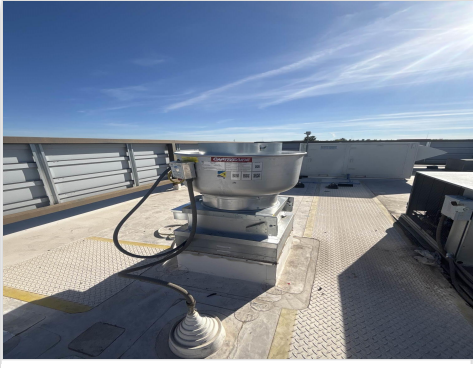
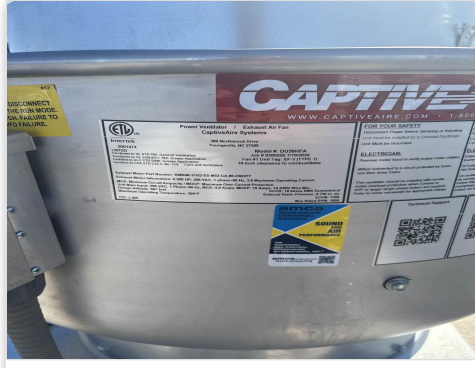
Unit Data - PHOTO LOG

Unit Data		
	Design	Actual
MFG	NA	CAPTIVEAIRE
Model Num	NA	DU50HFA
Serial Num	-	8385026
Type	UPBLAST	UPBLAST
Configuration	VERTICAL	VERTICAL

Test Data		
	Design	Actual
CFM	1350	1322
Fan RPM	-	1195
Fan Rotation	-	CCW
Motor RPM	-	1195
System SetPt	-	52.8HZ
RL Voltage	-	210
RL Amperage	-	2.7
Total ESP	-	0.57"
Fan Inlet SP	-	-0.57"
Fan Discharge SP	-	ATMS

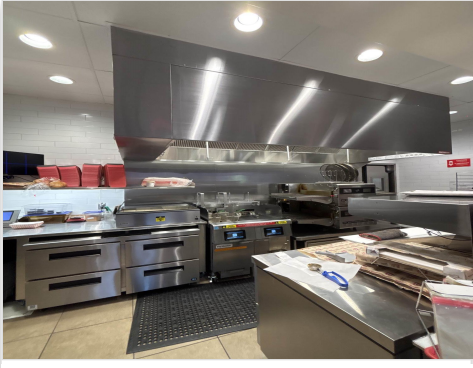
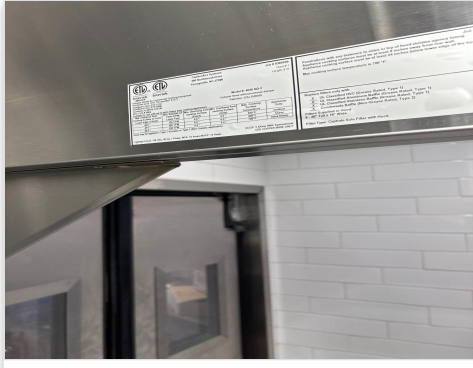
Unit Data - PHOTO LOG

Design	Actual
MFG	CAPTIVEAIRE	CAPTIVEAIRE
Model Num	6030ND-2-F	6030ND-2-F
Job / Serial Num	-	8385026
Type	-	TYPE I CANOPY
Hood length	-	108"
Hood Width	-	60"

Design	Actual
Filter Type	-	BAFFLE
Filter Size 1	-	20X16
Filter Qty 1	-	6
Filter AK factor size 1	-	2.08
Filter Total AK Area	-	12.48
Filter1 FPM	-	105
Filter2 FPM	-	102
Filter3 FPM	-	115
Filter4 FPM	-	114
Filter5 FPM	-	102
Filter6 FPM	-	103
Filter Ave FPM(corr)	-	106
CFM	1350	1322
