Report: TAB Report
Function: Test, Adjust, & Balance
Date: 02/20/2026
Completed By: National TAB

02-09-26 Freddys - Marshall, TX

KT Ventures

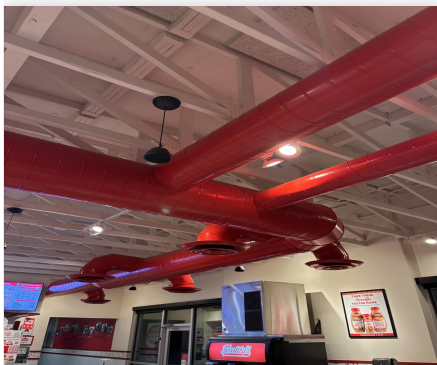
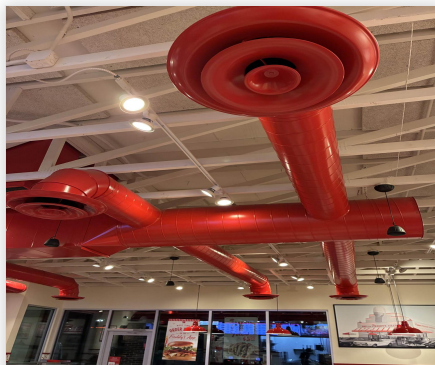
Issue Name : NO DAMPERS ON ANY DIFFUERS FOR RTU-1 (DINING ROOM)
Description : NONE OF THE DIFFUSERS IN THE DINING ROOM AND BATHROOMS HAD A DAMPER. THIS MUST BE CORRECTED BEFORE THE UNIT CAN BE BALANCED
Created By : National TAB **Assigned To :** National TAB - Dan Hertenstein
Status : Open
Priority : Urgent **Asset Tag :** RTU-1
Originated Date : 02/10/2026 - Zack Osborne - National TAB

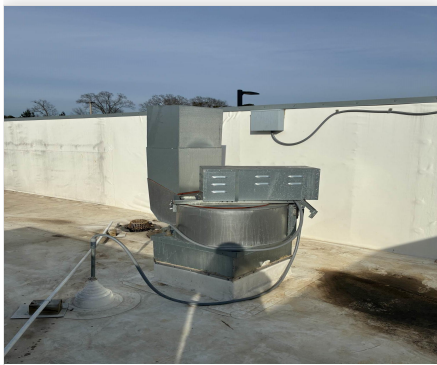
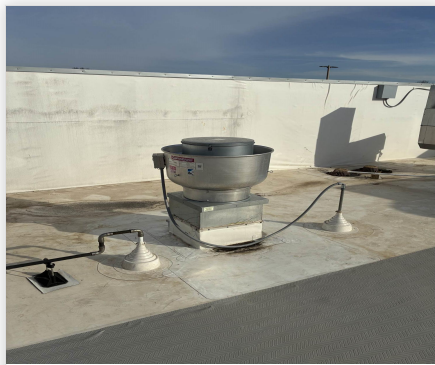
Issue Name : NO HINGE KIT ON KITCHEN EXHAUST FANS
Description : NEITHER KITCHEN EXHAUST FAN HAS A HINGE KIT INSTALLED. THEY CANNOT BE LEANED BACK IN THE FUTURE FOR CLEANING.
Created By : National TAB **Assigned To :** National TAB - Dan Hertenstein
Status : Open
Priority : Urgent **Asset Tag :**
Originated Date : 02/10/2026 - Zack Osborne - National TAB

[1] UNIT DOES NOT HAVE HINGE KIT INSTALLED. UNIT IS ALSO TOO HEAVY TO TILT BACK FOR PRESSURE READING.

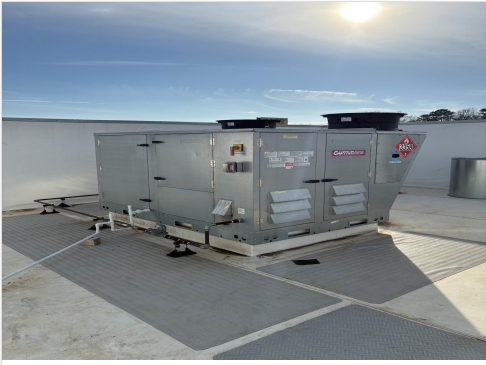
Unit Data - PHOTO LOG

Asset: DOAS-1

Unit Data		
	Design	Actual
MFG	CAPTIVEAIRE	CAPTIVEAIRE
Serial Num	-	6382484
Model Num	CASRTU3-I.200-15-15T	CAS-HVAC3-I.200-15-15T
Type	RTU	DOAS
Configuration	VERTICAL	VERTICAL
Num OA Filters 1	-	4
OA Filter Size 1	-	16X25X2
Num Final Filter 1	-	8
Final Filter Size 1	-	20X25X2

Notes:
[1] UNIT IS DOUBLE WALLED. DRILLING FOR PRESSURE READING NOT RECCOMENDED.

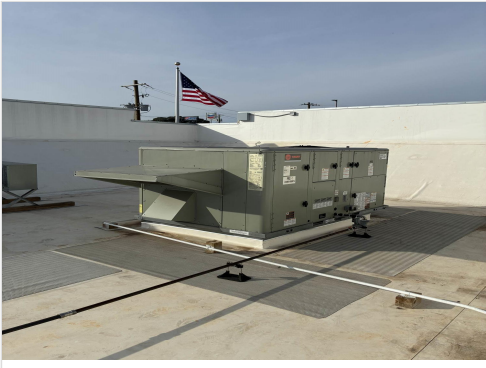
Unit Data - PHOTO LOG

Asset: RTU-1

Unit Data		
	Design	Actual
MFG	CAPTIVEAIRE	TRANE
Serial Num	-	243010097L
Model Num	CASRTU3-I.200-15-15T	YSJ-150
Type	RTU	RTU
Configuration	VERTICAL	VERTICAL
Num OA Filters 1	-	1
OA Filter Size 1	-	39X25
Num Final Filter 1	-	3
Final Filter Size 1	-	18X24X2
Num Final Filter 2	-	3
Final Filter Size 2	-	18X18X2

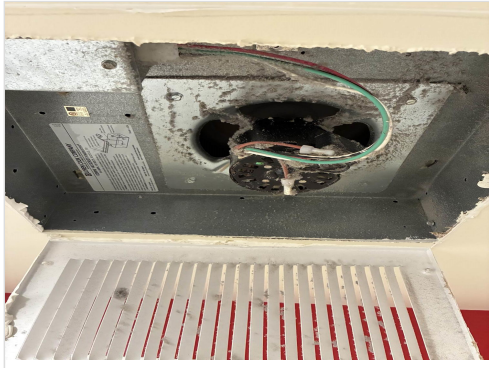
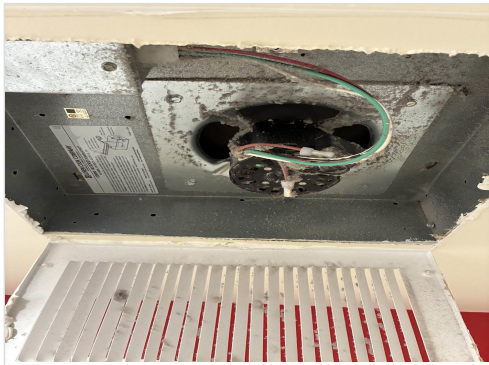
Unit Data - PHOTO LOG

Asset: EF-2

Unit Data		
	Design	Actual
MFG	GREENHECK	LOREN COOK
Model Num	SP-A200-390	GEMINI-140
Serial Num	-	NA
Type	DOWNBLAST	CEILING MOUNT
Configuration	VERTICAL	VERTICAL

Motor Data		
	Design	Actual
Motor MFG	-	QUEACE
Motor Rpm	900	1550
Phase	1	1
Voltage (rated)	120	115
Amperage (rated)	-	0.4

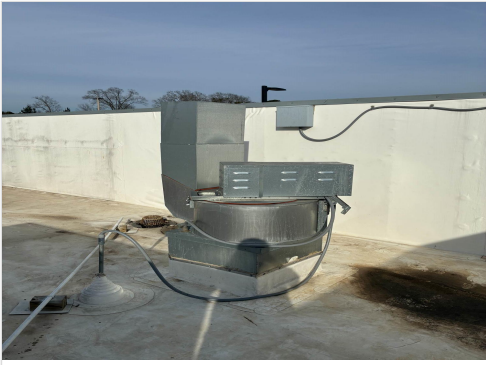
Unit Data - PHOTO LOG

Asset: KEF-1

Unit Data		
	Design	Actual
MFG	GREENHECK	CAPTIVEAIRE
Model Num	SP-A200-390	CASRE18DD
Serial Num	-	6382484
Type	UPBLAST	UPBLAST
Configuration	VERTICAL	VERTICAL

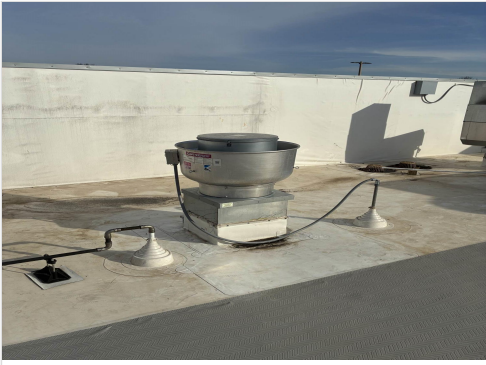
Unit Data - PHOTO LOG

Asset: KEF-2

Unit Data		
	Design	Actual
MFG	GREENHECK	CAPTIVEAIRE
Model Num	SP-A200-390	DU50HFA
Serial Num	-	6382484
Type	UPBLAST	UPBLAST
Configuration	VERTICAL	VERTICAL
