Report: TAB RPT
Function: Test, Adjust, & Balance
Date: 7/15/2022

PROJECT
05-16 CULVERS - LOWELL, MI

Project: 05-16 CULVERS - LOWELL, MI

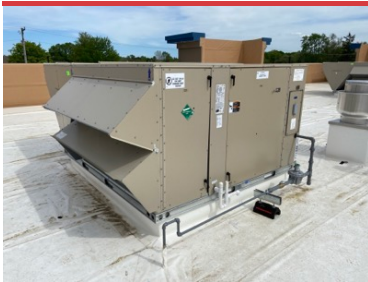
KITCHEN RTU

Unit Data		
	Design	Actual
MFG	LENNOX	LENNOX
Serial Num	-	5622D00934
Model Num	NA	LGH210H
Type	-	RTU
Configuration	-	VERTICAL
Num OA Filters 1	-	3
OA Filter Size 1	-	12.75X23.25
Num Final Filter 1	-	6
Final Filter Size 1	-	24X24X2

Test Data		
	Design	Actual
SF CFM	6150	6197
SF RPM	-	816
RA CFM	4250	4209
OA CFM	1900	1988
RL Voltage	-	210/209/209
RL Amperage	-	7.3/7.3/7.3
SF Rotation	-	CW
RA Damper Position	-	70%
Min OA Damper Position	-	30%
Min OA Damper Type	-	ECON
OA Enthalpy Setpt	-	NA
Brake Horse Power	-	2.73

Notes:RESOLVED - DIFFUSERS 1-1 & 1-2 CANNOT BALANCE WITHIN DESIGN. DUCTWORK WAS MODIFIED WHERE THEY HAD TO CONNECT A FLEX IN ORDER TO GET PAST THE WOODEN TRUSSES AND THEN BACK TO HARD DUCT. DAMPERS ARE 100% OPEN

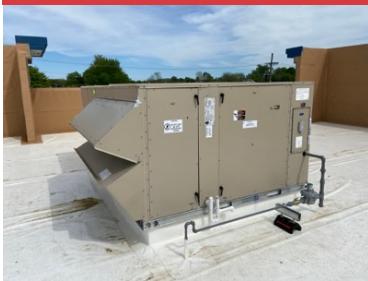
DINING RTU

Unit Data		
	Design	Actual
MFG	LENNOX	LENNOX
Serial Num	-	5622C02462
Model Num	NA	LGH180H4
Type	-	RTU
Configuration	-	VERTICAL
Num OA Filters 1	-	3
OA Filter Size 1	-	12.75X23.25
Num Final Filter 1	-	6
Final Filter Size 1	-	24X24X2

Test Data		
	Design	Actual
SF CFM	6150	6203
SF RPM	-	753
RA CFM	4250	4252
OA CFM	1900	1951
RL Voltage	-	208/209/209
RL Amperage	-	6.7/6.7/6.7
SF Rotation	-	CW
RA Damper Position	-	75%
Min OA Damper Position	-	25%
Min OA Damper Type	-	ECON
OA Enthalpy Setpt	-	NA
Brake Horse Power	-	2.51

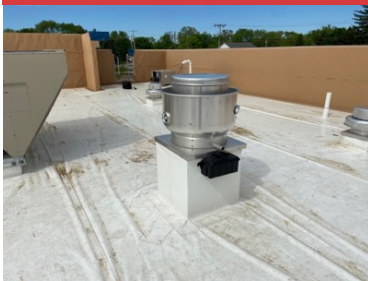
GRIDDLE FAN

Unit Data		
	Design	Actual
MFG	ACCUREX	ACCUREX
Model Num	XRUB-160XP-15	XRUB-160XP-15
Serial Num	-	19528778
Type	UPBLAST	UPBLAST
Configuration	VERTICAL	VERTICAL

Test Data		
	Design	Actual
CFM	1500	1567
Fan RPM	1377	2234
Fan Rotation	-	CCW
Motor RPM	-	1725
RL Voltage	-	209/209/208
RL Amperage	-	3.5/3.3/3.2
Suction ESP	-	-1.21"
Discharge ESP	-	ATM
Total ESP	1.0"	1.21"

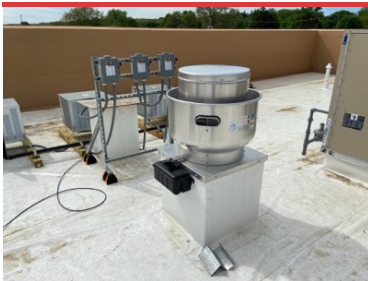
FRYER FAN

Unit Data		
	Design	Actual
MFG	ACCUREX	ACCUREX
Model Num	XRUB-140-7	XRUB-140-7
Serial Num	-	19528779
Type	UPBLAST	UPBLAST
Configuration	VERTICAL	VERTICAL

Test Data		
	Design	Actual
CFM	1500	1583
Fan RPM	1377	1015
Fan Rotation	-	CCW
Motor RPM	-	1725
RL Voltage	-	209/209/208
RL Amperage	-	1.6/1.6/1.6
Suction ESP	-	-0.56"
Discharge ESP	-	ATM
Total ESP	1.0"	0.56"

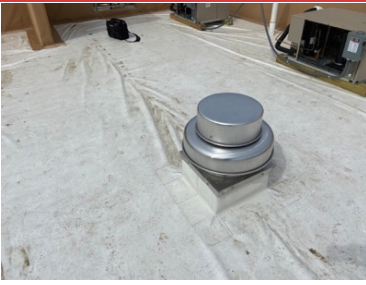
DISH FAN

Unit Data		
	Design	Actual
MFG	ACCUREX	ACCUREX
Model Num	XRED-095-D	XRED-095-D
Serial Num	-	19528777
Type	DOWNBLAST	DOWNBLAST
Configuration	HORIZONTAL	VERTICAL

Test Data		
	Design	Actual
CFM	350	341
Fan RPM	1455	DD
Fan Rotation	-	CCW
Motor RPM	-	DD
System SetPt	-	7.0
RL Voltage	-	116
RL Amperage	-	1.88
Total ESP	0.5"	0.25"
Fan Inlet SP	-	-0.25"
Fan Discharge SP	-	ATM

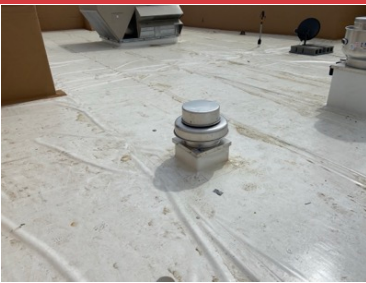
RESTROOM FAN

Test Data		
	Design	Actual
CFM	375	346
Fan RPM	1479	1364
Fan Rotation	-	CCW
Motor RPM	-	1364
System SetPt	-	7.0
RL Voltage	-	116
RL Amperage	-	1.0
Total ESP	0.5"	0.33"
Fan Inlet SP	-	-0.33"
Fan Discharge SP	-	ATM

Notes:[1] FAN IS RUNNING AT MAX SPEED. BACK DRAFT DAMPER IS COMPLETELY OPEN. FACE DAMPERS INSTALLED ARE FULLY OPEN.

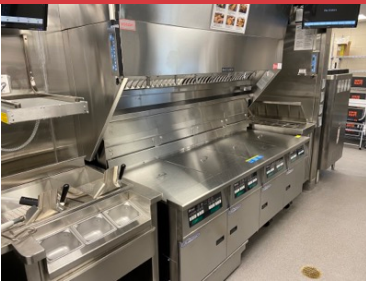
GRIDDLE HOOD

Test Data Exhaust		
	Design	Actual
Filter Type	-	X-TRACTOR
Filter Size 1	-	16X16
Filter Qty 1	-	4
Filter AK factor size 1	-	1.53
Filter Total AK Area	-	6.12
Filter1 FPM	-	280
Filter2 FPM	-	256
Filter3 FPM	-	233
Filter4 FPM	-	253
Filter Ave FPM(corr)	-	256
CFM	-	1567

Performance Data		
	Design	Actual
Smoke Generation Type	-	45 SEC SMOKE EMITTER
Hood Capture %	-	YES
End Panels Installed (Y/N)	-	YES

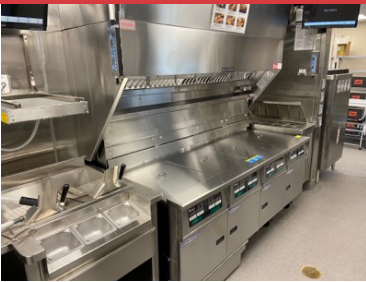
FRYER HOOD

Test Data Exhaust		
	Design	Actual
Filter Type	-	XTRACTOR
Filter Size 1	-	16X16
Filter Qty 1	-	5
Filter AK factor size 1	-	1.53
Filter Total AK Area	-	7.65
Filter1 FPM	-	218
Filter2 FPM	-	198
Filter3 FPM	-	195
Filter4 FPM	-	199
Filter5 FPM	-	225
Filter Ave FPM(corr)	-	207
CFM	-	1583

Performance Data		
	Design	Actual
Smoke Generation Type	-	45 SEC SMOKE EMITTER
Hood Capture %	-	100%
End Panels Installed (Y/N)	-	YES

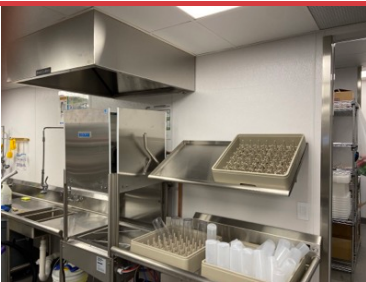
DISH HOOD

Unit Data		
	Design	Actual
MFG	ACCUREX	ACCUREX
Model Num	XD3-42-S	XD3-42-S
Serial Num	-	19568686
Type	TYPE II CCANOPY	TYPE II
Hood length	42"	42"
Hood Width	42"	42"

Test Data		
	Design	Actual
Exhaust CFM	350	341
