Report: TAB Report
Function: Test, Adjust, & Balance
Date: 04/10/2025
Completed By: National TAB

PROJECT
04-07-25 DOLLAR TREE- MONEE, IL

Project: 04-07-25 DOLLAR TREE- MONEE, IL

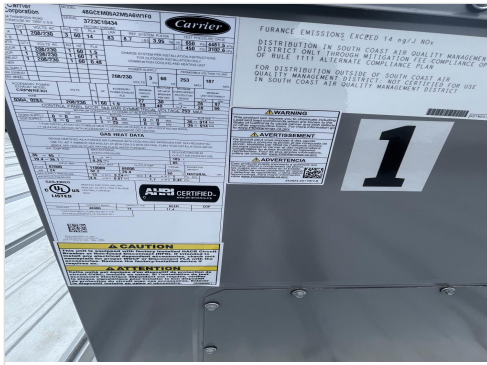
Asset: RTU1

- [1] Damper on diffuser 1-2/1-3 restroom diffusers fully closed and high on flow at: 1-2 66/50CFM 1-3 63/50CFM. Could not reduce further.
- [2] Diffuser 1-5 in storage room missing/not Installed. Proportionally balanced storage diffusers high to account for missing diffuser to achieve design airflow.
