Report: TAB Report
Function: Test, Adjust, & Balance
Date: 04/02/2026
Completed By: National TAB

PROJECT
08-11-25 WHATABURGER #1613
SIMPSONVILLE, SC

Project: 08-11-25 WHATABURGER #1613 SIMPSONVILLE, SC

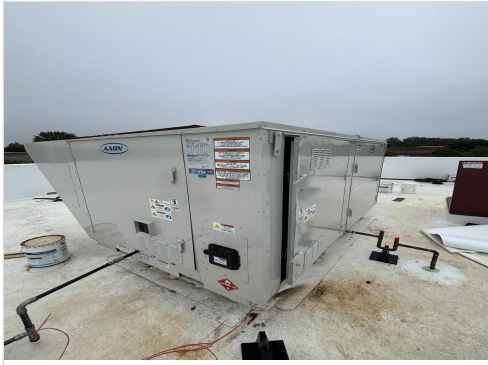
Unit Data - PHOTO LOG

Unit Data	
	Actual
MFG	AAON
Serial Num	202506-BNGP123647
Model Num	RNA-020-3-0-FABY-S0-21-000-A
Num OA Filters 1	3
OA Filter Size 1	22X19
Num OA Filters 2	6
OA Filter Size 2	20X25X2

Test Data		
	Design	Actual
SF CFM (Traverse)	-	3852
SF CFM	3850	3840
RA CFM (Traverse)	-	1299
RA CFM	1390	1254
OA CFM	2460	2586
RL Voltage	-	205/205/204
RL Amperage	-	8.4/8.6/9.1
SF System SetPt	-	VFD/63.00Hz
RA Damper Position	-	2"
Min OA Damper Position	-	1"
Min OA Damper Type	-	ECON

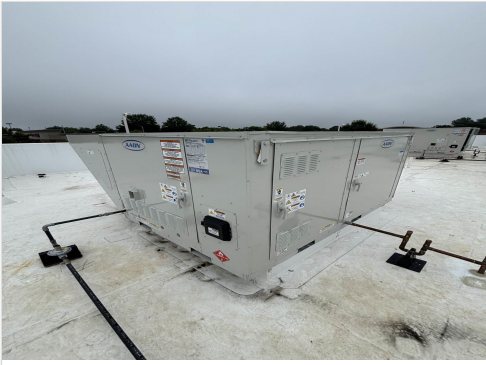
Unit Data - PHOTO LOG

Unit Data	
	Actual
MFG	AAON
Serial Num	202506-BNGZ123630
Model Num	RN-011-3-0-FABY-S0-21-000-A
Num OA Filters 1	2
OA Filter Size 1	23.5X17
Num OA Filters 2	4
OA Filter Size 2	20X25X2

Test Data		
	Design	Actual
SF CFM (Traverse)	-	2095
SF CFM	2050	2095
RA CFM (Traverse)	-	515
RA CFM	500	497
OA CFM	1550	1598
RL Voltage	-	205/205/204
RL Amperage	-	2.9/2.9/2.9
SF System SetPt	-	VFD/49
RA Damper Position	-	0.5"
Min OA Damper Position	-	3"
Min OA Damper Type	-	ECON

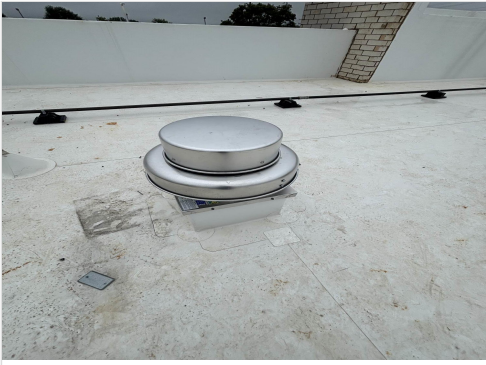
Unit Data - PHOTO LOG

Unit Data		
	Design	Actual
MFG	GREENHECK	GREENHECK
Model Num	G-080-VG	G-080-VG-1-17-X
Serial Num	-	26814738
Type	DOWNBLAST	UPBLAST
Configuration	VERTICAL	VERTICAL

Test Data		
	Design	Actual
CFM	300	303
Fan Rotation	-	CCW
System SetPt	-	SPEED CONTROLLER, 5.5
RL Voltage	-	110
RL Amperage	-	0.56
Total ESP	0.50"	0.42"
Fan Inlet SP	-	0.42"
Fan Discharge SP	-	ATM

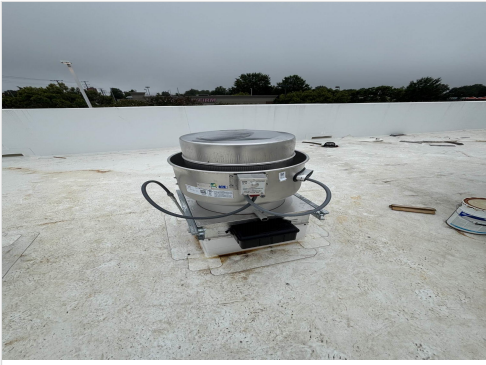
Unit Data - PHOTO LOG

Unit Data		
	Design	Actual
MFG	GREENHECK	GREENHECK
Model Num	CUE-140-VG	CUE-140-10-VG-1-26-G
Serial Num	-	26815112 25D
Type	UPBLAST	UPBLAST
Configuration	VERTICAL	VERTICAL

Test Data		
	Design	Actual
CFM	1994	2052
Fan Rotation	-	CCW
System SetPt	-	SPEED CONTROLLER, 6
RL Voltage	-	206
RL Amperage	-	2.9
Total ESP	1.00"	0.87"
Fan Inlet SP	-	0.87"
Fan Discharge SP	-	ATM

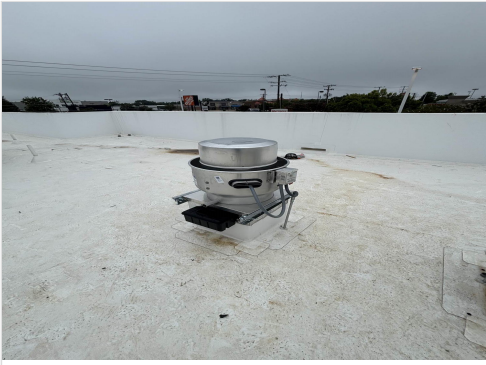
Unit Data - PHOTO LOG

Unit Data		
	Design	Actual
MFG	GREENHECK	GREENHECK
Model Num	CUE-120-VG	CUE-120-5-VG-1-22-G
Serial Num	-	26815118 25D
Type	UPBLAST	UPBLAST
Configuration	VERTICAL	VERTICAL

Test Data		
	Design	Actual
CFM	1216	1249
Fan Rotation	-	CCW
System SetPt	-	6.5
RL Voltage	-	211
RL Amperage	-	3.4
Total ESP	0.75"	0.46"
Fan Inlet SP	-	0.46"
Fan Discharge SP	-	ATM

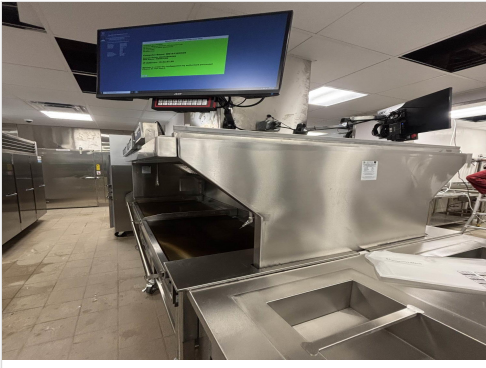
Unit Data - PHOTO LOG

Unit Data		
	Design	Actual
MFG	H&K DALLAS INC.	H&K DALLAS INC.
Model Num	HKD023	HKD027
Job / Serial Num	-	8162646-001
Type	TYPE 1	TYPE I
Hood length	73"	87"
Hood Width	22.19"	27.5"

Test Data Exhaust		
	Design	Actual
Filter Type	FLAMEGAURD FILTERS	FLAMEGUARD
Filter Size 1	12X20	12X20
Filter Qty 1	8	8
Filter AK factor size 1	1.5	1.5
Filter Total AK Area	12	12
Filter1 FPM	-	167
Filter2 FPM	-	193
Filter3 FPM	-	175
Filter4 FPM	-	157
Filter5 FPM	-	171
Filter6 FPM	-	178
Filter7 FPM	-	185
Filter8 FPM	-	145
Filter Ave FPM(corr)	-	171
CFM	1994	2052

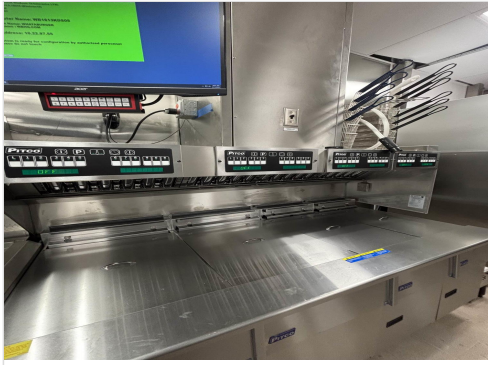
Unit Data - PHOTO LOG

Unit Data		
	Design	Actual
MFG	H&K DALLAS INC.	H&K DALLAS INC.
Model Num	HKD023	HKD023
Job / Serial Num	-	8165631-001
Type	TYPE 1	TYPE 1
Hood length	73"	70.5"
Hood Width	22.19"	23"

Test Data Exhaust		
	Design	Actual
Filter Type	FLAMEGAURD	FLAMEGUARD
Filter Size 1	12X20	12X20
Filter Size 2	12X16	12X16
Filter Qty 1	2	1
Filter Qty 2	2	3
Filter AK factor size 1	1.5	1.5
Filters AK factor size 2	1.16	1.16
Filter Total AK Area	5.32	4.98
Filter1 FPM	-	259
Filter2 FPM	-	232
Filter3 FPM	-	276
Filter4 FPM	-	237
Filter Ave FPM(corr)	-	251
CFM	1216	1249
