Report: EVALUATION
Function: Test, Adjust, & Balance
Date: 10/31/2024
Completed By: National TAB

PROJECT
Chili's - Orlando, FL

Project: Chili's - Orlando, FL

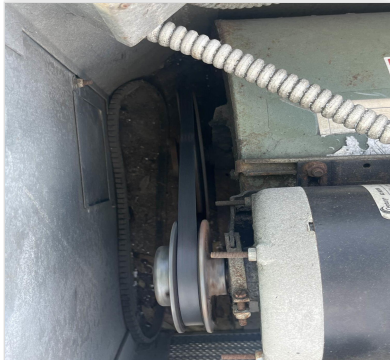
Issue Name : MUA#1 sheaves are misaligned
Description : Shaves are not aligned causing fan to vibrate and make excessive noise. Sheaves need to be aligned in order to prevent further damage done to the fan.
Created By : National TAB **Assigned To :** National TAB - Ian Fuller
Status : Open
Priority : High **Asset Tag :**
Originated Date : 01/13/2025 - Ian Fuller - National TAB

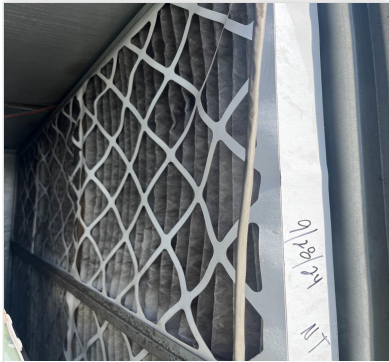
Issue Name : RTU#1 and RTU#4 has dirty final filters installed
Description : Recommended to replace final filters with new MERV 7 filters.
Created By : National TAB **Assigned To :** National TAB - Ian Fuller
Status : Open
Priority : Medium **Asset Tag :**
Originated Date : 01/13/2025 - Ian Fuller - National TAB

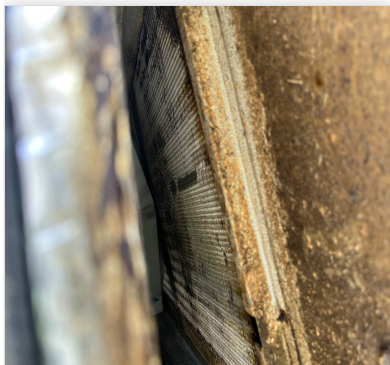
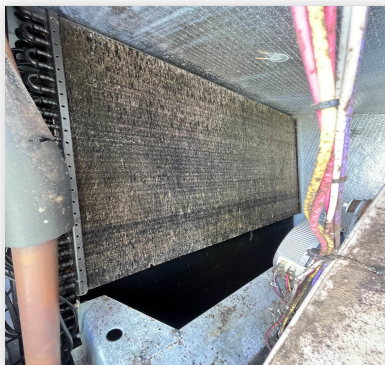
Issue Name : RTU#2 and RTU#6 evaporator coils are dirty
Description : Recommended to clean coils with cold water in order to improve air flow as well as cooling of unit.
Created By : National TAB **Assigned To :** National TAB - Ian Fuller
Status : Open
Priority : Urgent **Asset Tag :**
Originated Date : 01/13/2025 - Ian Fuller - National TAB

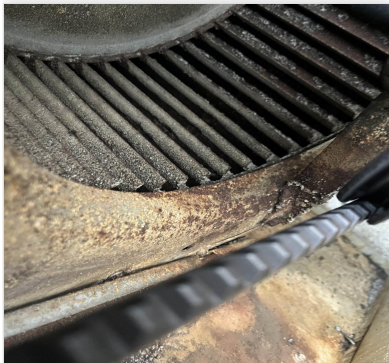
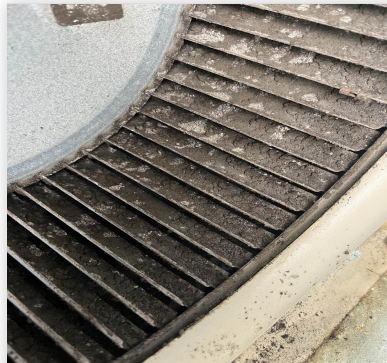
Issue Name : RTU#2 and RTU#6 have excessive buildup on blower wheel blades
Description : Recommended to clean blades of debris in order to improve efficiency as well as air flow of the unit.
Created By : National TAB **Assigned To :** National TAB - Ian Fuller
Status : Open
Priority : Medium **Asset Tag :**
Originated Date : 01/13/2025 - Ian Fuller - National TAB

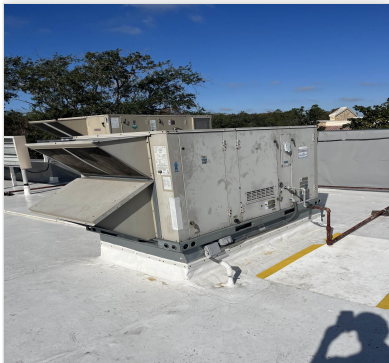
Issue Name : RTU#2 economizer is not functional
Description : Prodigy Board shows Alarm 147 indicating an OA damper issue. Currently economizer is not modulating and is fully closed.
Created By : National TAB **Assigned To :** National TAB - Ian Fuller
Status : Open
Priority : Urgent **Asset Tag :**
Originated Date : 01/13/2025 - Ian Fuller - National TAB

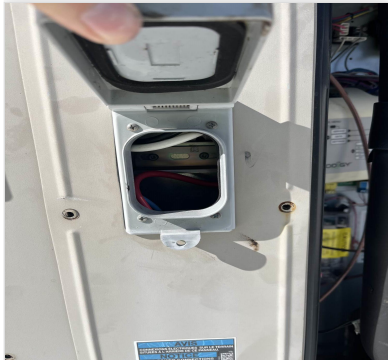
Issue Name : RTU#2 is missing disconnect
Description : Unable to turn off unit at roof. Recommended to install disconnect.
Created By : National TAB **Assigned To :** National TAB - Ian Fuller
Status : Open
Priority : High **Asset Tag :**
Originated Date : 01/13/2025 - Ian Fuller - National TAB

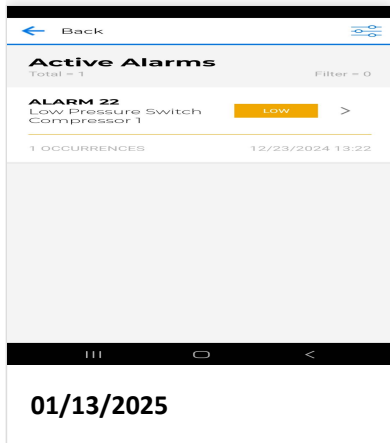
Issue Name : RTU#4 has low pressure switch alarm on compressor 1
Description : Core app shows alarm 22 indicating a low pressure switch on compressor, turning off the compressor. Recommended, to resolve issue in order to fully cool space.
Created By : National TAB **Assigned To :** National TAB - Ian Fuller
Status : Open
Priority : **Urgent** **Asset Tag :**
Originated Date : 01/13/2025 - Ian Fuller - National TAB

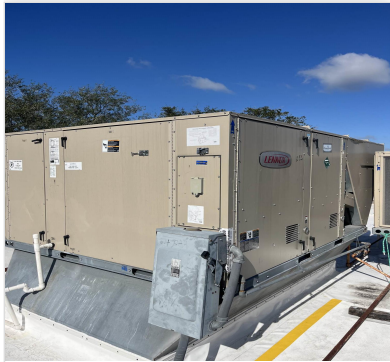
Issue Name : RTU#4 outside air filter is becoming impacted
Description : Recommended to clean or replace filters.
Created By : National TAB **Assigned To :** National TAB - Ian Fuller
Status : Open
Priority : Medium **Asset Tag :**
Originated Date : 01/13/2025 - Ian Fuller - National TAB

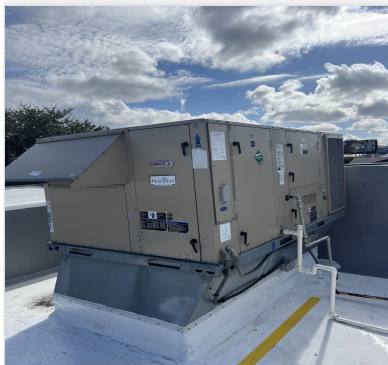
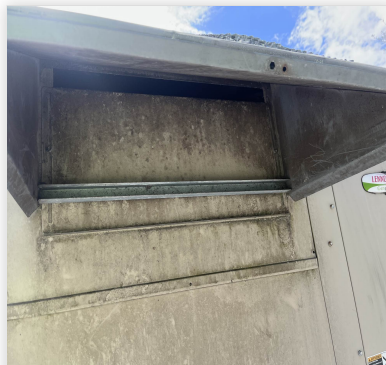
Issue Name : RTU#5 and RTU#6 do not have OA filters installed
Description : Recommended to install OA filters to prevent large debris entering unit. RTU#6 OA filter provided does not fit on the OA hood.
Created By : National TAB **Assigned To :** National TAB - Ian Fuller
Status : Open
Priority : Urgent **Asset Tag :**
Originated Date : 01/13/2025 - Ian Fuller - National TAB

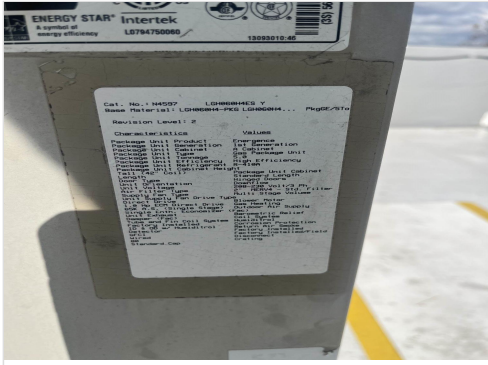
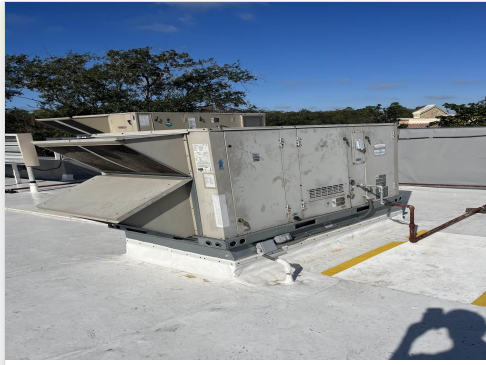
Asset: RTU2

OA DAMPER IS NOT FUNCTIONING

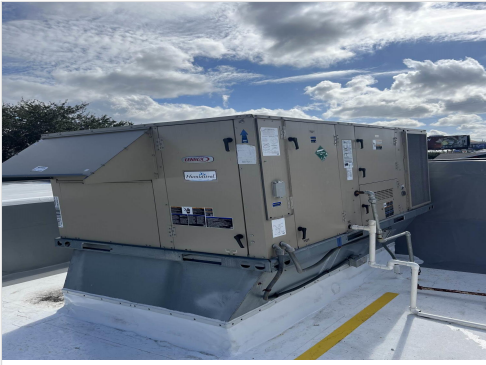
Asset: RTU5

MISSING OA FILTER

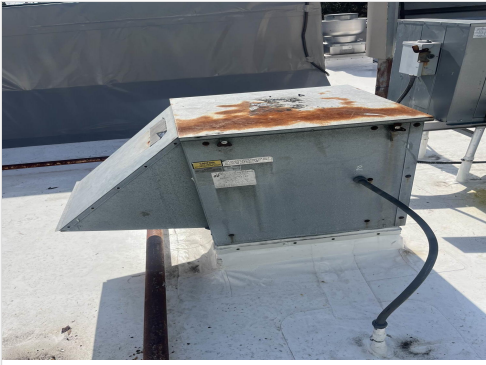
Asset: MUA1

Drive Data	
	Actual
Motor Sheave Size	4.25"
Motor Bore Size	0.625"
Fan Sheave Size	8.5"
Fan Sheave Bore	0.75"
Belt CL Distance	12.0"
Num of Belts	1
Belt Size	AX41
Belt Alignment Verified	NOT ALIGNED
