Report: EVALUATION
Function: Test, Adjust, & Balance
Date: 10/31/2024
Completed By: National TAB

PROJECT
Chili's - Lady Lake, FL

Project: Chili's - Lady Lake, FL

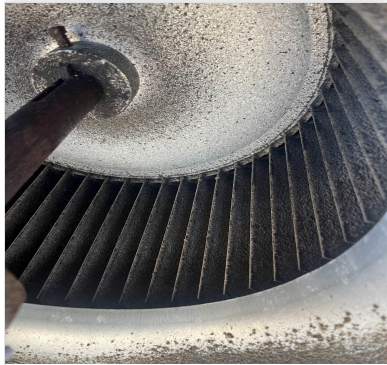
Issue Name : RTU#2 blower wheel is dirty
Description : Recommended to clean blower wheel in order to prevent air flow issues.
Created By : National TAB **Assigned To :** National TAB - Ian Fuller
Status : Open
Priority : High **Asset Tag :**
Originated Date : 11/04/2024 - Ian Fuller - National TAB

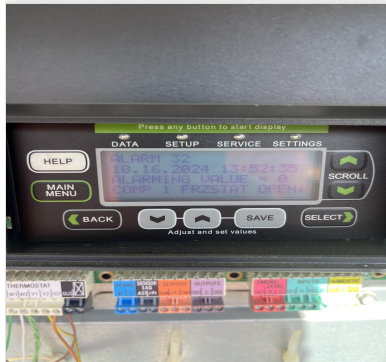
Issue Name : RTU#3 alarm 32: Comp 1 FRZSTAT
Description : Alarm has shutdown use of compressor 1. Unit is unable to fully cool space.
Created By : National TAB **Assigned To :** National TAB - Ian Fuller
Status : Open
Priority : Urgent **Asset Tag :**
Originated Date : 11/04/2024 - Ian Fuller - National TAB

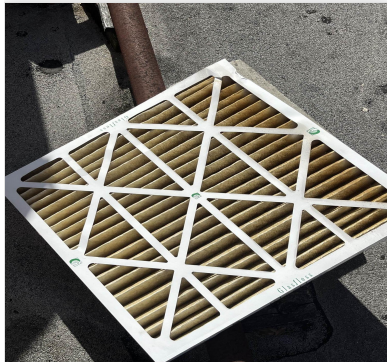
Issue Name : RTU#3 has dirty final filters
Description : Final filters are compacted with dirt. Filters need to be replaced.
Created By : National TAB **Assigned To :** National TAB - Ian Fuller
Status : Open
Priority : High **Asset Tag :**
Originated Date : 11/04/2024 - Ian Fuller - National TAB

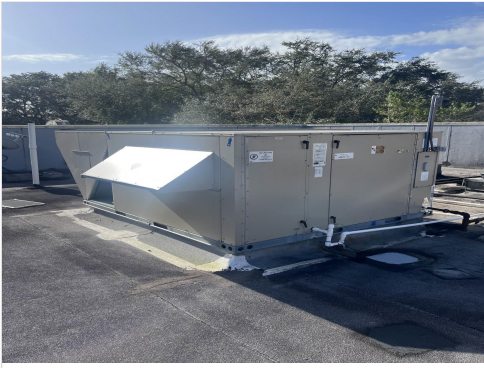
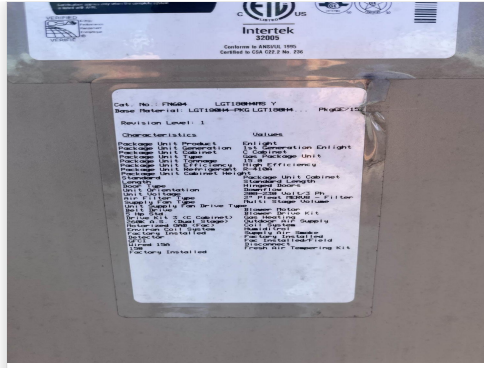
Performance Data		
	Design	Actual
MA Plenum SP	-	-0.30"
Fan Suction SP	-	-0.67"
Total ESP	-	0.42"
Fan Total SP	-	0.79"
OA Temp (db/wb)	-	87 F / 74 F
SA Temp (db/wb)	-	62 F / 58 F

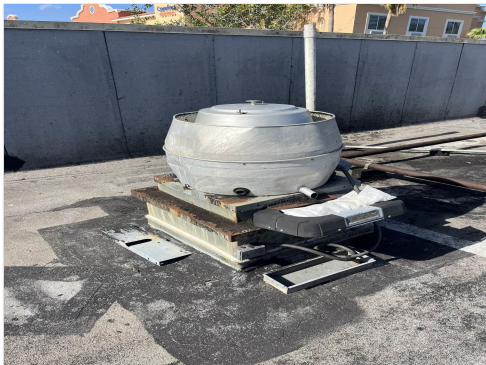
CD13936D_FB1A_43ED_8D..

Drive Data	
	Actual
Motor Sheave Size	4.25
Motor Bore Size	0.625"
Motor Sheave SetPt	NA
Fan Sheave Size	4.0"
Fan Sheave Bore	0.75"
Belt CL Distance	4.75"
Num of Belts	1
Belt Size	AX20

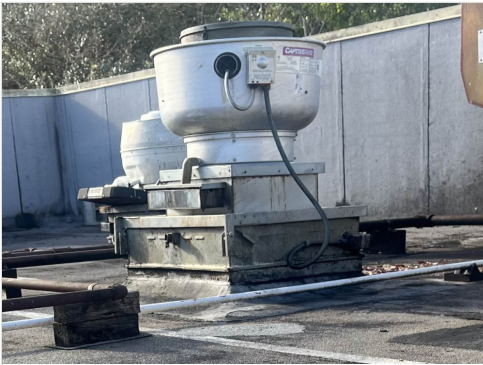
DF3FF170_381D_493F_BA..

Drive Data	
	Actual
Motor Sheave Size	DD
Motor Bore Size	DD
Motor Sheave SetPt	DD
Fan Sheave Size	DD
Fan Sheave Bore	DD
Belt CL Distance	DD
Num of Belts	DD
Belt Size	DD

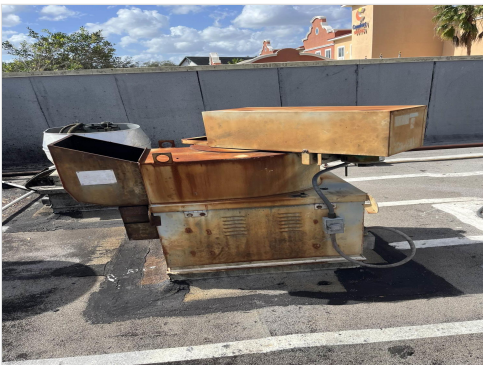
1605309A_21C1_41BC_94..

Drive Data	
	Actual
Motor Sheave Size	5.0"
Motor Bore Size	0.875"
Motor Sheave SetPt	0 TURNS OUT
Fan Sheave Size	6.25"
Fan Sheave Bore	1.25"
Belt CL Distance	23.0"
Num of Belts	1
Belt Size	A60

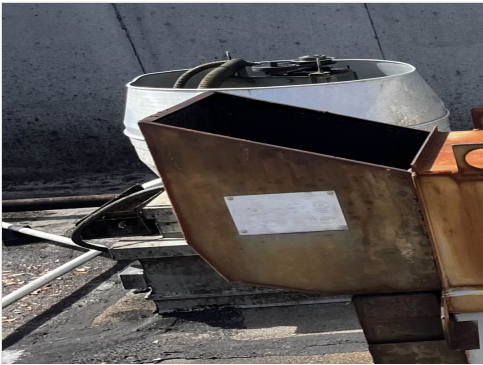
EF32A116_4B55_4705_BF..

Drive Data	
	Actual
Motor Sheave Size	4.25"
Motor Bore Size	0.625"
Motor Sheave SetPt	4.0 TURNS OUT
Fan Sheave Size	4.0"
Fan Sheave Bore	0.75"
Belt CL Distance	5.25"
Num of Belts	1
Belt Size	AX20

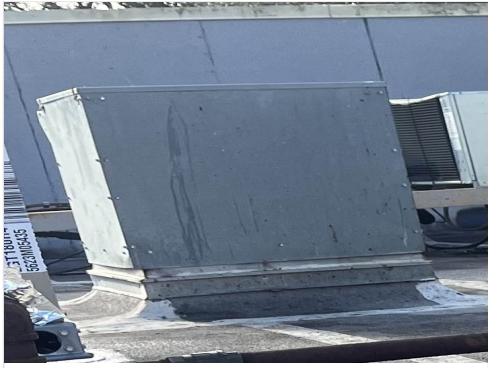
Drive Data	
	Actual
Motor Sheave Size	MVL44B
Motor Bore Size	0.625"
Fan Sheave Size	6.5"
Fan Sheave Bore	0.875"
Belt CL Distance	13.5"
Num of Belts	1
Belt Size	A41
Belt Alignment Verified	NOT ALLIGNED

Notes:
AVG VEL: 141 FPM AT INTAKE

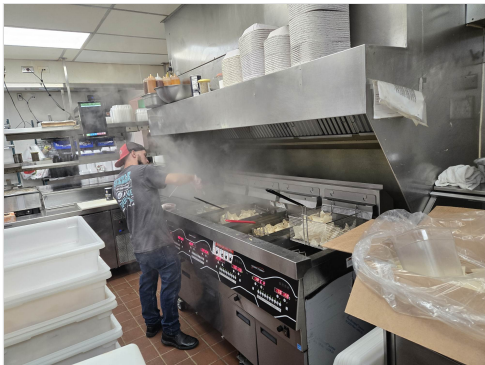
20241031_100511_83005..

Cooking Equipment	
	Actual
Item 1	FRYER

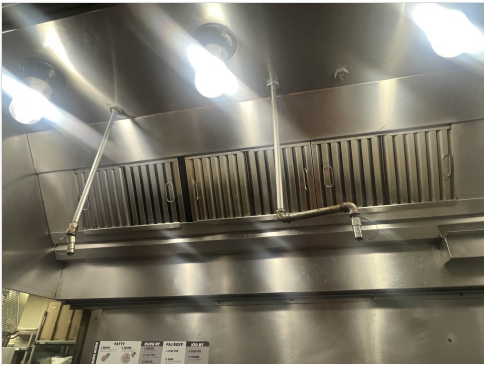
9F67C5FA_1742_40F1_B8..

Cooking Equipment	
	Actual
Item 1	GRILL

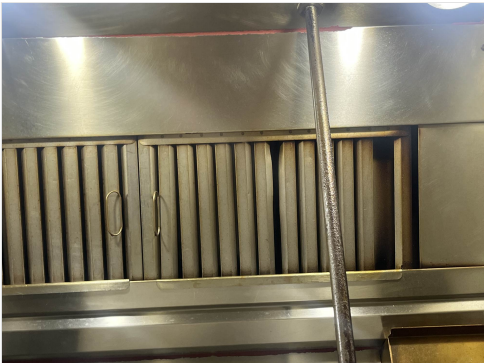
1E3FBF09_A3E2_4BFF_B9..

Cooking Equipment	
	Actual
Item 1	ROASTER

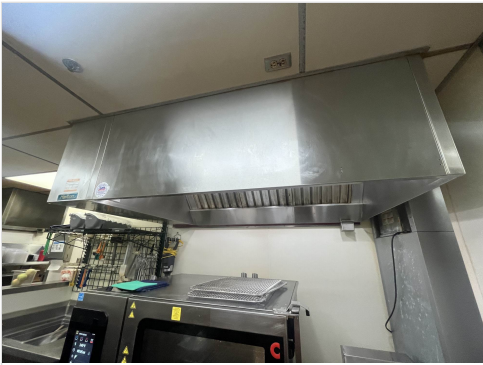
Notes:
OVEN HOOD
5.5" overhang
