Report: EVALUATION
Function: Test, Adjust, & Balance
Date: 10/31/2024
Completed By: National TAB

PROJECT
Chili's - Orlando, FL

Project: Chili's - Orlando, FL

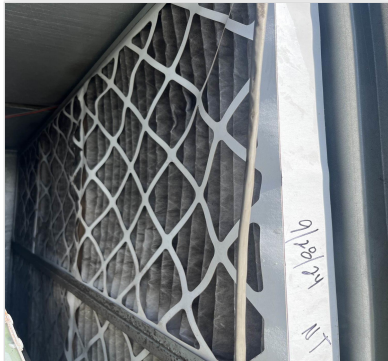
Issue Name : All RTU's have dirty final filters installed
Description : Recommended to replace final filters with new MERV 7 filters.
Created By : National TAB **Assigned To :** National TAB - Ian Fuller
Status : Open
Priority : Medium **Asset Tag :**
Originated Date : 01/13/2025 - Ian Fuller - National TAB

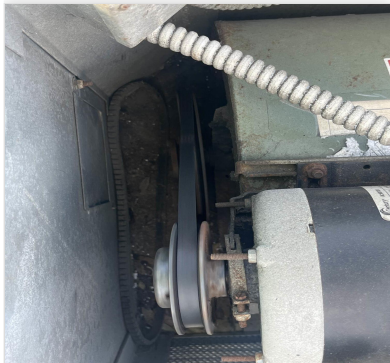
Issue Name : MUA#1 sheaves are misaligned
Description : Shaves are not aligned causing fan to vibrate and make excessive noise. Sheaves need to be aligned in order to prevent further damage done to the fan.
Created By : National TAB **Assigned To :** National TAB - Ian Fuller
Status : Open
Priority : High **Asset Tag :**
Originated Date : 01/13/2025 - Ian Fuller - National TAB

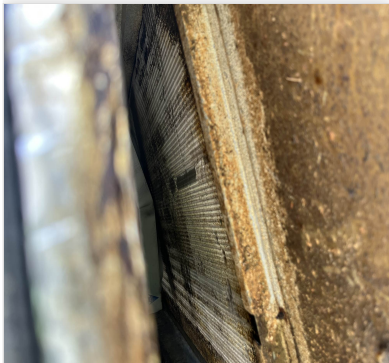
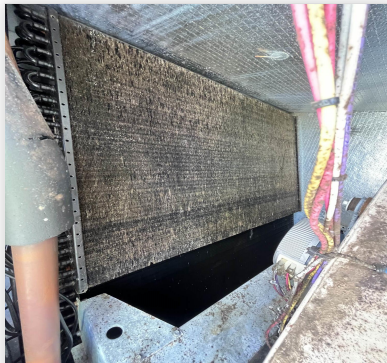
Issue Name : RTU#2 and RTU#6 evaporator coils are dirty
Description : Recommended to clean coils with cold water in order to improve air flow as well as cooling of unit.
Created By : National TAB **Assigned To :** National TAB - Ian Fuller
Status : Open
Priority : Urgent **Asset Tag :**
Originated Date : 01/13/2025 - Ian Fuller - National TAB

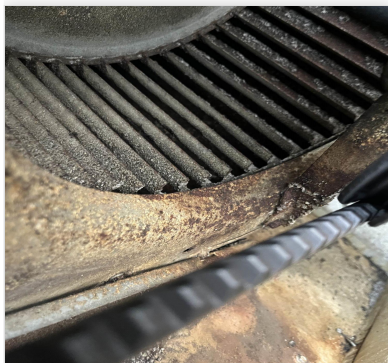
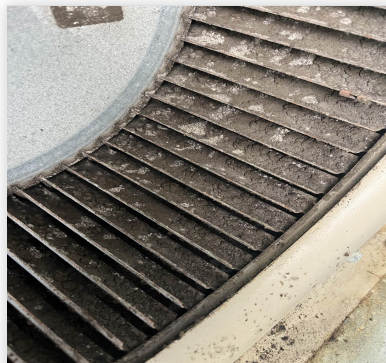
Issue Name : RTU#2 and RTU#6 have excessive buildup on blower wheel blades
Description : Recommended to clean blades of debris in order to improve efficiency as well as air flow of the unit.
Created By : National TAB **Assigned To :** National TAB - Ian Fuller
Status : Open
Priority : Medium **Asset Tag :**
Originated Date : 01/13/2025 - Ian Fuller - National TAB

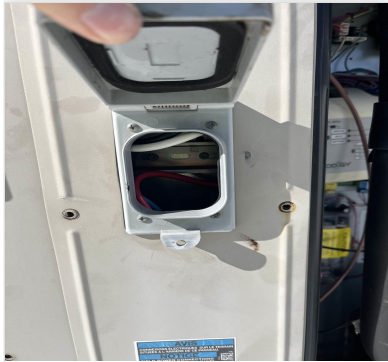
Issue Name : RTU#2 is missing disconnect
Description : Unable to turn off unit at roof. Recommended to install disconnect.
Created By : National TAB **Assigned To :** National TAB - Ian Fuller
Status : Open
Priority : High **Asset Tag :**
Originated Date : 01/13/2025 - Ian Fuller - National TAB

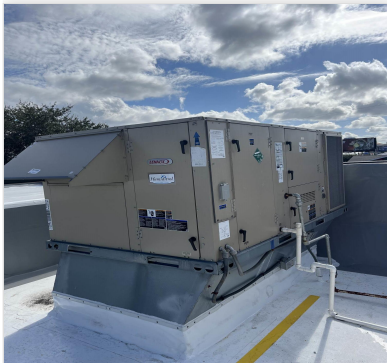
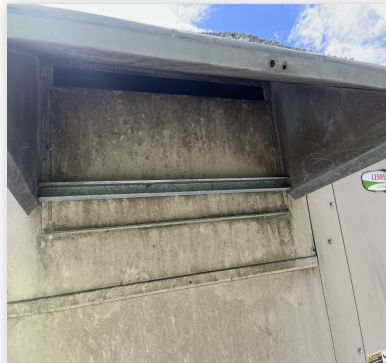
Issue Name : RTU#5 and RTU#6 do not have OA filters installed
Description : Recommended to install OA filters to prevent large debris entering unit. RTU#6 OA filter provided does not fit on the OA hood.
Created By : National TAB **Assigned To :** National TAB - Ian Fuller
Status : Open
Priority : Urgent **Asset Tag :**
Originated Date : 01/13/2025 - Ian Fuller - National TAB

MISSING OA FILTER
