Report: EVALUATION
Function: Test, Adjust, & Balance
Date: 10/31/2024
Completed By: National TAB

PROJECT
Chili's - Orlando, FL

Project: Chili's - Orlando, FL

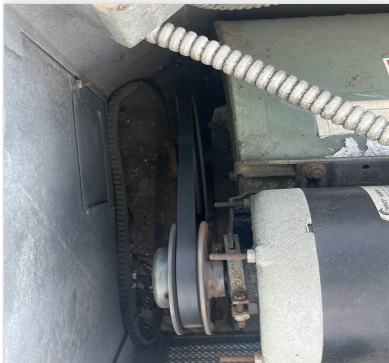
Issue Name : MUA#1 sheaves are misaligned
Description : Shaves are not aligned causing fan to vibrate and make excessive noise. Sheaves need to be aligned in order to prevent further damage done to the fan.
Created By : National TAB **Assigned To :** National TAB - Ian Fuller
Status : Open
Priority : High **Asset Tag :**
Originated Date : 01/13/2025 - Ian Fuller - National TAB

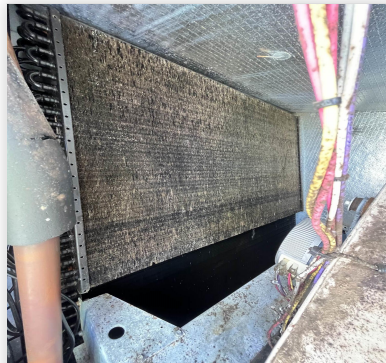
Issue Name : RTU#2 and RTU#6 evaporator coils are dirty
Description : Recommended to clean coils with cold water in order to improve air flow as well as cooling of unit.
Created By : National TAB **Assigned To :** National TAB - Ian Fuller
Status : Open
Priority : Urgent **Asset Tag :**
Originated Date : 01/13/2025 - Ian Fuller - National TAB

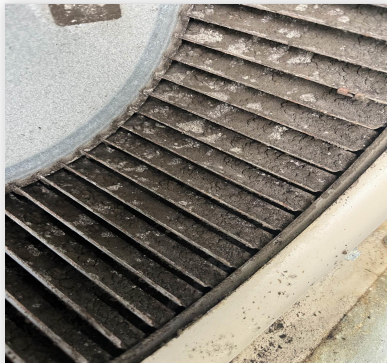
Issue Name : RTU#2 and RTU#6 have excessive buildup on blower wheel blades
Description : Recommended to clean blades of debris in order to improve efficiency as well as air flow of the unit.
Created By : National TAB **Assigned To :** National TAB - Ian Fuller
Status : Open
Priority : Medium **Asset Tag :**
Originated Date : 01/13/2025 - Ian Fuller - National TAB

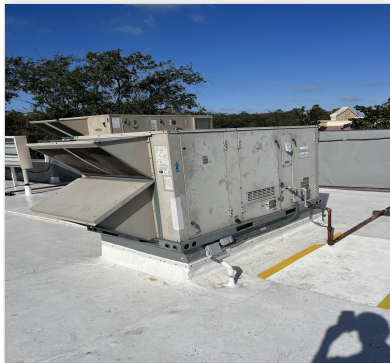
Issue Name : RTU#2 economizer is not functional
Description : Prodigy Board shows Alarm 147 indicating an OA damper issue. Currently economizer is not modulating and is fully closed.
Created By : National TAB **Assigned To :** National TAB - Ian Fuller
Status : Open
Priority : Urgent **Asset Tag :**
Originated Date : 01/13/2025 - Ian Fuller - National TAB

OA DAMPER IS NOT FUNCTIONING
