Report: TAB Report
Function: Test, Adjust, & Balance
Date: 02/04/2025
Completed By: National TAB

02-03-25 CHIPOTLE #5377 WESTLAKE, FL

Project: 02-03-25 CHIPOTLE #5377 WESTLAKE, FL

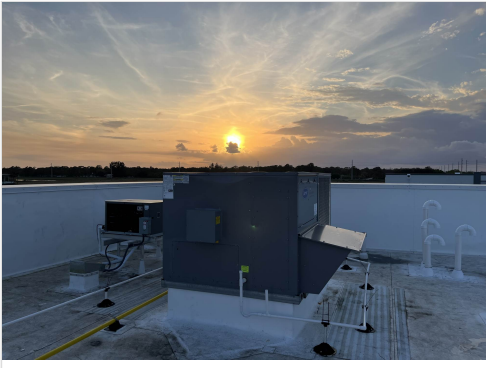
Unit Data - PHOTO LOG

Asset: RTU1

General	
	Actual
Fan Rotation Correct	YES
Unit Filters Clean	CONSTRUCTION FILTERS
Condensate Drain Installed	YES

Notes:
Recommend replacing final filters before turnover with a MERV 8 or greater replacement.

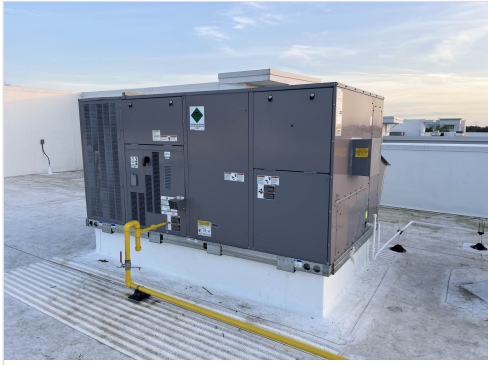
Unit Data - PHOTO LOG

Asset: RTU2

General	
	Actual
Fan Rotation Correct	YES
Unit Filters Clean	CONSTRUCTION FILTERS
Condensate Drain Installed	YES

Notes:
Recommend replacing final filters before turnover with a MERV 8 or greater replacement.

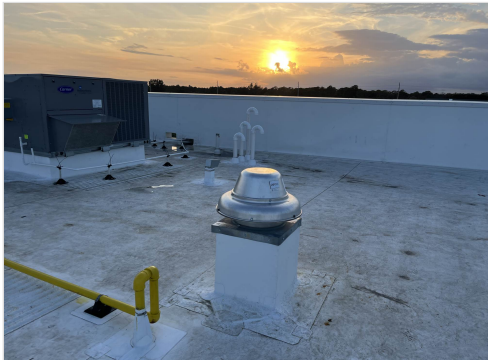
Unit Data - PHOTO LOG

Asset: EF2

Test Data		
	Design	Actual
CFM	150	152
Fan RPM	-	739
Fan Rotation	-	CCW
Motor RPM	-	739
System SetPt	-	40P
RL Voltage	-	122
RL Amperage	-	0.32
Total ESP	0.60"	0.09"
Fan Inlet SP	-	-0.09"
Fan Discharge SP	-	ATM

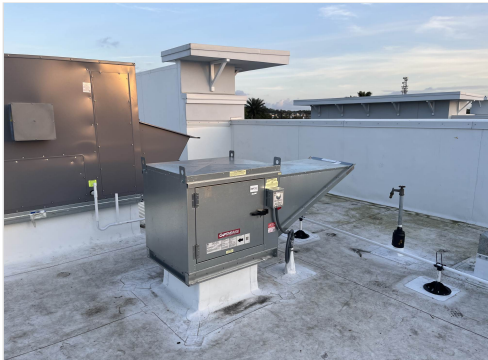
Unit Data - PHOTO LOG

Asset: MAU1

Test Data		
	Design	Actual
CFM	1300	1313
SF RPM	-	1041
Motor RPM	-	1041
SF System SetPt	-	35.9Hz
RL Voltage	-	69V VFD
RL Amperage	-	1.6A VFD

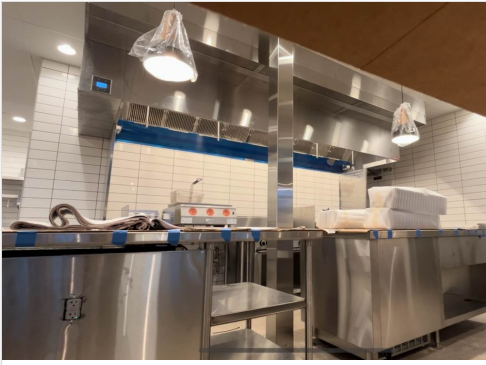
Unit Data - PHOTO LOG

Asset: HD1

Test Data Exhaust		
	Design	Actual
Filter Type	BAFFLE	BAFFLE
Filter Size 1	16X16	16X16
Filter Qty 1	9	9
Filter AK factor size 1	1.62	1.62
Filter Total AK Area	14.58	14.58
Filter1 FPM	-	169
Filter2 FPM	-	166
Filter3 FPM	-	169
Filter4 FPM	-	200
Filter5 FPM	-	190
Filter6 FPM	-	179
Filter7 FPM	-	178
Filter8 FPM	-	154
Filter9 FPM	-	143
Filter Ave FPM(corr)	-	172
CFM	2550	2508
