**Report: Test and Balance
Date: 1/13/2020**

**PROJECT
FREDDY'S - MERRIAM, KS**

Project: FREDDY'S - MERRIAM, KS

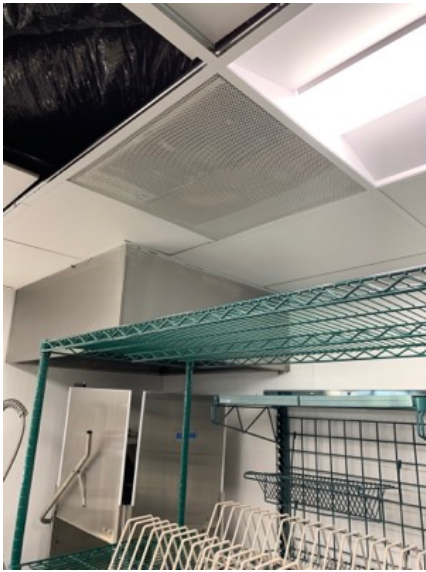
Diffuser 3-4 Is Missing Damper
Damper needs to be installed and closed 100%.
Diffuser is affecting hood culture

PRIORITY (HIGH/LOW/INFO ONLY)	
HIGH	Diffuser 3-4 near the dishwasher is missing a damper. Needs to be installed and closed 100% for hood performance. Cardboard was temporarily installed during testing.
HIGH	RTU-2 is tripping off. Whenever OCP is energized at the roof the unit is tripping off. BCS is aware.
HIGH	RTU-1 Thermostast is blank. Thermostat went blank while adjusting parameters. BCS is aware.
HIGH	Griddle hood capture is approximately 70%. There is a lot of smoke loss when tested at the cooking surface of the griddles. Smoke is drifting towards the back doors. Recommend moving or capping the return grille that is highlighted and then installing a perforated diffuser in its place with 12" neck and balancing damper. Griddle is also not centered under the hood. There is 11" overhang on the side closest to the back door and 22" on the side closest to the front of house.
HIGH	There is smoke rollout on the fryer hood due to smoke getting trapped under the fry warmer. Recommend modified end panel and air device to the left of the hood.

Asset	Area Served	Notes
SGRD4	DISHWASH	Diffuser 3-4 near the dishwasher is missing a damper. Needs to be installed and closed 100% for hood performance. Cardboard was temporarily installed during testing.
SGRD5	OFFICE	DAMPER FULLY OPEN. RECOMMEND INSTALLING 8". 6" IS INSTALLED.

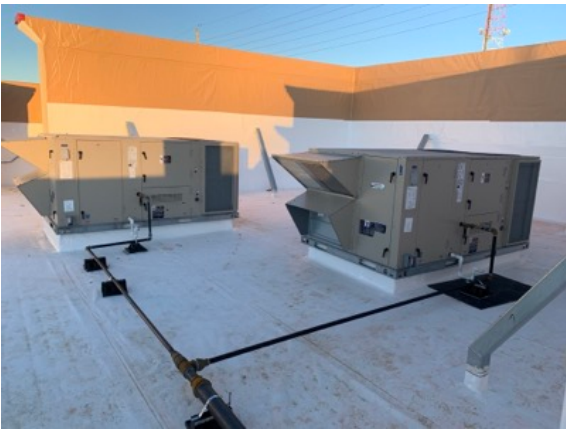
RTU-2 Tripping Off
Whenever OCP is energized at the roof the unit is tripping off

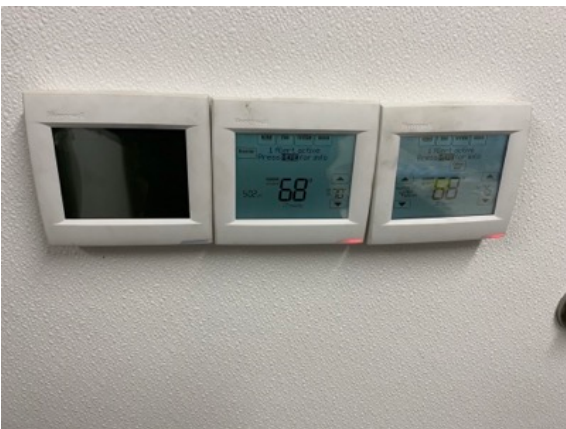
RTU1 Thermostat Is Blank
The thermostat went blank while adjusting parameters

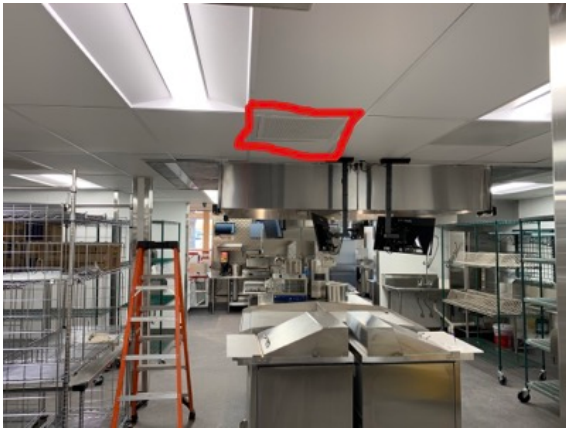
Griddle Hood Capture About 70% Capture
There is a lot of smoke loss when tested at the cooking surface of the griddles. Smoke is drifting towards the back doors. Recommend moving or capping the return grille that is highlighted and then installing a perforated diffuser in its place with 12" neck and balancing damper.

Notes: Griddle hood capture is approximately 70%. There is a lot of smoke loss when tested at the cooking surface of the griddles. Smoke is drifting towards the back doors. Recommend moving or capping the return grille that is highlighted and then installing a perforated diffuser in its place with 12" neck and balancing damper. Griddle is also not centered under the hood. There is 11" overhang on the side closest to the back door and 22" on the side closest to the front of house.

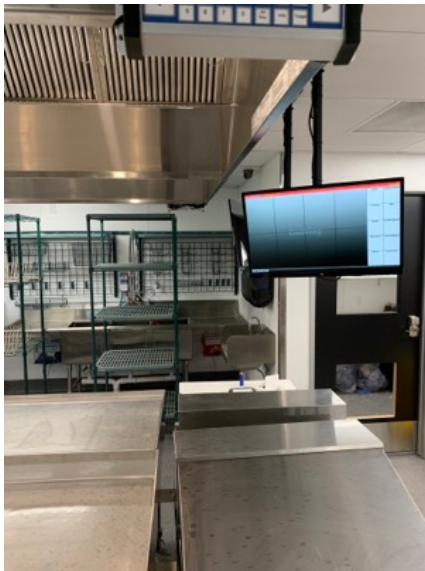
Griddle Hood Not Centered Over Equipment
11" overhang on side closest to back door and 22" on side closest to front of house. This is contributing to smoke rollout

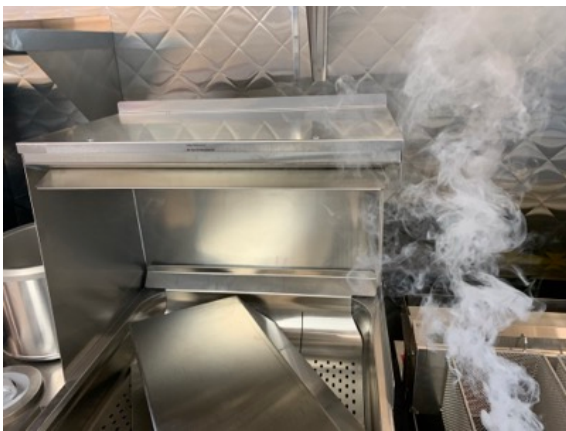
Smoke Rollout On Fryer Hood
Slight rollout cases by smoke getting trapped under the fry warmer

Notes: There is smoke rollout on the fryer hood due to smoke getting trapped under the fry warmer. Recommend modified end panel and air device to the left of the hood.

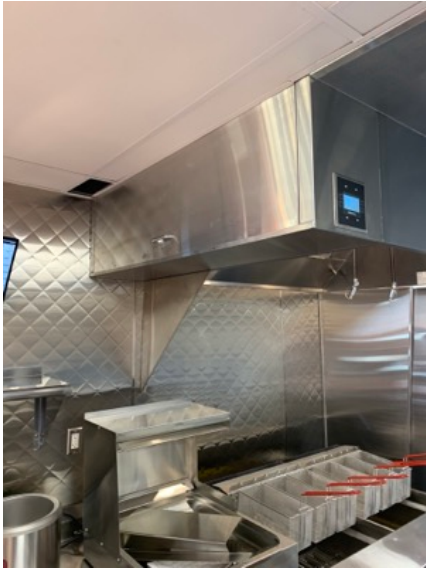
Pre Wire Panel Is Not Accessible
Blocked by the ceiling grid. Ceiling grid needs to
be reinstalled to allow for removal of door

HIGH	Humidity sensor wiring is not completed. There is currently only one twisted pair installed but there needs to be two. The controls contractor has the schematic and is working on resolving.
HIGH	There is no access to the hood control panel without taking down the ceiling grid. Recommend reworking the ceiling grid design so that there is access.

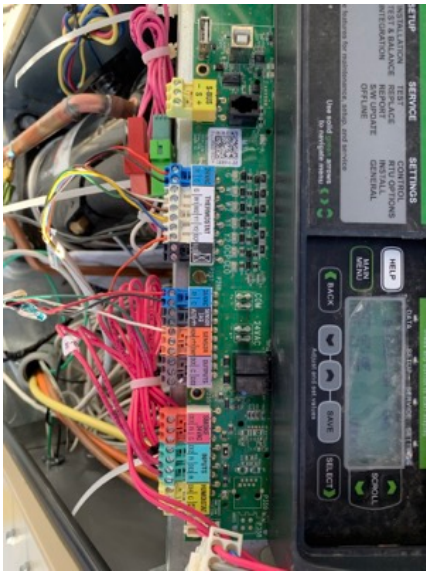
IN PROGRESS - Humidity Sensor Wiring Not
Correct
BCS is in the process of resolving
