**Report: TAB Report**  
**Function: Test, Adjust, & Balance**  
**Date: 01/21/2026**  
**Completed By: National TAB**

**PROJECT**  
**01-12-26 WAWA #6610 AYLETT, VA**

12065 KING WILLIAM ROAD

AYLETT , VA 23009

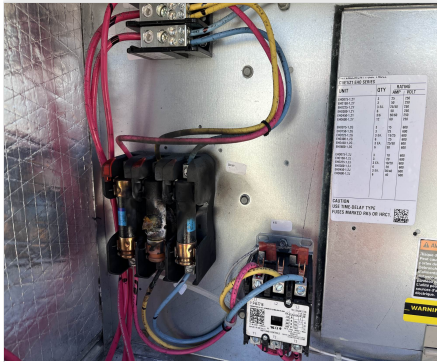
**Issue Name :** RTU-2 Heating Inoperable  
**Description :** Electric heating equipped in RTU-2 non-functional, fuses blown.  
**Created By :** National TAB **Assigned To :** National TAB - Brianna Biggs  
**Status :** Open  
**Priority :** Medium **Asset Tag :**  
**Originated Date :** 01/16/2026 - John Barresi - National TAB

Heating fuses blown on RTU-2, heating currently unavailable.

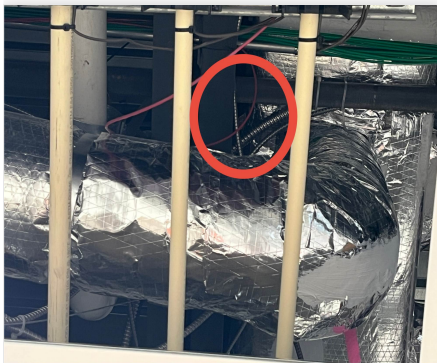
**Issue Name :** Supply 2-5 Low CFM  
**Description :** No matter different adjustments, Supply 2-5 will not deliver required CFM. Unable to physically reach damper in ductwork myself as reach is blocked by other pipes/tubes in the way. Damper was forced open by turning the lever with a stick; unable to verify how open/closed damper is.  
**Created By :** National TAB                      **Assigned To :** National TAB - Brianna Biggs  
**Status :** Open  
**Priority :** Medium                                      **Asset Tag :**  
**Originated Date :** 01/15/2026 - John Barresi - National TAB

unable to push air to diffuser 2-5, damper pushed open with stick, too much construct to reach damper successfully with ladder, unable to tell how open/closed 2-5 is.
