Report: Test and Balance
Date: 10/7/2021

PROJECT
KROGER 035-547 FRISCO, TX (PLATINUM PREDESIGN)

3205 W MAIN ST
FRISCO, TX

Project: KROGER 035-547 FRISCO, TX (PLATINUM PREDESIGN)

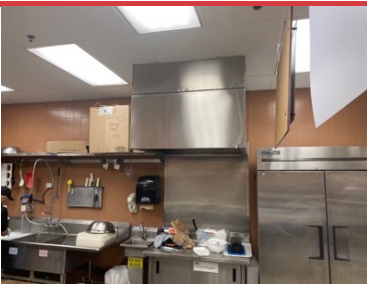
SEAFOOD HOOD

INFO ONLY	Hood 2 in the Deli is operating at 303 CFM/ft. For fryer cooking application 225 CFM/linear foot is typical. Recommend reducing closer to this airflow during final balancing to improve overall building performance.
INFO ONLY	Hood 3 (EF-4) in the Seafood area is not in use.

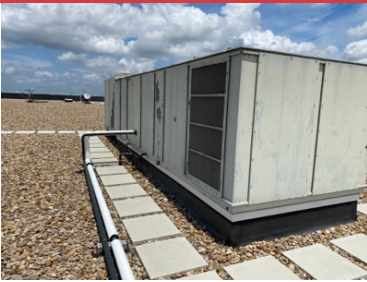
RTU NORTH

Missing 1-12X24X2. 2-24X24X2

RTU CHECKLIST	
RTU Unit Tag & Area Served:	RTU north main sales
Belts are tight and in good working order	yes
Pulleys are properly aligned	yes
Does the motor sheave have any additional adjustment?	yes
Disconnect switch installed?	yes
All electrical connections visually look in tack and no evidence of electrical damage? Describe:	yes
No noticeable vibration or noise exist correct? If so, specify:	yes
Outside air dampers installed and functioning	yes
If outside air is not functioning describe why?	n/a
Any loose Insulation inside RTU/AHU? If so, specify where:	no
Condensate Pans & drains free of debris & not clogged with Debris (dirt)?	yes
Any loose debris or components within Unit? If so, remove & describe. If cannot remove specify why.	RTU IS MISSING 1-12X24X2 AND 2- 24X24X2 FILTERS
Date of Inspection	6/24/2021

PRIORITY (HIGH/LOW/INFO ONLY)	
HIGH	RTU-1 (Main Sales unit) is missing 1-12X24X2 and 2- 24X24X2 FILTERS
HIGH	Building is currently net -2706 CFM. Recommendations below for slowing hood exhausts fans should help neutralize pressure along with increasing outside air on all RTU's during final balancing. Kroger corporate recommends approximately +1000 CFM building pressurization.
LOW	All RTU evaporator coils should be cleaned
LOW	All outside air filters for RTU's are clogged with dirt and need to be cleaned.
LOW	RTU-5 (bakery) has loose insulation inside filter door. Recommend securing
LOW	All RTU filters are dirty and should be replaced.
LOW	Condensor fins are bent on all RTU's. If possible to straighten, this would help improve performance.
LOW	All Trane RTU door hinges are damaged.
INFO ONLY	Hood 1 in the Deli is operating at 306 CFM/ft. For oven cooking application 150 CFM/linear foot is typical. May not be able to reduce that low but should be able to lower significantly during final balancing to improve overall building performance.

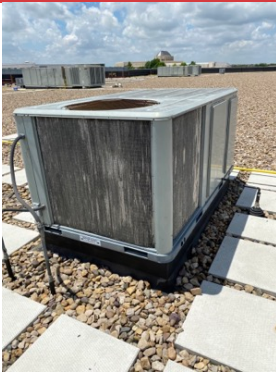
PHARMACY RTU3 CONDENSER COIL

Damaged fins

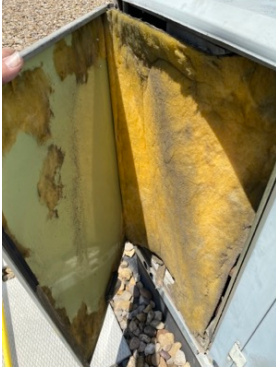
BAKERY RTU5 LOOSE INSULATION

RTU CHECKLIST (GENERAL AREAS)	
List all RTU(s) Unit Tag & Area Served for this checklist:	all RTU's general areas
List any RTU # that dont have belts tight and in good working order	n/a
List any RTU # that dont have pulleys properly aligned	n/a
Does the motor sheave have any additional adjustment? List any RTU's that are at max adjustment:	none
List any RTU # that dont have Disconnect switch installed?	n/a
All electrical connections visually look in tack and no evidence of electrical damage? Describe for each RTU:	yes
No noticeable vibration or noise exist correct? If so, specify type of noise & which RTU #:	yes
List any RTU # that dont have Outside air dampers installed and functioning	n/a
If outside air is not functioning describe why & which RTU #'s:	O/A filters are clogged
Any loose Insulation inside RTU/AHU? If so, specify where & which RTU #:	rtu5 bakery has loose insulation inside filter door

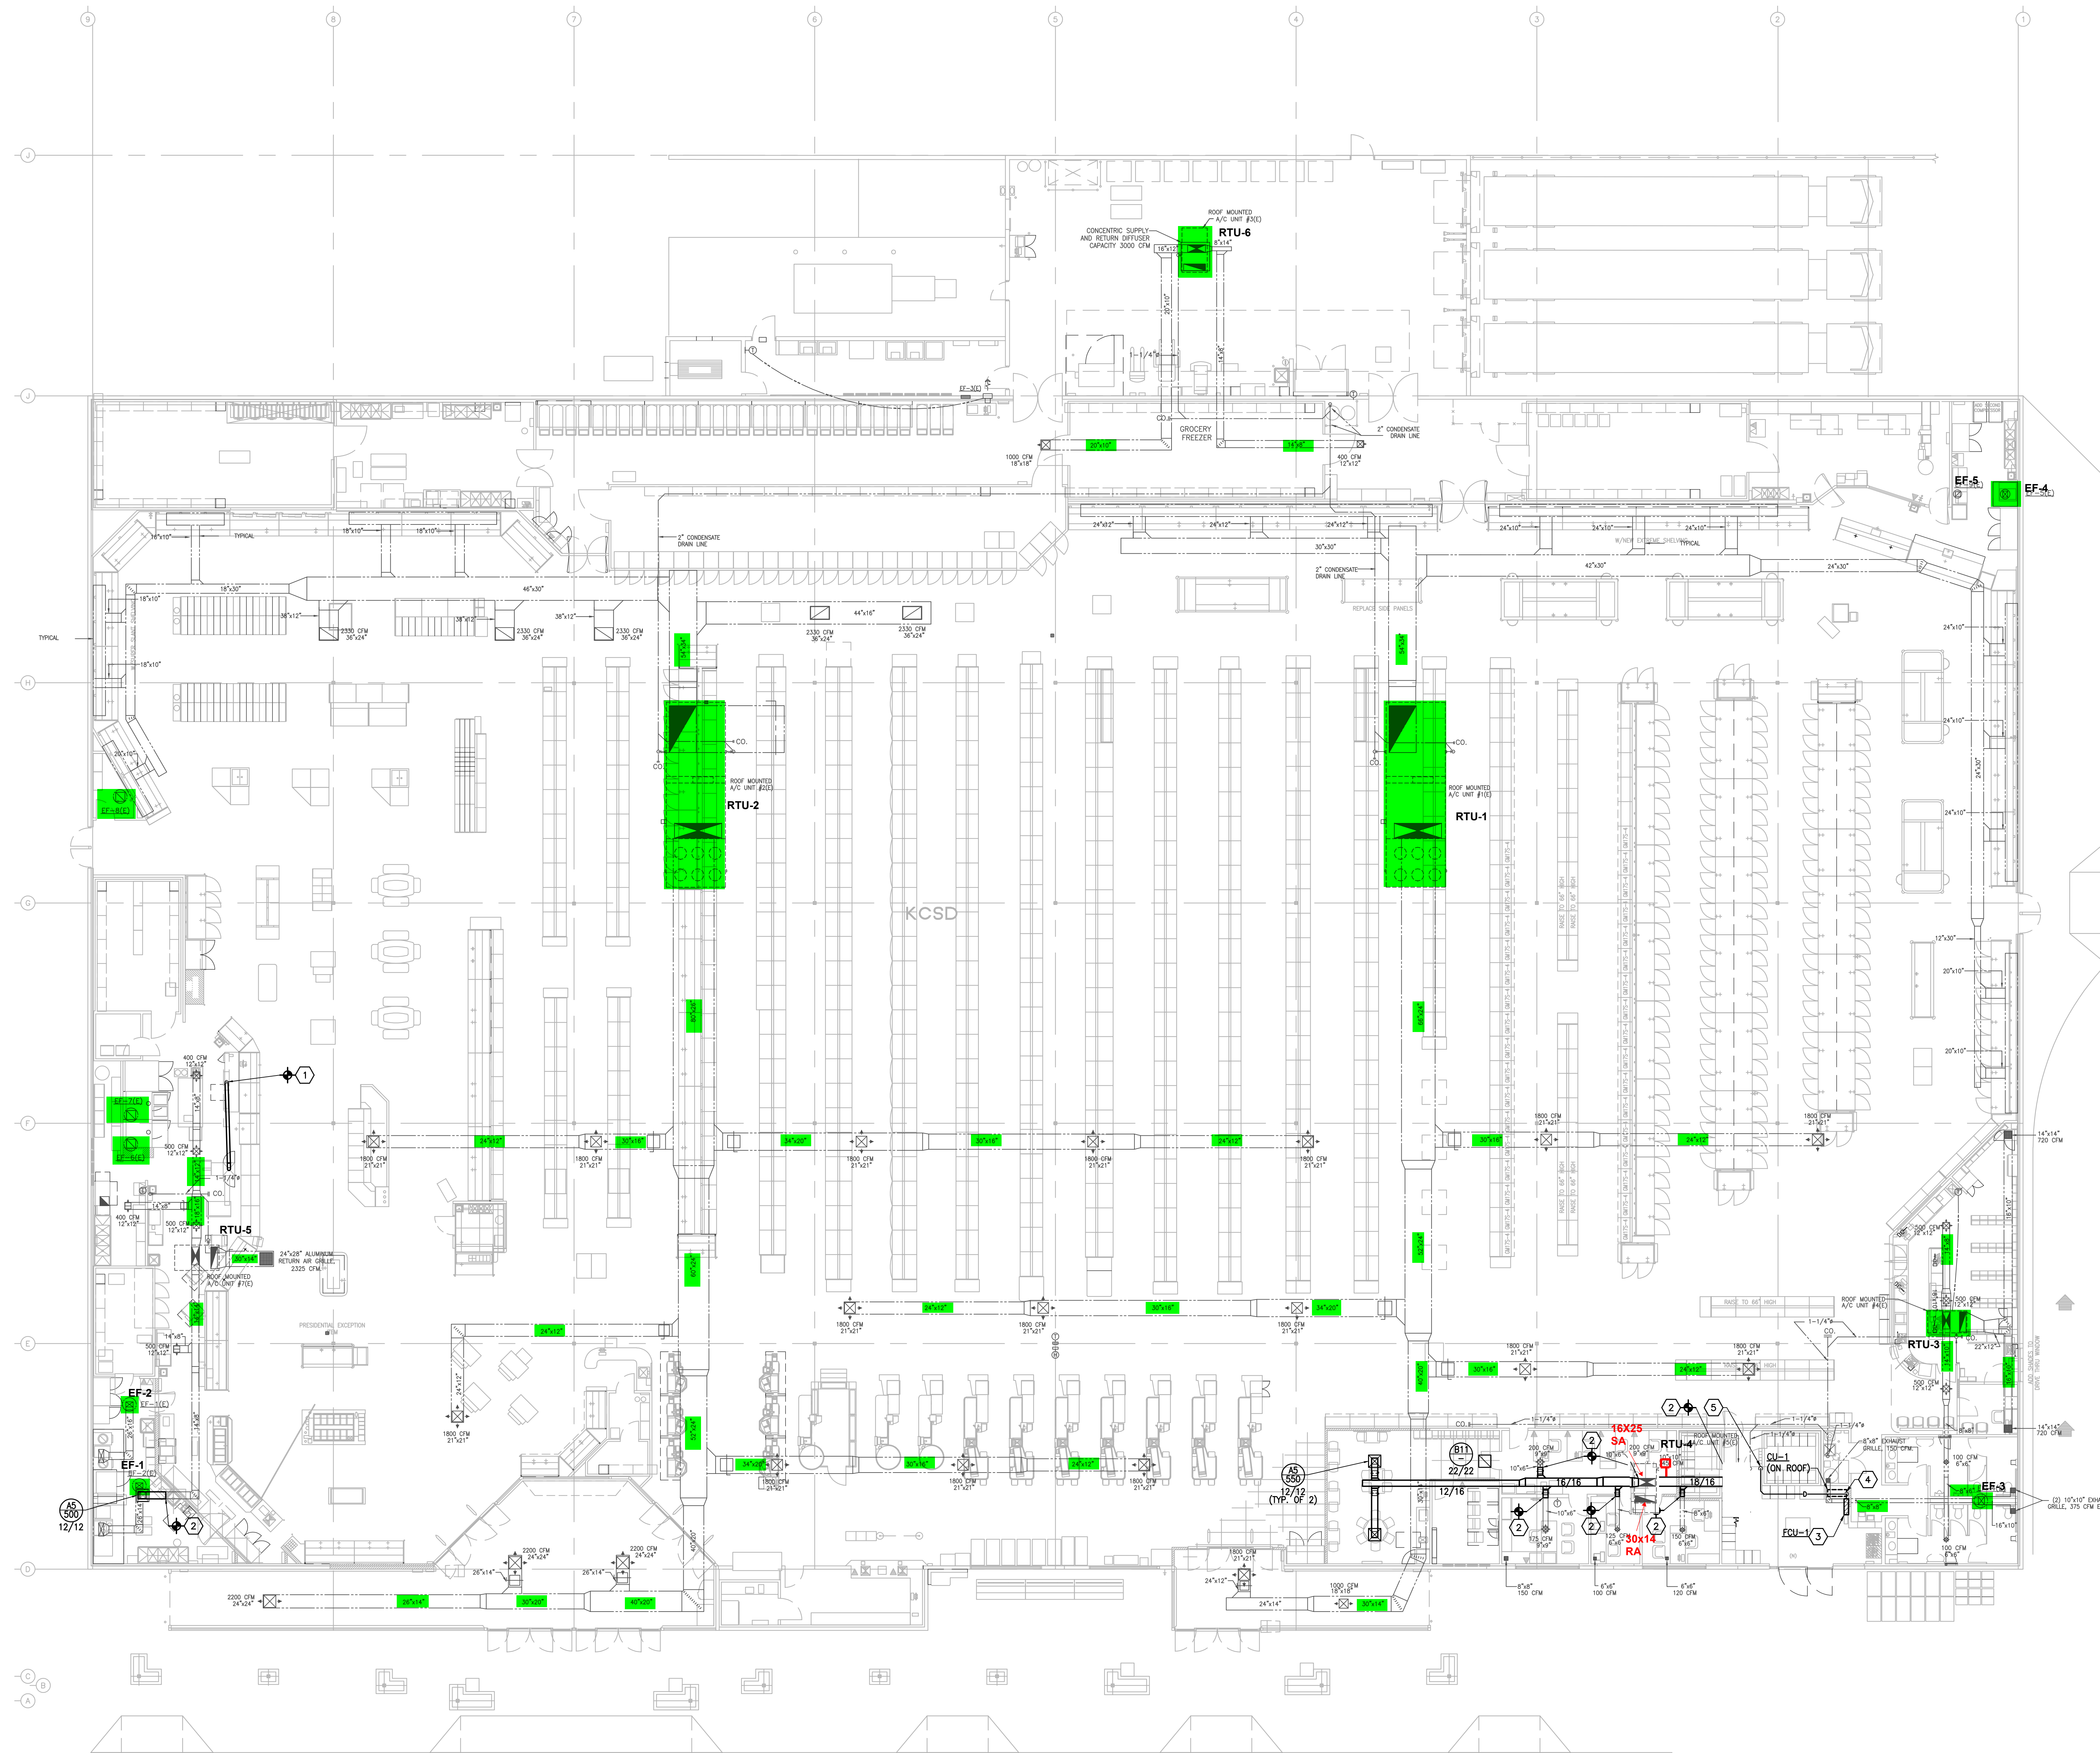
N   01 HVAC PLAN
SCALE: 3/32"=1'-0"

1. CONNECT 6" DOUBLE WALL TYPE "B" FLUE FOR TORTILLA MAKER TO EXISTING PIPING ROUTED UP THRU ROOF.
2. CONNECT TO EXISTING SUPPLY AIR DUCTWORK LOCATED ABOVE CEILING.
3. DUCTLESS SPLIT SYSTEM FAN COIL UNIT. ROUTE REFRIGERANT PIPING CONCEALED WITHIN WALL AND ABOVE CEILING TO CONDENSING UNIT ON ROOF. COORDINATE EXACT LOCATION WITH KROGER PM PRIOR TO INSTALLATION. RE: DETAIL HSD-11/MS.1 FOR MORE INFORMATION.
4. 3/4" CONDENSATE DRAIN PUMPED UP TO ABOVE CEILING.
5. CONDENSATE PIPING TURN DOWN TO APPROVED INDIRECT WASTE RECEPTOR BELOW. RE: P1.1 FOR DRAIN LOCATIONS.
