**Report: FINAL TAB REPORT
Function: Test, Adjust, & Balance
Date: 10/03/2022**

SWEETGREEN #NYM237 - GARDEN CITY, NY

Project: SWEETGREEN #NYM237 - GARDEN CITY, NY

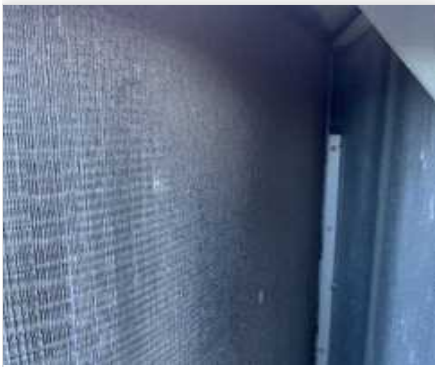
condensers.png

Issue Name : Condenser Coils for both RTU's are dirty and should be cleaned.
Description : .
Created By : National TAB **Assigned To :** National TAB - Will Turnbough
Status : Open
Originated Date : 10/04/2022 - Will Turnbough - National TAB

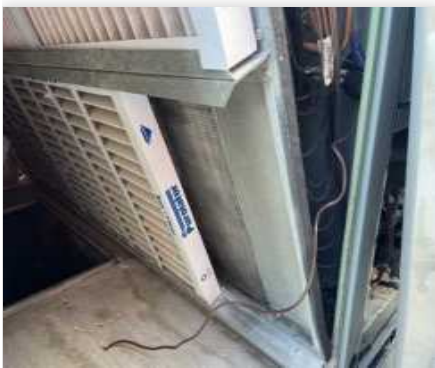
filters.png

Issue Name : Evaporator filters

Description : Evaporator coil filters are the wrong size and not adequately covering the coil. RTU's currently have (5) 20x25x2 filters. Correct sizes are (3) 20x25x2 and (3) 20x20x2

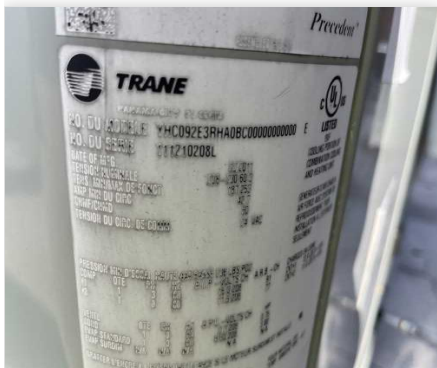
Image_2022_09_28T1510...

Issue Name : RTU-1

Description : RTU-1 SHOWS TO BE A YHC067 IN THE M-SHEETS. IT IS ACTUALLY A YHC092. UNIT IS SCHEDULED FOR 1600 CFM. GRILLES ADD TO 1300 CFM. GC DOES NOT HAVE SUBMITTALS DUE TO UNITS BEING EXISTING.

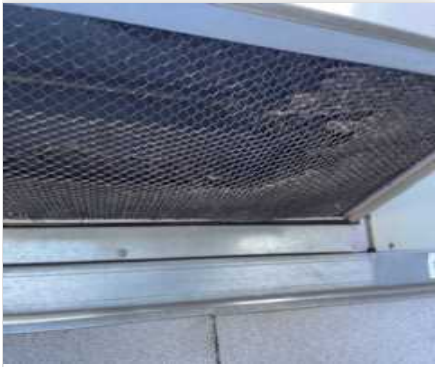
oafilters.png

Issue Name : RTU-1 OA Filter

Description : OA Filter is degrading and needs to be replaced.

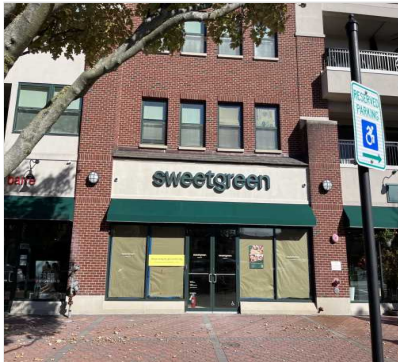
Image_2022_09_29T0856...

STORE FRONT

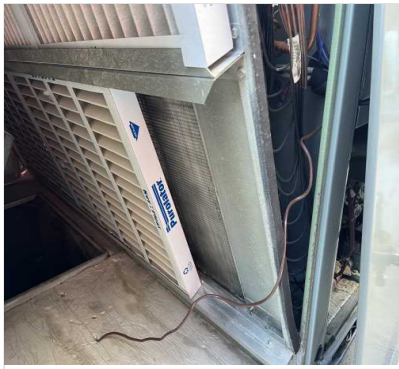
Economizers are assembled and functional?	YES
DCV Max damper opening position is set to minimum?	YES
Free cooling enthalpy set point set for lowest setting (Typically "D")	YES
Motors are all operating below the FLA rating?	YES
Are belts tight?	N/A
If direct drive unit is the speed controller working.	YES
Is gas piping installed and valves turned on?	GAS PIPING IS INSTALLED BUT VALVES ARE KEPT OFF DUE TO GAS NOT YET BEING TURNED ON TO SWEETGREEN SPACE.
Unit free of noticeable noise and vibrat	YES
Issue	CURRENT EVAPORATOR COIL FILTERS ARE WRONG SIZE AND ARE NOT ADEQUATELY COVERING COIL. RTUS CURRENTLY HAVE (5) 20x25x2 FILTERS. CORRECT SIZES ARE (3) 20x25x2 AND (3) 20x20x2 FILTERS.

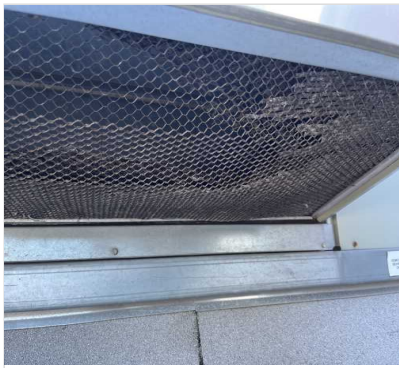
RTU-1 OUTSIDE AIR FILTER IS CORRODING.

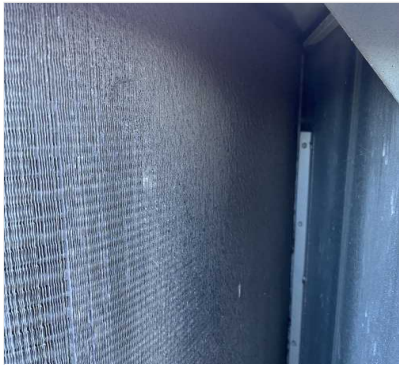
BOTH RTU CONDENSER COILS ARE DIRTY.

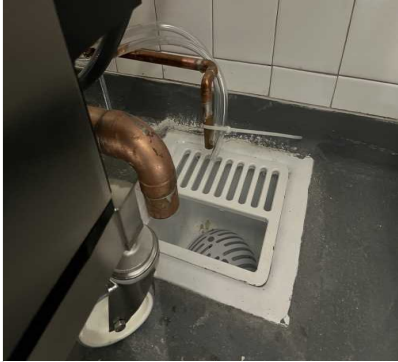
Is the oven covered by a hood?	YES
What is the hood overhang over the front of the hood?	21 1/2"
What is hood overhang over the left and right sides of the oven?	LEFT 16 1/2" RIGHT 6" UNABLE TO COMPLETELY CENTER OVEN UNDER FAN DUE TO DRAIN BEHIND OVEN. OVEN IS MOVED AS FAR LEFT AS POSSIBLE.

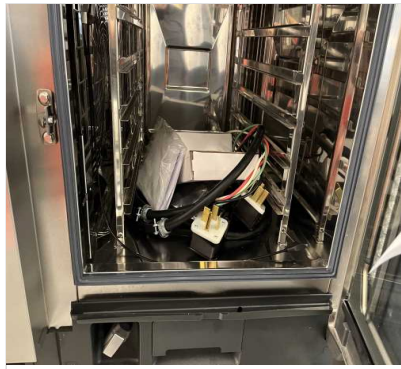
Image_2022_09_29T0924...

<p>Image_2022_09_29T0943...</p>	
If vertical end panels are specified, are they installed?	NOT SPECIFIED
SMOKE TEST AT HOOD	100%
If oven is capable of turning on, it is required to be turned on for smoke test. Was oven on for smoke test?	NOT CAPABLE OF TURNING ON. ELECTRICAL CORDS NOT YET INSTALLED.

Smoke test the oven at the flue on the top of the hood - Capture %?	100%
Smoke test the oven at perimeter of the oven - capture %?	100%
Smoke test the oven at the perimeter of the hood - capture %?	100%
IF NO HOOD IS INSTALLED ABOVE THE OVEN	
If no hood is installed above the oven, and it is only a grille, smoke test at the top of the oven at the flue and note the capture %. If smoke capture is very poor, hold the candle up by the grille after a few seconds so that the smoke alarms don't get set off.	N/A
SMOKE TEST AT OVEN	
Confirm that the internal fan turns on as you open the oven door?	OVEN IS NOT CAPABLE OF TURNING ON AT TIME OF BALANCE.
Smoke test at the oven doors as you are opening the door - capture %?	N/A
Smoke test at the oven doors when the doors are shut - capture %?	N/A
EXHAUST DISCHARGE AND OA INTAKES	
Identify where the exhaust air is discharged and take pictures	EXHAUST AIR IS DISCHARGED THROUGH EF-1 UPBLAST CONFIGURATION.

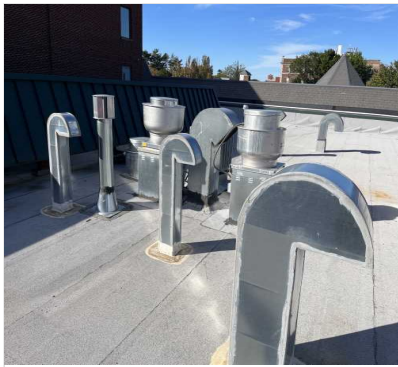
Are there any outside air intakes nearby that would be able to re-entrain the exhaust smoke? Take pictures

ALL NEARBY DUCTS ARE EXHAUST

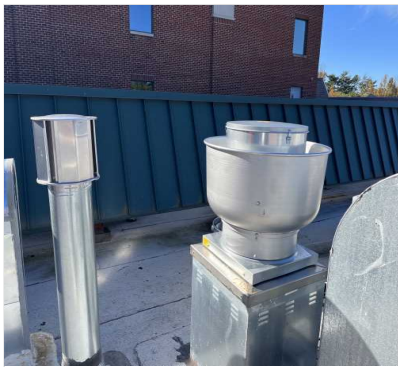
Are there any building entrances or windows near the exhaust discharge where smoke that will cause smoke to enter unwanted spaces?

NO. EXHAUST FANS AND OUTLETS ARE SEPARATED FROM RTUS BY WALL ON ROOF.
