**Report: FINAL TAB REPORT**  
**Function: Test, Adjust, & Balance**  
**Date: 10/03/2022**

## SWEETGREEN #NYM237 - GARDEN CITY, NY

191 7TH ST ST, B

GARDEN CITY, NY

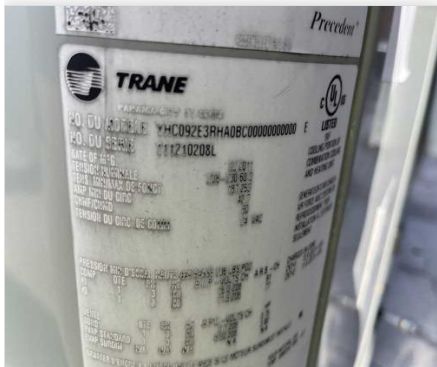
Image\_2022\_09\_28T1510...

**Description :** RTU-1 SHOWS TO BE A YHC067 IN THE M-SHEETS. IT IS ACTUALLY A YHC092. UNIT IS SCHEDULED FOR 1600 CFM. GRILLES ADD TO 1300 CFM. GC DOES NOT HAVE SUBMITTALS DUE TO UNITS BEING EXISTING.

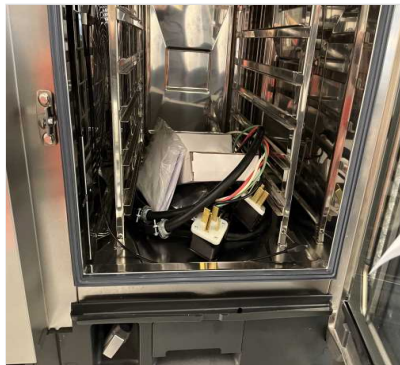
Image\_2022\_09\_29T0924...

| Can kitchen equipment be turned on for final smoke test? | NO. ELECTRICAL CORD TO OVEN IS NOT YET INSTALLED |

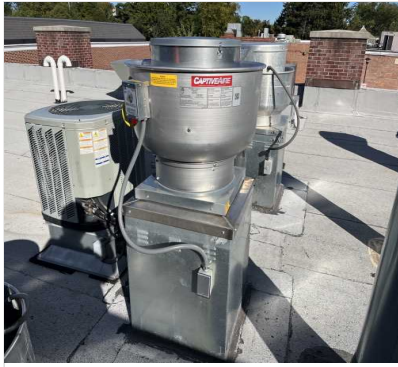
Image\_2022\_09\_29T0943...

| Identify where the exhaust air is discharged and take pictures | EXHAUST AIR IS DISCHARGED THROUGH EF-1 UPBLAST CONFIGURATION. |

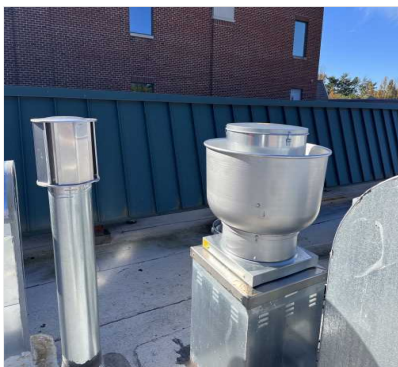
Image\_2022\_09\_29T0943...

NO. EXHAUST FANS AND OUTLETS ARE SEPARATED FROM RTUS BY WALL ON ROOF.
