Report: TAB Report
Function: Test, Adjust, & Balance
Date: 10/22/2025
Completed By: National TAB

PROJECT
10-20-25 QT #1111 SPARTANBURG, SC

Project: 10-20-25 QT #1111 SPARTANBURG, SC

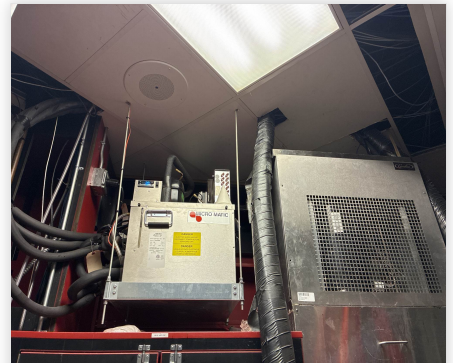
Issue Name : Diffuser Blocked
Description : The diffuser is in the correct location but is blocked by a ceiling tile. The air is being pushed elsewhere.
Created By : National TAB **Assigned To :** National TAB - Dan Hertenstein
Status : Open
Priority : InfoOnly **Asset Tag :** SGRD13
Originated Date : 10/22/2025 - Alex Bauer - National TAB

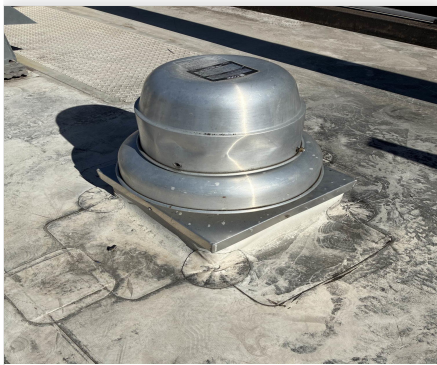
Issue Name : EF-1 Speed Controller Not Working
Description : EF-1 speed controller not functioning properly. Exhaust only runs at max speed. High flow.
Created By : National TAB **Assigned To :** National TAB - Dan Hertenstein
Status : Open
Priority : Low **Asset Tag :** EF1
Originated Date : 10/23/2025 - Alex Bauer - National TAB

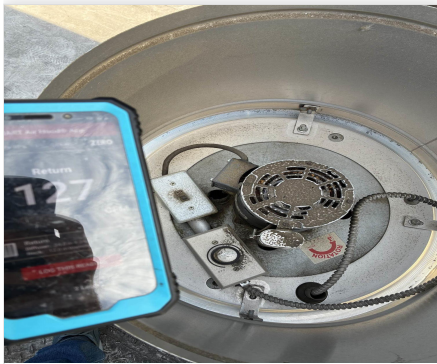
Issue Name : EF-2 Low Flow
Description : EF-2 low flow. The speed dial is set to max.
Created By : National TAB **Assigned To :** National TAB - Dan Hertenstein
Status : Open
Priority : InfoOnly **Asset Tag :** EF2
Originated Date : 10/24/2025 - Alex Bauer - National TAB

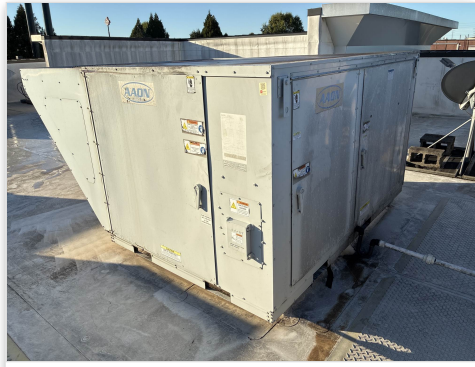
Asset: RT-1

Unit Data	
	Actual
MFG	AAON
Serial Num	201109-ANEK05349
Model Num	RN-013-8-0-EA0A-152
Num OA Filters 1	1
OA Filter Size 1	44.5X22.5

Test Data		
	Design	Actual
SF CFM	4200	4340
SF RPM	-	DD/40 Hz
OA CFM (Hoods On)	800	862
OA CFM (Hoods Off)	350	369
RL Voltage	-	124 VFD
RL Amperage	-	8.20 VFD
VFD Max SetPt	-	40 Hz
OA Damper Position (Hoods On)	-	46%
OA Damper Position (Hoods Off)	-	26%

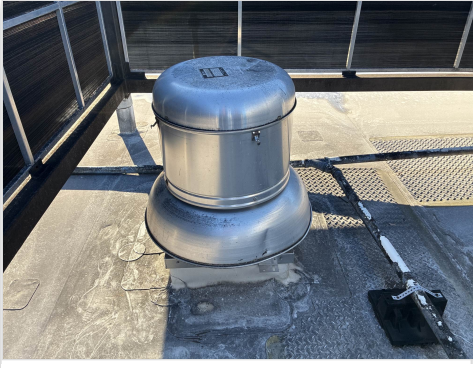
Asset: EF2

Unit Data		
	Design	Actual
MFG	NA	COOK
Model Num	NA	120 ACE 120C13D 33
Serial Num	-	418SD82032- 00/0002101
Type	-	UPBLAST
Configuration	-	VERTICAL

Test Data		
	Design	Actual
CFM	525	253
Fan RPM	-	DD
Fan Rotation	-	CCW
Motor RPM	-	DD
System SetPt	-	MAX ON DAIL
RL Voltage	-	NA
RL Amperage	-	NA
Total ESP	-	0.17"
Fan Inlet SP	-	-0.17"
Fan Discharge SP	-	ATMO

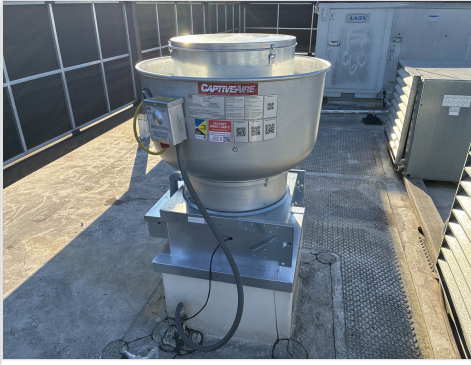
Asset: EF3

Design	Actual
MFG	NA	CAPTIVEAIRE
Model Num	NA	DU50HFA
Serial Num	-	8236640
Type	UPBLAST	UPBLAST
Configuration	VERTICAL	VERTICAL
