Report: TAB Report
Function: Test, Adjust, & Balance
Date: 04/29/2025
Completed By: National TAB

04-28-25 Penn Station (Massillon, OH)

1139 Lincoln Way East

Massillon , OH 44646

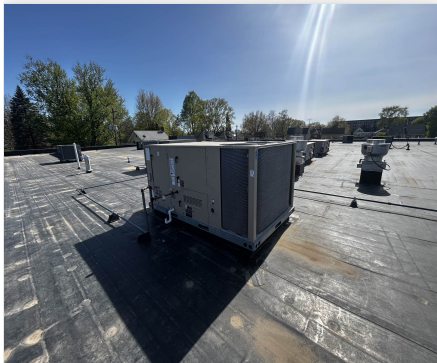
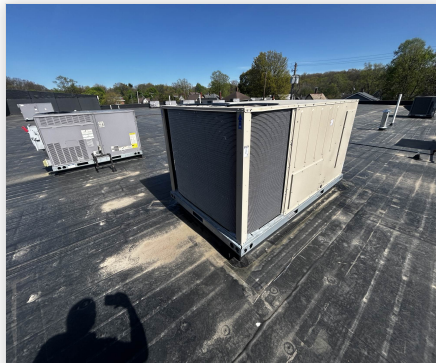
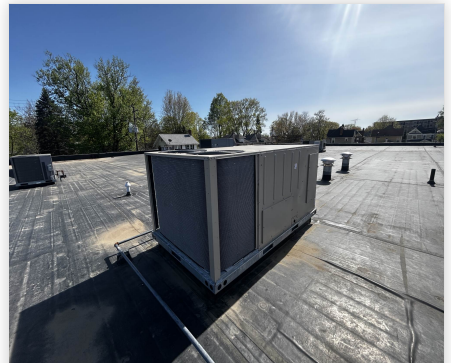
Issue Name : Hail Guards
Description : RTU1 & RTU2 are missing their hail guards recommend installing
Created By : National TAB **Assigned To :** National TAB - Kristopher Passley
Status : Open
Priority : Medium **Asset Tag :**
Originated Date : 04/29/2025 - Kristopher Passley - National TAB

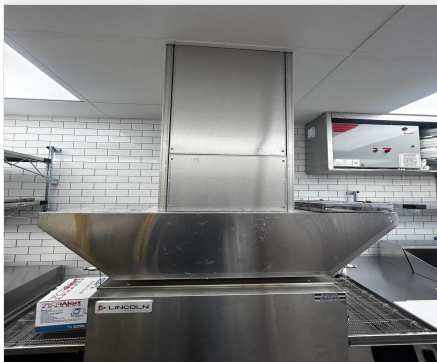
Issue Name : Hood 2 Tag
Description : Tag is missing from hood
Created By : National TAB **Assigned To :** National TAB - Kristopher Passley
Status : Open
Priority : Low **Asset Tag :**
Originated Date : 04/29/2025 - Kristopher Passley - National TAB

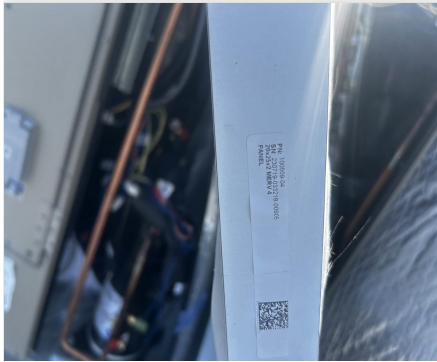
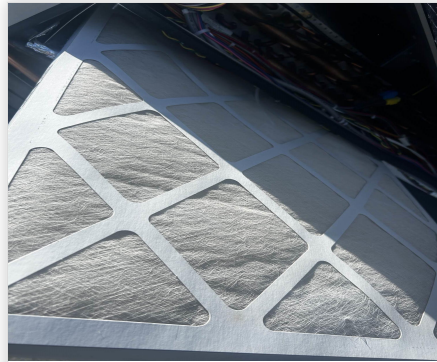
Issue Name : RTU-1 Final Filters
Description : Final filters are filled with construction dust and is currently a MERV 4 rated filter. Recommend replacing filters with MERV 8 or better.
Created By : National TAB **Assigned To :** National TAB - Kristopher Passley
Status : Open
Priority : Medium **Asset Tag :**
Originated Date : 04/29/2025 - Kristopher Passley - National TAB

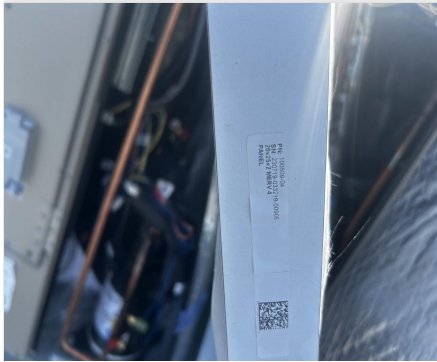
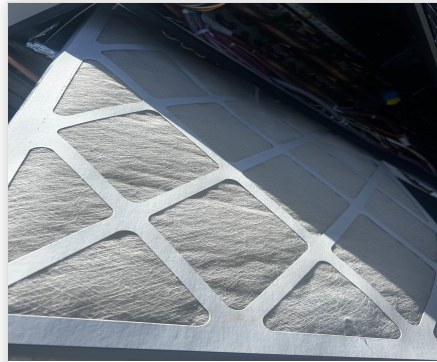
Issue Name : RTU-2 Final Filters
Description : Final filters are filled with construction dust and is currently a MERV 4 rated filter. Recommend replacing filters with MERV 8 or better.
Created By : National TAB **Assigned To :** National TAB - Kristopher Passley
Status : Open
Priority : Medium **Asset Tag :**
Originated Date : 04/29/2025 - Kristopher Passley - National TAB

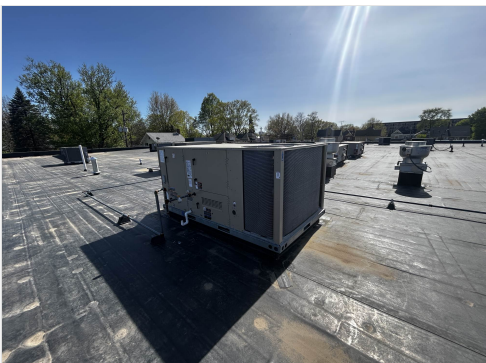
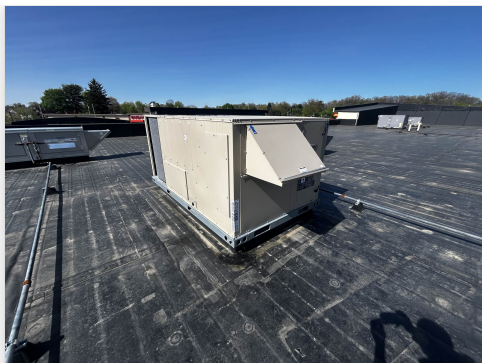
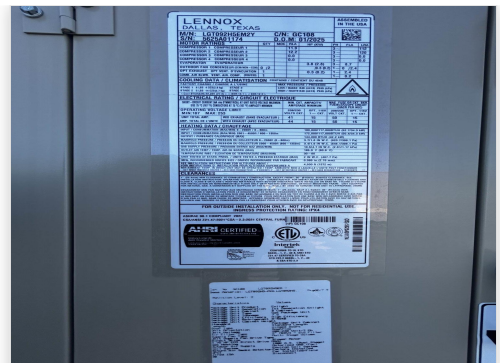
Unit Data - PHOTO LOG

Unit Data		
	Design	Actual
MFG	LENNOX	LENNEX
Serial Num	-	5625A01174
Model Num	LGH092H	LGT092H5EM2Y
Type	RTU	RTU
Configuration	VERTICAL	VERTICAL
Num OA Filters 1	-	1
OA Filter Size 1	-	16"X25"X1"
Num Final Filter 1	-	4
Final Filter Size 1	-	20"X25"X2"

General	
	Actual
Fan Rotation Correct	YES
Unit Filters Clean	NO
Condensate Drain Installed	YES

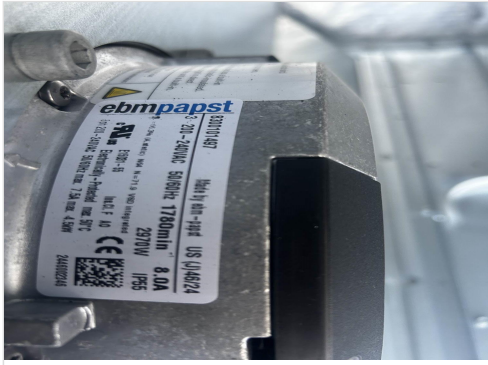
Motor Data - PHOTO LOG

Motor Data		
	Design	Actual
Motor MFG	-	EBMPAPST
Frame	-	IP55
Horsepower	-	3.8
Motor Rpm	-	1780
Phase	-	3
Rated Voltage	-	200-240
Rated Amperage	-	8.0

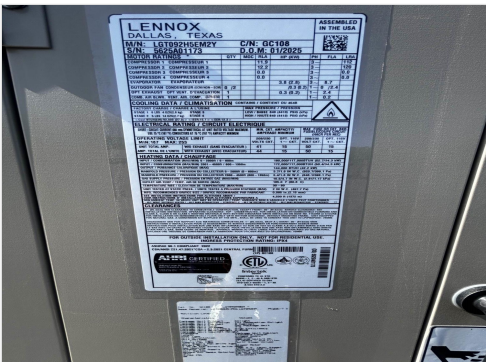
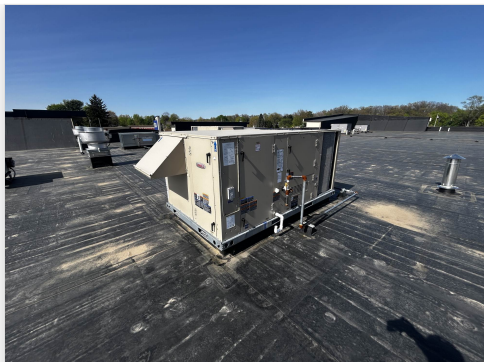
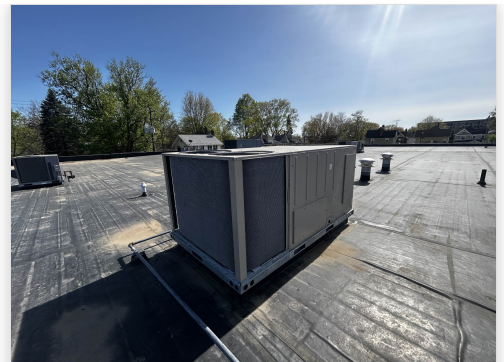
Unit Data - PHOTO LOG

Unit Data		
	Design	Actual
MFG	LENNOX	LENNOX
Serial Num	-	5625A01173
Model Num	LGH092H	LGT092H5EM2Y
Type	RTU	RTU
Configuration	VERTICAL	VERTICAL
Num OA Filters 1	-	1
OA Filter Size 1	-	16"X25"X1"
Num Final Filter 1	-	4
Final Filter Size 1	-	20"X25"X2"

General	
	Actual
Fan Rotation Correct	YES
Unit Filters Clean	NO
Condensate Drain Installed	YES

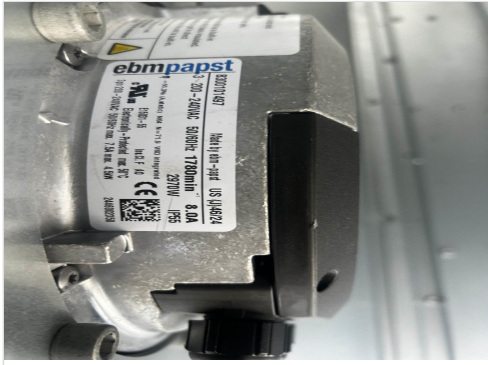
Motor Data - PHOTO LOG

Motor Data		
	Design	Actual
Motor MFG	-	EBMPAPST
Frame	-	IP55
Horsepower	-	3.8
Motor Rpm	-	1780
Phase	-	3
Rated Voltage	-	200-240
Rated Amperage	-	8.7
